**River Corridor Plan for Tubbs and Ladd Brook in Pownal  
and Bennington, Vermont**

**December 14, 2017**

**Fitzgerald Environmental Associates, LLC.**  
18 Severance Green, Suite 203  
Colchester, VT 05446

**Bennington County Regional Commission**  
111 South Street, Suite 203  
Bennington VT, 05201

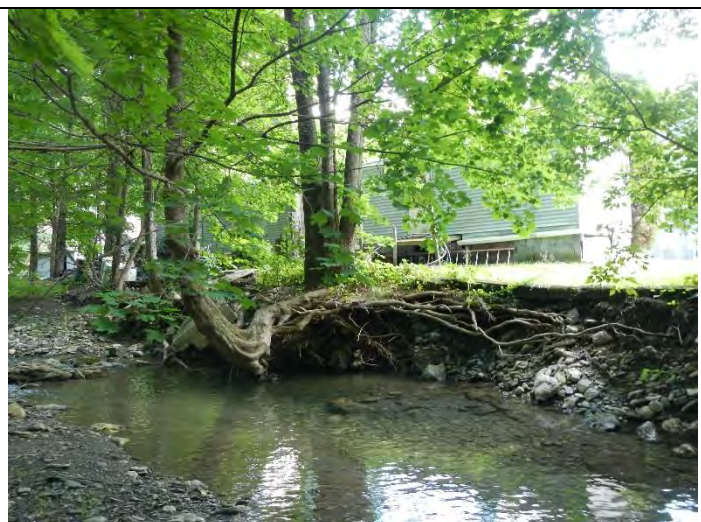
**Reach Highlights:** Historically this reach was incised due to straightening through agricultural fields. There is evidence of deposition from sediment loads working their way through the channel following T.S. Irene. We assessed this reach as stage II progressing towards stage III due to the channel’s relatively stable banks and little evidence of planform adjustment. The stream departed from a C to a F-type channel due to incision and entrenchment.

Incised channel in a very broad valley

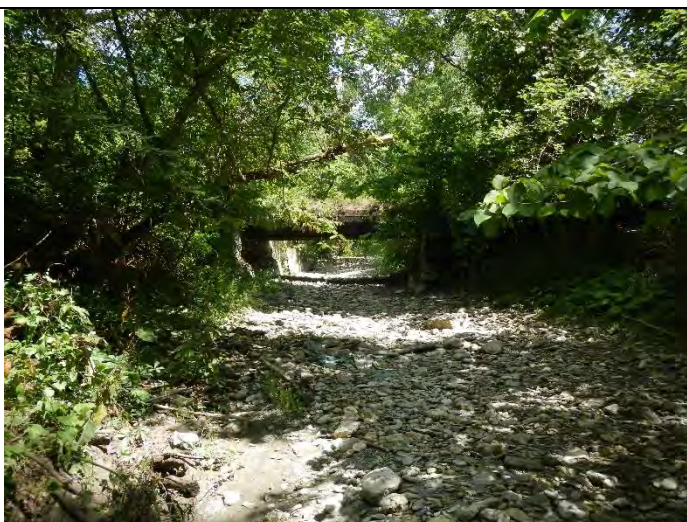
F-type channel; partially dry during assessment

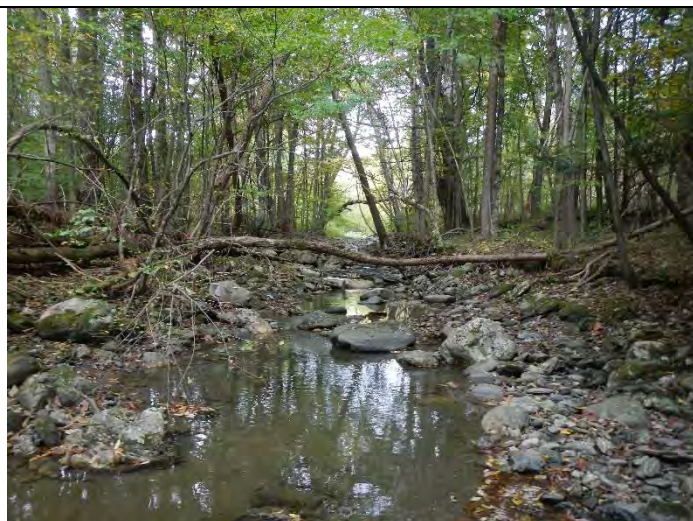
C-type channel in a narrow unconfined valley

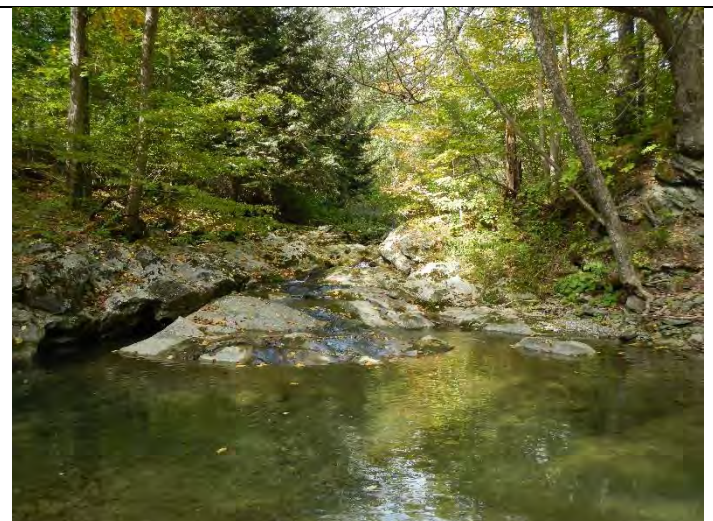
Bedrock cascade grade control

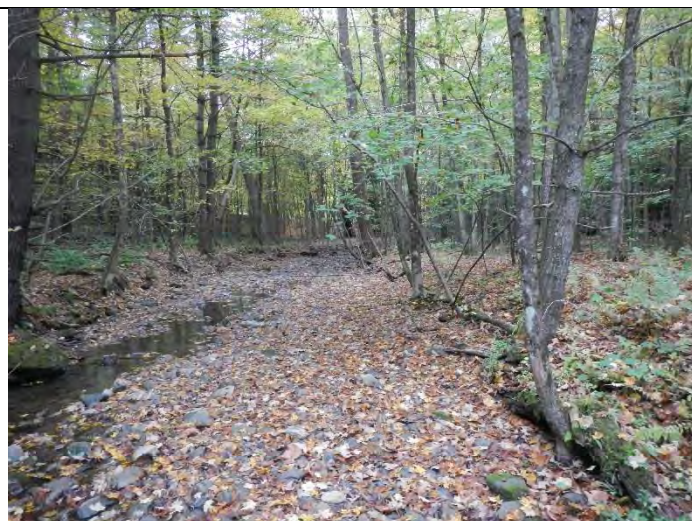
C-type channel in an unconfined valley

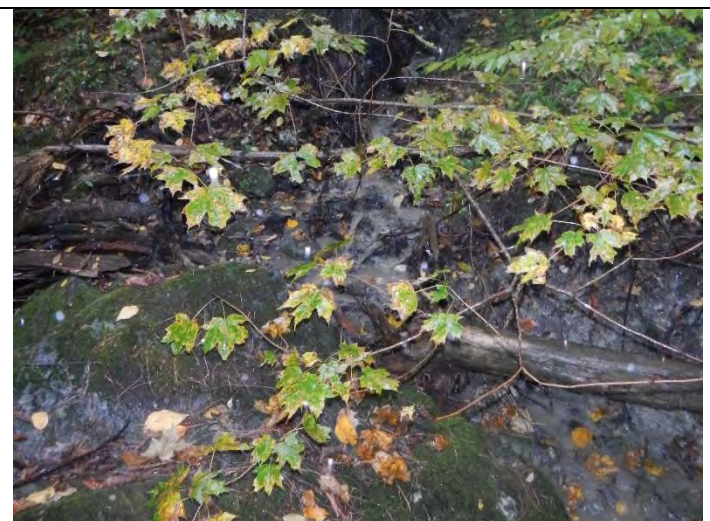
Stormwater runoff from Hemlock Hill Road

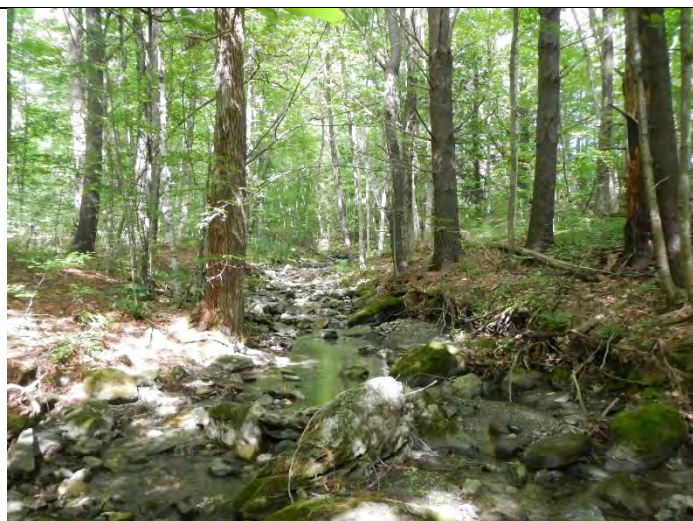
Broader valley upstream of bedrock gorge

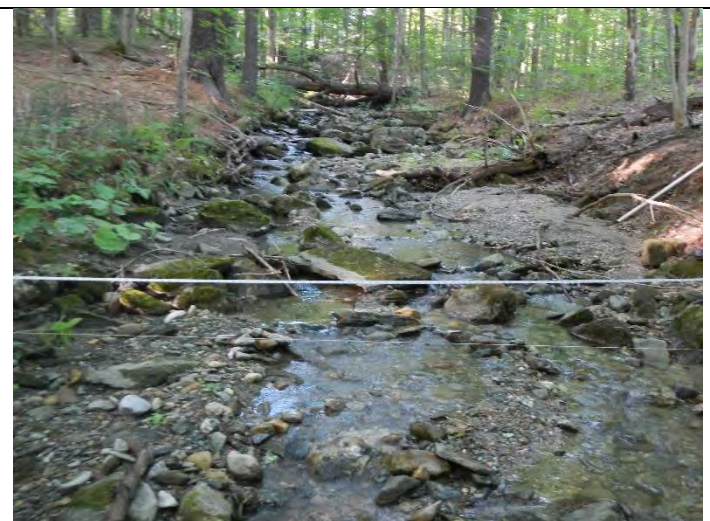
Poorly sorted sediment in an aggrading channel

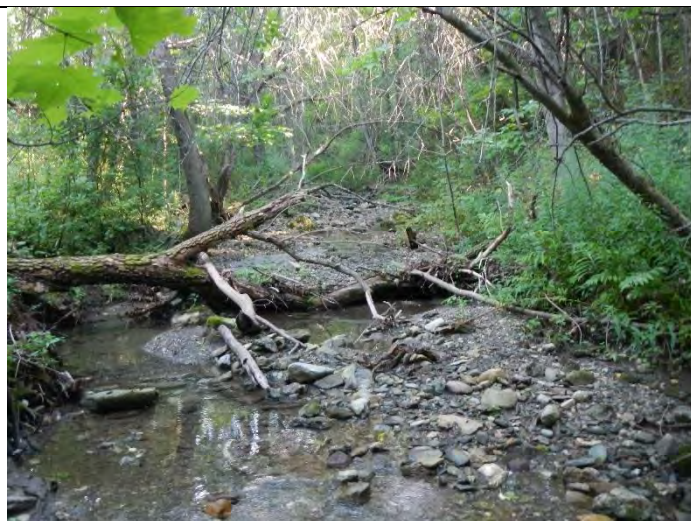
Adjusting channel in an unconfined valley

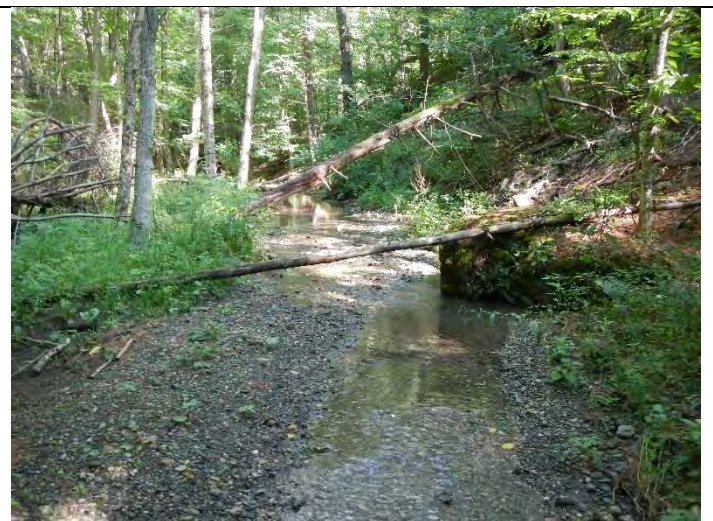
Aggradation of gravel

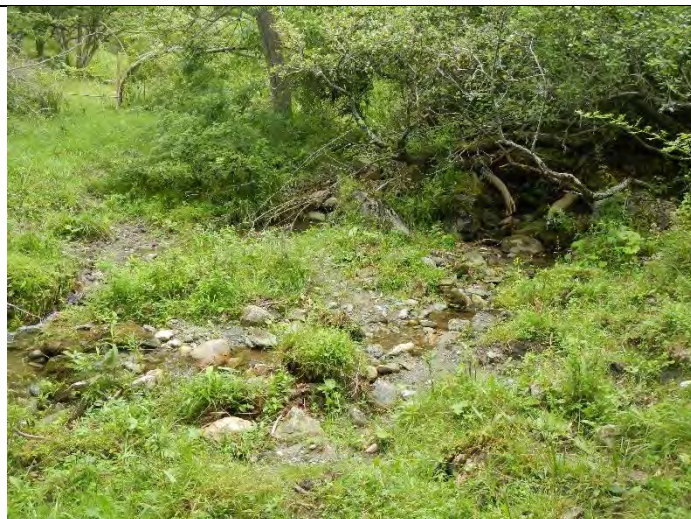
Channel braiding and aggradation

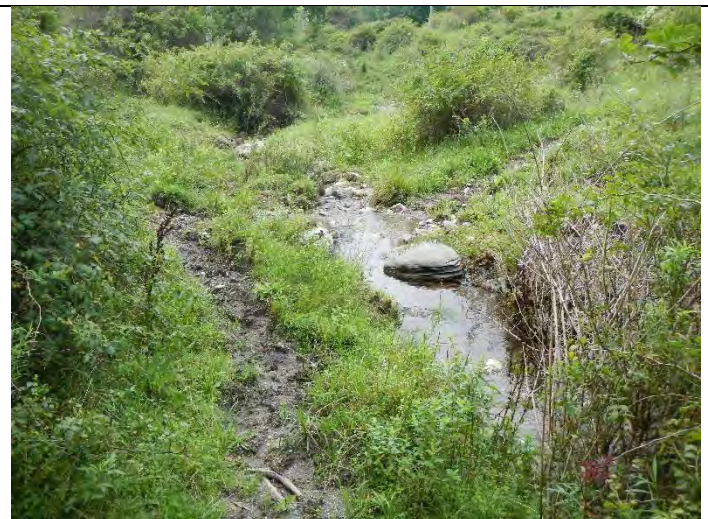
Cow paths adjacent to and crossing the reach

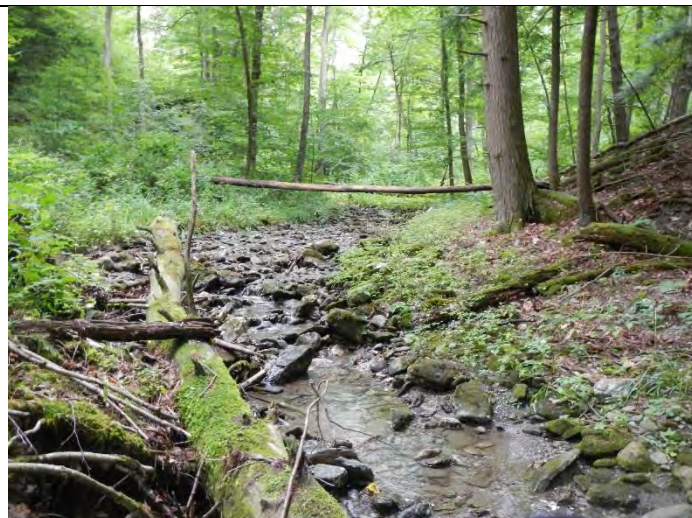
Narrow valley with a widening channel

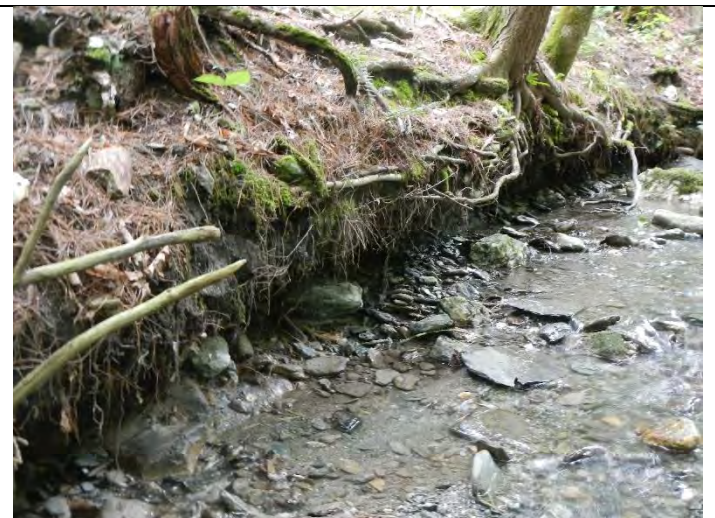
Scoured banks and poorly sorted sediment

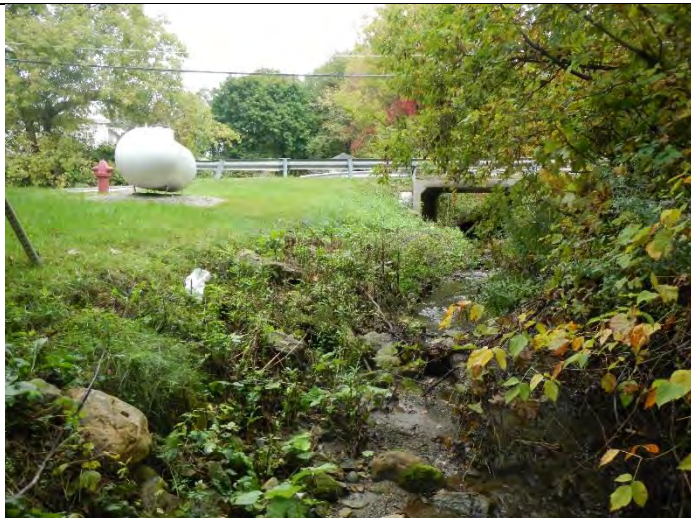
Incised channel in a very broad valley

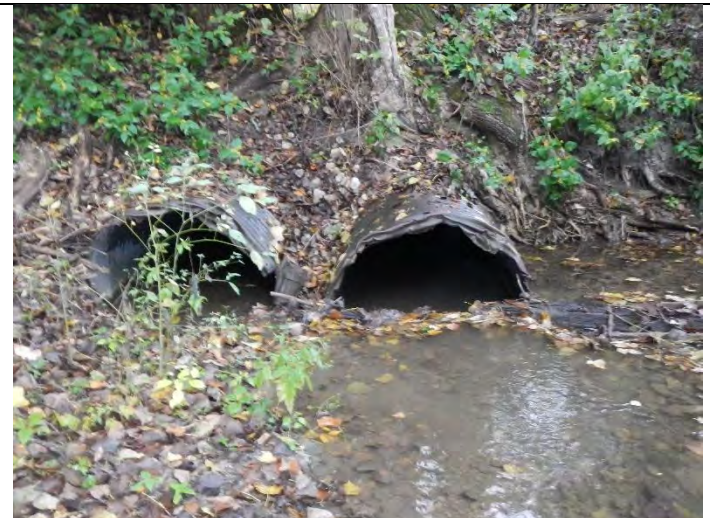
Constrictions affecting channel drainage

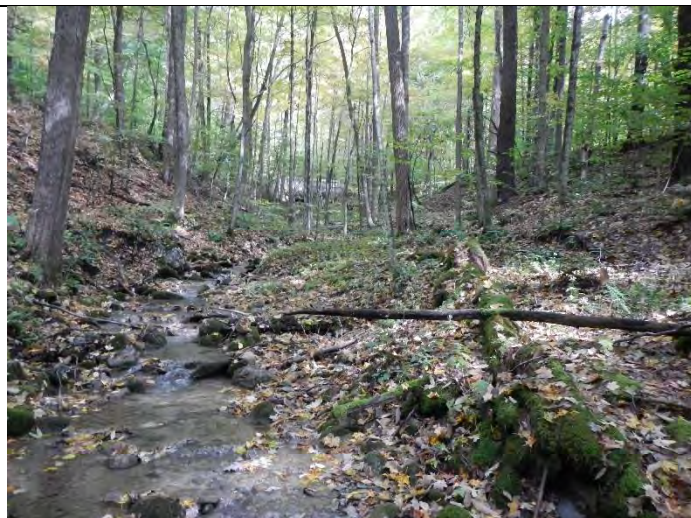
Planform adjustment in a semi-confined valley

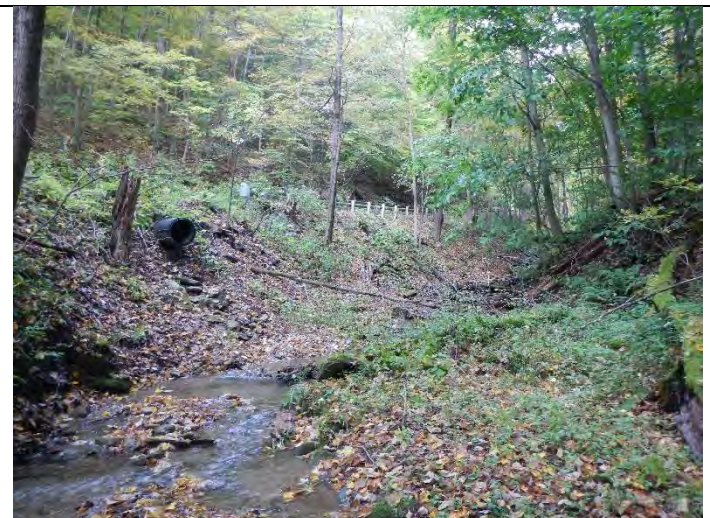
Stormwater outlet and steep embankment along Ladd Rd

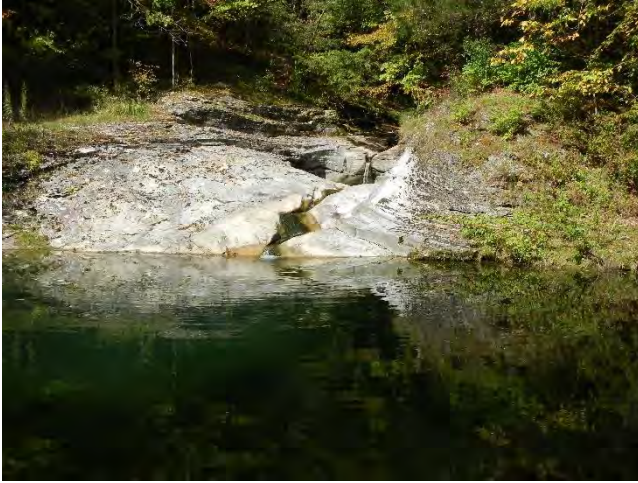
**Figure 4.7:** Grade controls in reach M01T1.02.

- Areas with numerous natural grade control on segments: M01T1.02, M01T1.04A, M05S1.02 (Figures 4.7 and 4.8).
- Small on-stream dams are located on reach M05S.01 (Figure 4.9) and M05S1.02 (Figure 4.10).

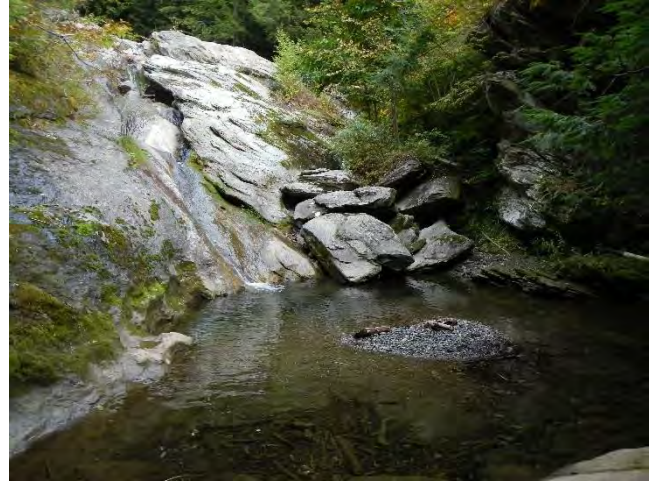
**Figure 4.8:** Grade controls in segment M01T1.04A.

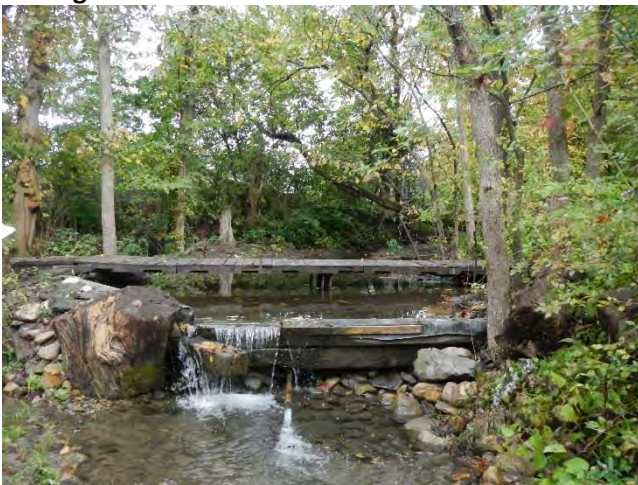
**Figure 4.9:** Small wooden dam in reach M05S1.01.

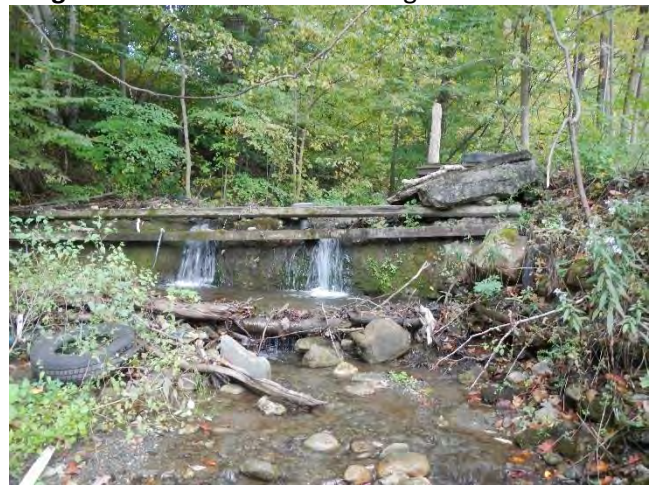
**Figure 4.10:** Small concrete dam in reach M05S1.02.

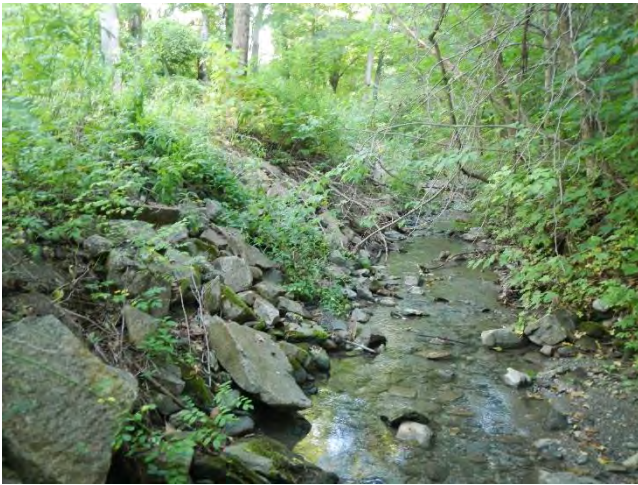
**Figure 4.11:** Bank armoring pinching channel along Mt. Anthony Road on segment M01T1.04C.

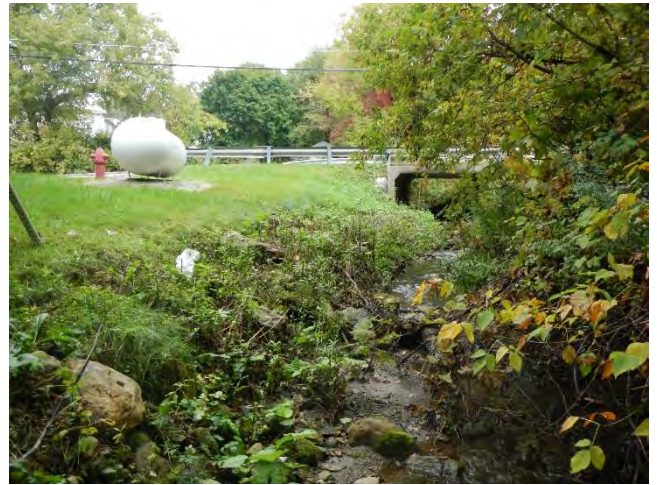
**Figure 4.12:** Church Street bank armoring in reach M05S1.01.

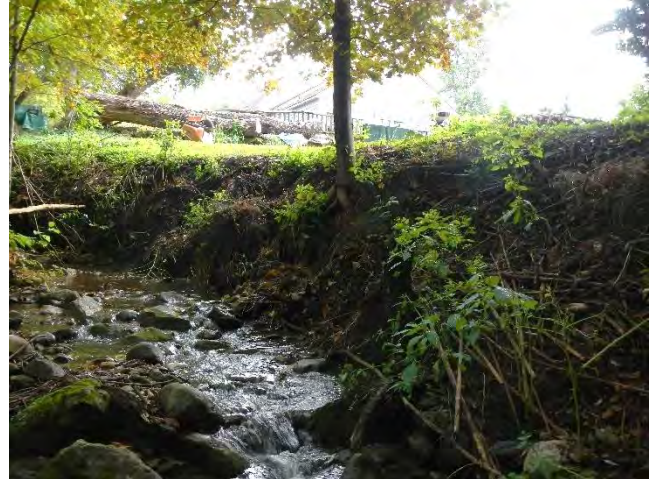
**Figure 4.14:** Bank erosion and buffer impacts in reach M05S1.01.

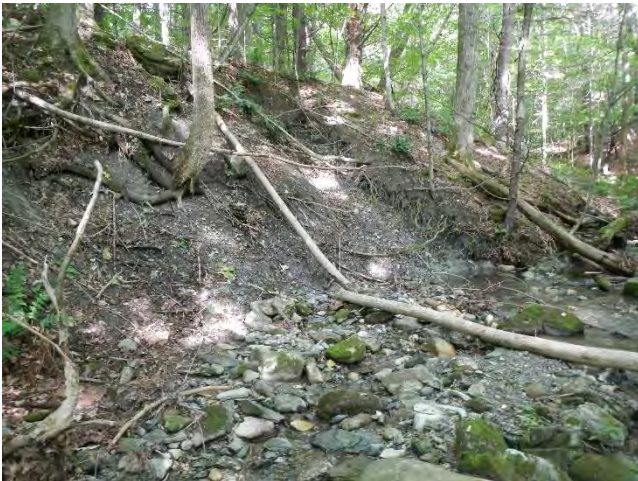
- Multiple mass failures in segments: M01T1.04B, M01T1.04C, M01T1.04S1.01, M05S1.02 (Figures 4.15 and 4.16).
- High density of riparian buffer width impacts in segments: M01T1.01, M01T1.04D, M05S1.01, M05S1.02.

**Figure 4.15:** Mass failure on reach M01T1.04C.

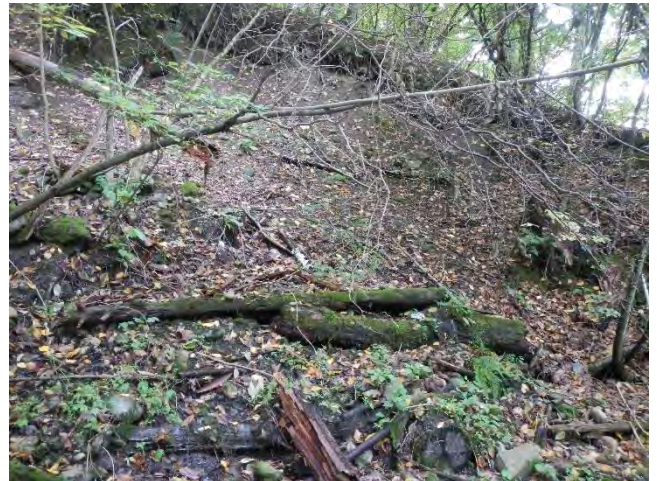
**Figure 4.16:** Mass failure on reach M05S1.02.

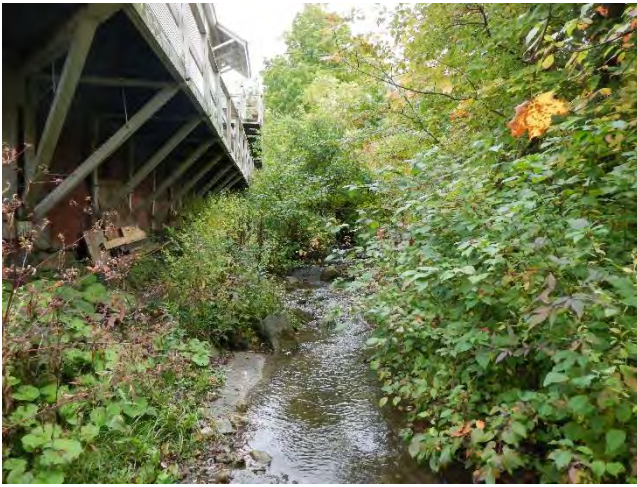
**Figure 4.19:** Extreme straightening along reach M05S1.01.

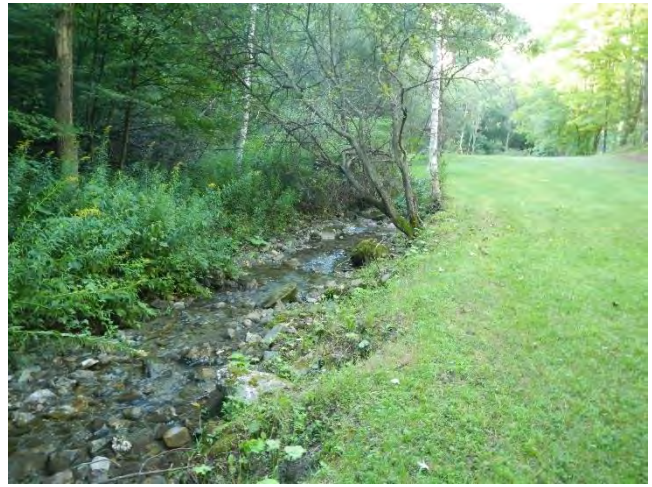
**Figure 4.20:** High straightening along segment M01T1.04C.

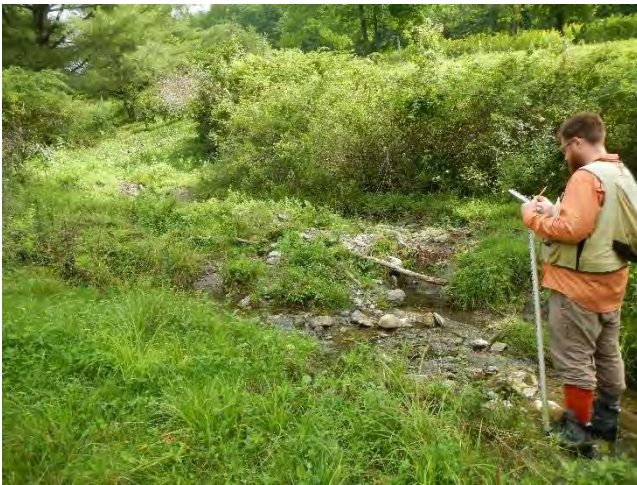
**Figure 4.21:** Extreme encroachment from Mt. Anthony Road embankment in Bennington on segment M01T1.04D.

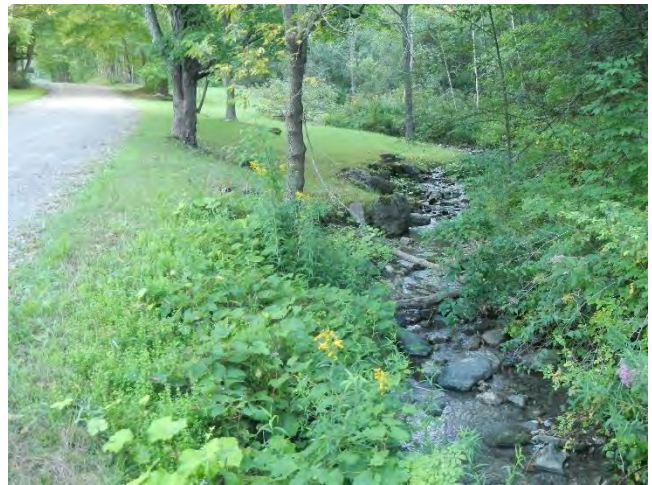
**Figure 4.22:** High encroachment along Mt. Anthony Road on reach M01T1.04C.

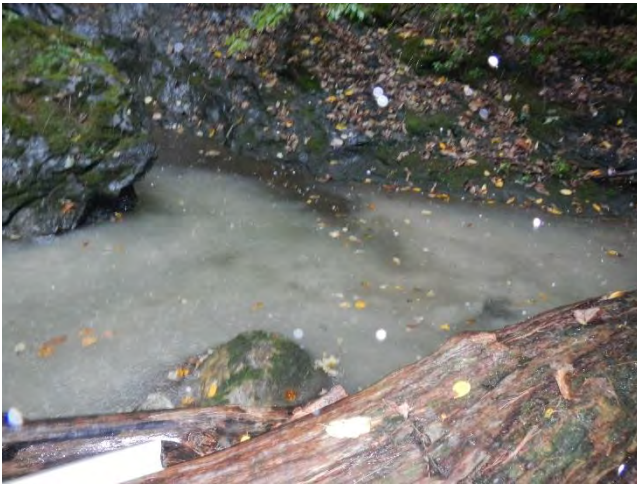
**Figure 4.25:** Turbid water entering channel from gully on M01T1.03.

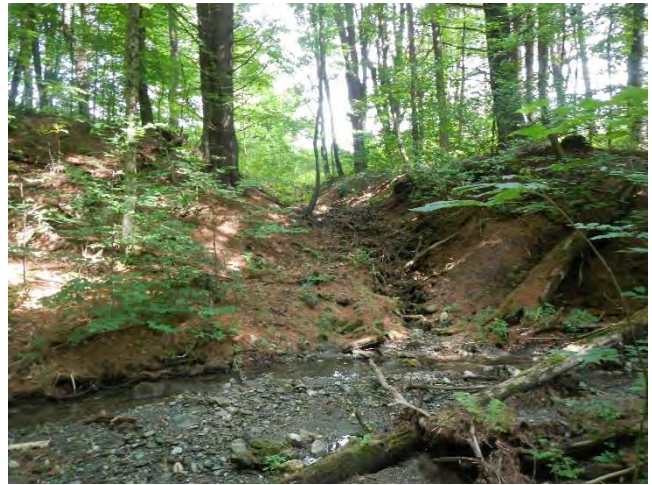
**Figure 4.26:** Gully on M01T1.04.C.

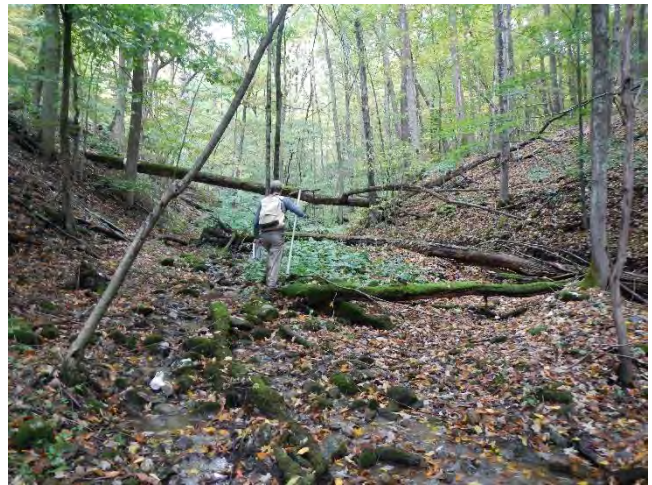
- Areas with high density of debris jams on segments: M01T1.03, M01T1.04.A, M01T1.04.B, M01T1.04.C, M01T1.04.S1.01, M05S1.02 (Figure 4.28).
- Areas with numerous natural grade control on segments: M01T1.02, M01T1.04A, M05S1.02.
- Small on-stream dams are located on reach M01T1.04.D.

**Figure 4.28:** Woody debris trapping sediment within the channel on M05S1.02.

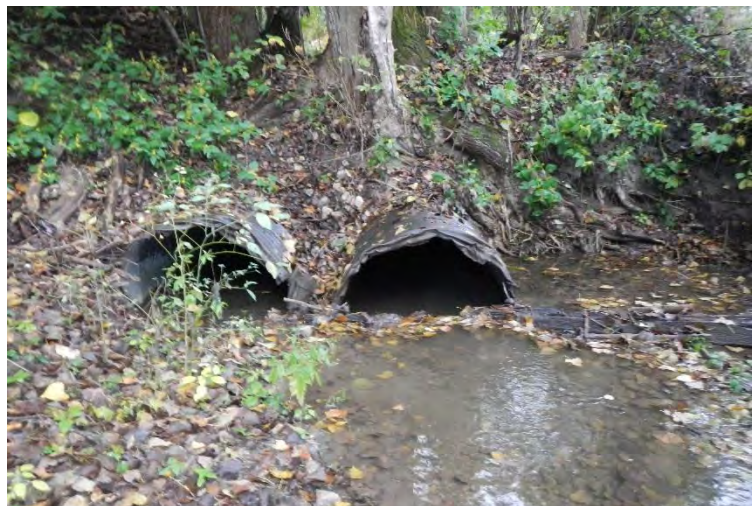
**Figure 5.1:** Partially plugged undersized culverts on Ladd Brook.

excessive erosion, and limited aquatic organism passage (Figure 5.1 and Tables 5.1 and 5.2). Debris jams formed during T.S. Irene on some of the larger bridges - particularly those with piers - exacerbating area flooding and infrastructure damage. As such structures come up for replacement, resizing them to accommodate expected discharge and sediment loads and placing them in proper alignment with stream channels is highly recommended.
