APPENDIX E:

High Priority Projects

Tubbs Brook High Priority Projects

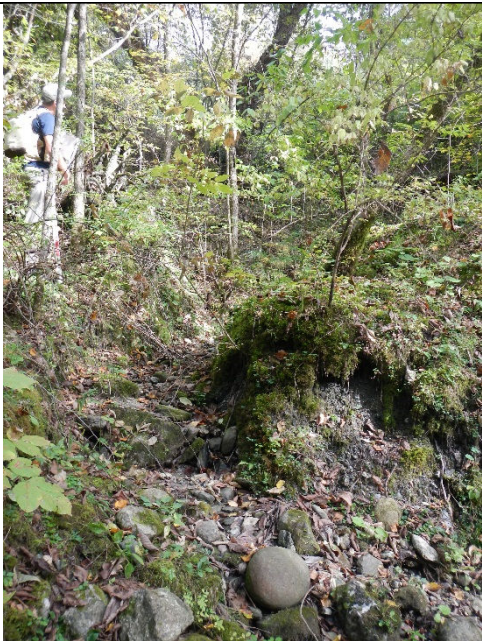
<p>Tributary: Tubbs Brook</p> <p>Town: Pownal</p> <p>Reach: M01T1.02</p> <p>Project #: TB 6</p> <p>Project Type: Stormwater Treatment and Gully Stabilization</p> <p>Site Description: A cross culvert carrying runoff from Skiparee Road and upstream areas has caused significant gully erosion of the valley wall and along the floodplain leading to Tubbs Brook. BCRC has submitted a Watershed Grant application to address this site.</p>

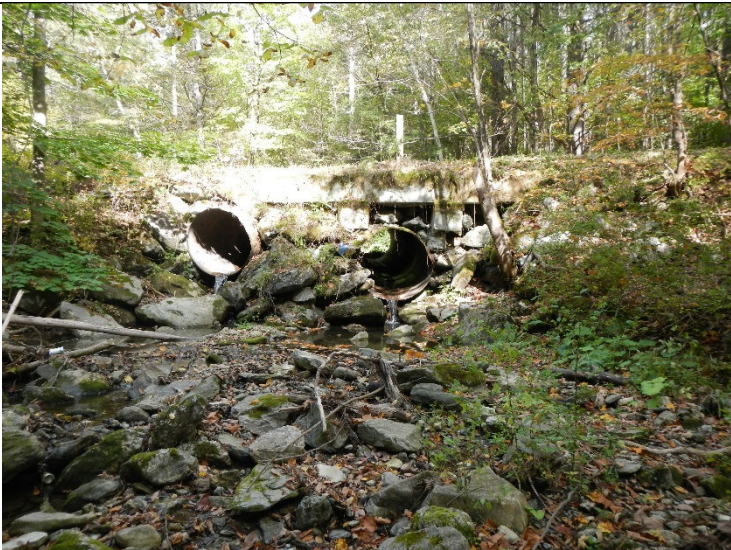
<p>Tributary: Tubbs Brook</p> <p>Town: Pownal</p> <p>Reach: M01T1.02</p> <p>Project #: TB 7</p> <p>Project Type: Culvert Replacement</p> <p>Site Description: Two culverts (5ft and 4ft diameter) are a major bankfull constriction and completely block upstream AOP.</p>

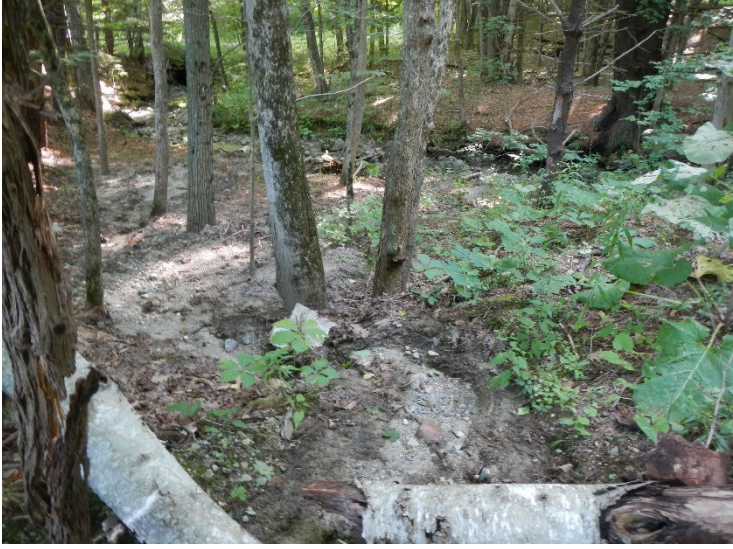
<p>Tributary: Tubbs Brook</p> <p>Town: Pownal</p> <p>Reach: M01T1.04.B</p> <p>Project #: TB 10</p> <p>Project Type: Stormwater Treatment</p> <p>Site Description: Stormwater runoff from Fowlers Way and Mt Anthony Rd spill on the floodplain and into the channel through a ditch turnout. Large plumes of fine sediment are visible on the floodplain and into the channel.</p>

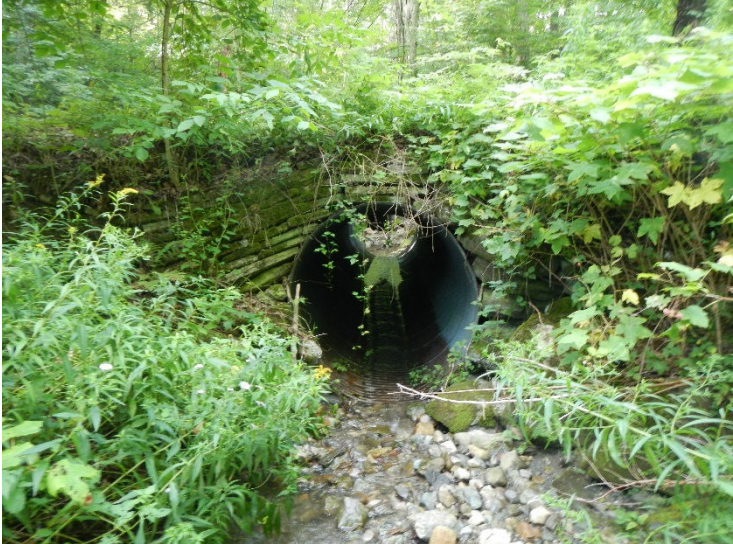
<p>Tributary: Tubbs Brook</p> <p>Town: Bennington</p> <p>Reach: M01T1.04.C</p> <p>Project #: TB 14</p> <p>Project Type: Culvert Removal and Driveway Relocation</p> <p>Site Description: Tubbs Brook flows through two undersized culverts. The downstream culvert under Mt Anthony Rd is scoured and the walls are failing. The upstream driveway culvert is a major bankfull constriction. Both culverts are significant AOP barriers.</p>

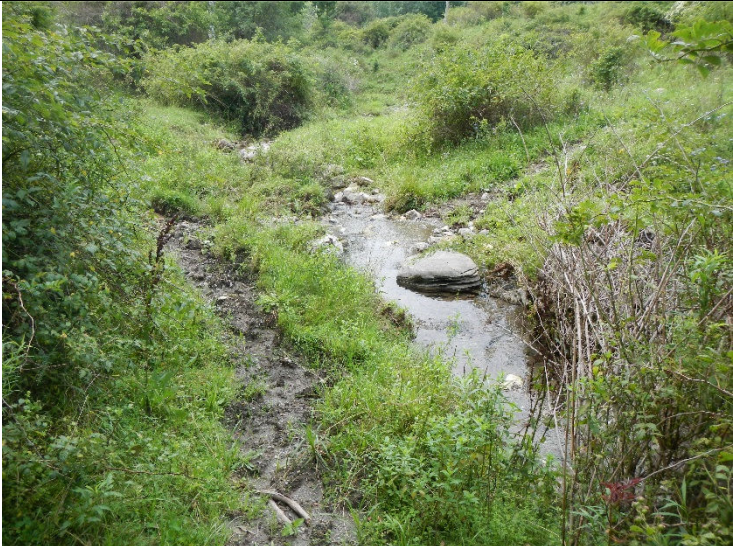
<p>Tributary: Tubbs Brook</p> <p>Town: Bennington</p> <p>Reach: M01T1.04.D</p> <p>Project #: TB 16</p> <p>Project Type: Corridor Protection</p> <p>Site Description: Approximately 800ft of the channel is openly accessed by pastured cattle. The channel and floodplain are impacted by trampling leading to increased erosion and likely significant nutrient inputs. Much of the stream corridor appears to be wetland.</p>

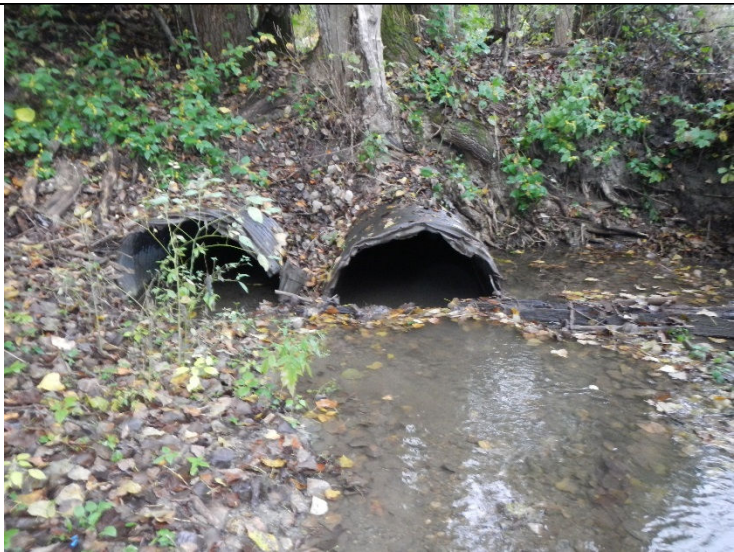
<p>Tributary: Ladd Brook</p> <p>Town: Pownal</p> <p>Reach: M05S1.01</p> <p>Project #: LB 1</p> <p>Project Type: Culvert Replacement</p> <p>Site Description: The two culverts (4ft diameter) under an old, possibly abandoned crossing west (downstream) of the railroad crossing are causing sediment and debris deposition at the inlet. Constriction may exacerbate flooding upstream in the mobile home park.</p>

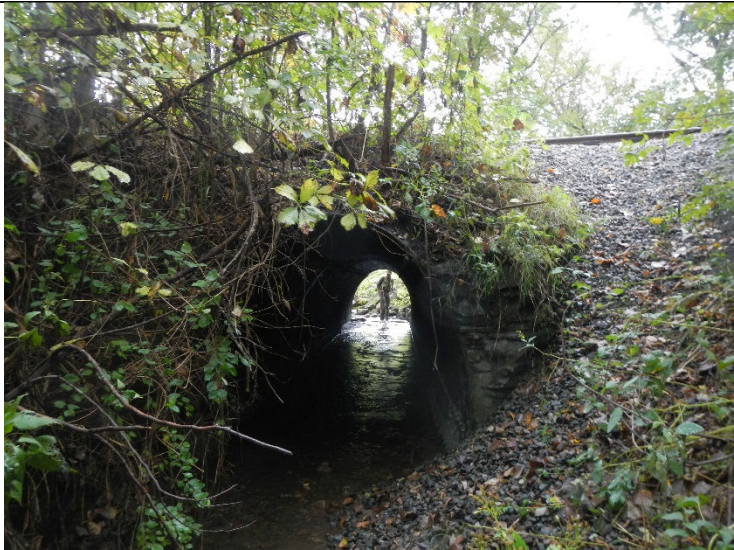
<p>Tributary: Ladd Brook</p> <p>Town: Pownal</p> <p>Reach: M05S1.01</p> <p>Project #: LB 2</p> <p>Project Type: Culvert Replacement or Retrofit</p> <p>Site Description: The railroad culvert is 6ft in diameter, while the bankfull channel width is 17ft (structure width is 35% of reference). Major flooding occurs in the adjacent mobile home park during large floods.</p>

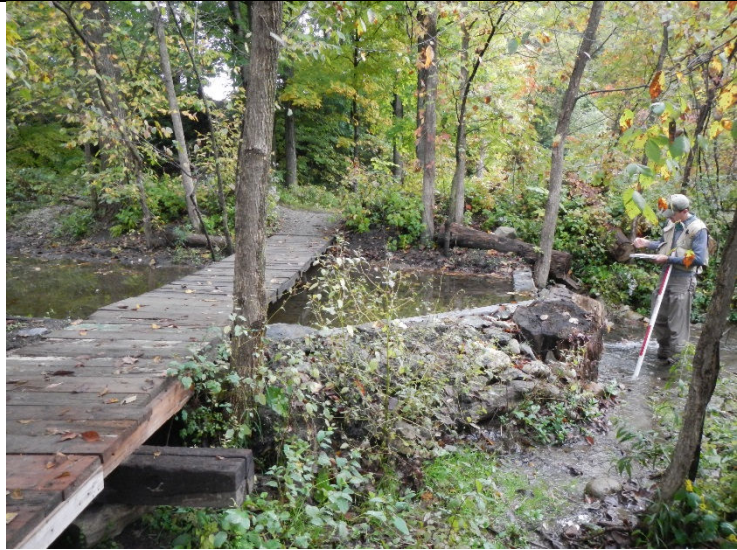
Tributary: Ladd Brook
Town: Pownal
Reach: M05S1.01
Project #: LB 3
Project Type: Barrier/Dam Removal
Site Description: A makeshift dam built from railroad ties, stumps, and a rubber liner is located just upstream of the mobile home park. Dam is causing aggradation upstream and may exacerbate flooding to nearby mobile homes.

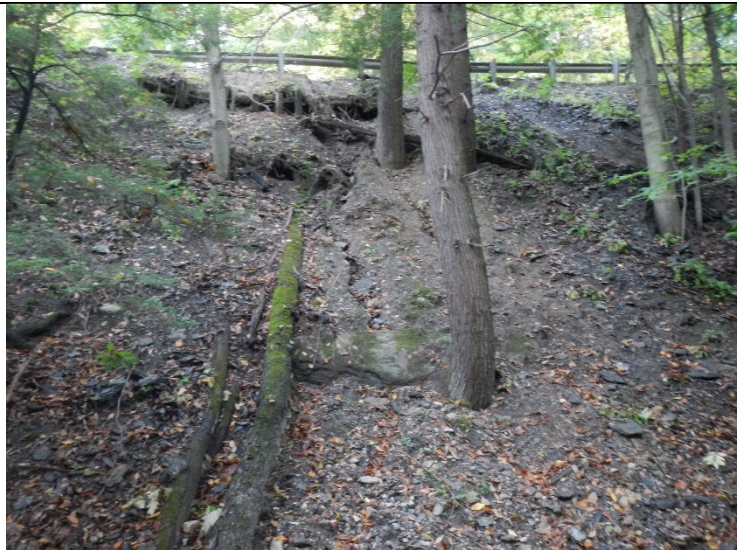
Tributary: Ladd Brook
Town: Pownal
Reach: M05S1.02
Project #: LB 7
Project Type: Road Maintenance and Erosion Control
Site Description: The road shoulder along Ladd Brook Road is extremely steep and eroding directly into the channel. Road grading likely pushes material further onto this slope increasing sediment loading. Town has attempted to stabilize with log terracing and makeshift soil nails.

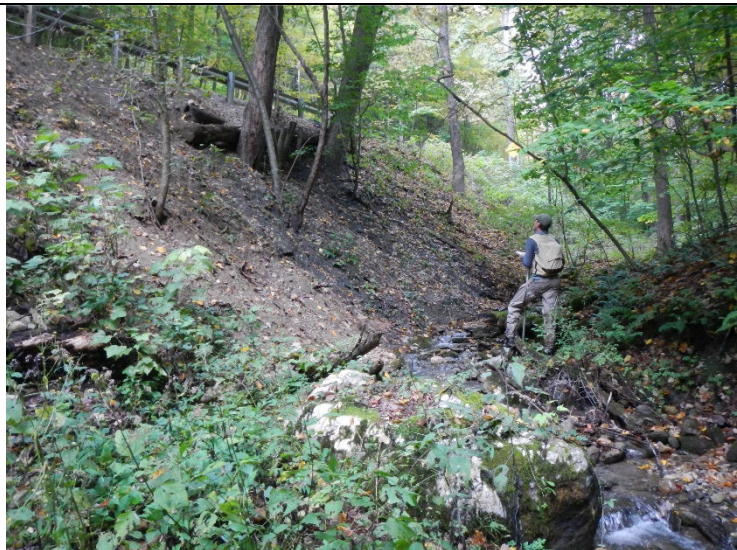
Tributary: Ladd Brook
Town: Pownal
Reach: M05S1.02
Project #: LB 11
Project Type: Road Maintenance and Erosion Control
Site Description: The road shoulder along Ladd Brook Road is extremely steep and eroding directly into the channel. Road grading likely pushes material further onto this slope increasing sediment loading. Town has attempted to stabilize with log terracing.

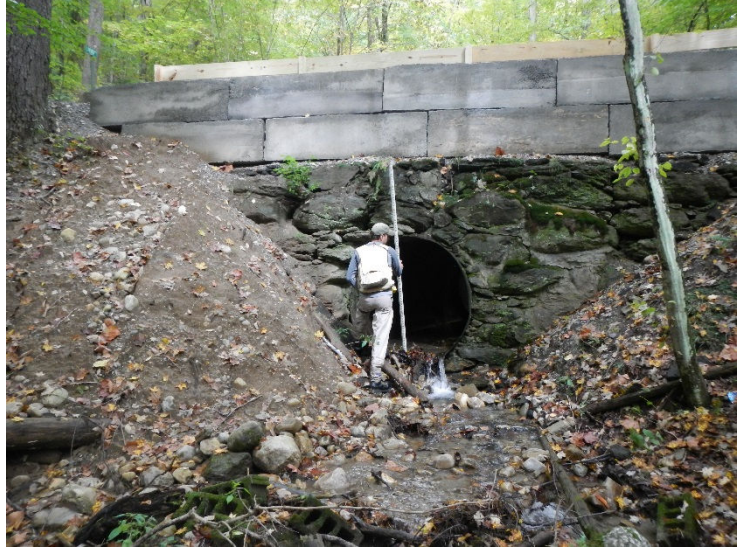
Project #: LB 12

Site Description: A pile of sediment was dumped along the bank just west (downstream) of the Lavino Road crossing. Sediment pile is not vegetated and is rilling fine sediment into the channel.

Project Type: Road Maintenance and Erosion Control

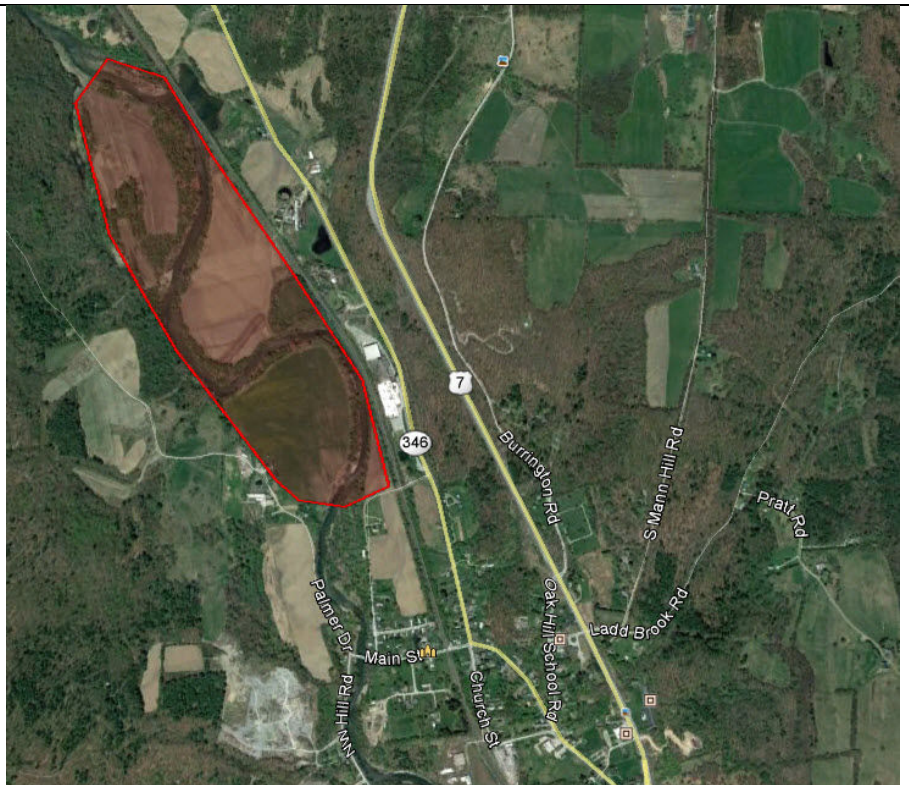
Project #: HR 4

Site Description: A large, undeveloped floodplain and river corridor is found just north of Pownal Village, in between Palmer Drive and Rt. 346. The floodplain and river corridor are intensively used for agriculture. This portion of the Hoosic River is the least incised portion in Vermont, indicating good floodplain access.

Project Type: River Corridor Protection
