Stormwater Master Plan Town of Sandgate, Vermont

December 29, 2017

Prepared by:

Fitzgerald Environmental Associates, LLC.
18 Severance Green, Suite 203
Colchester, VT 05446

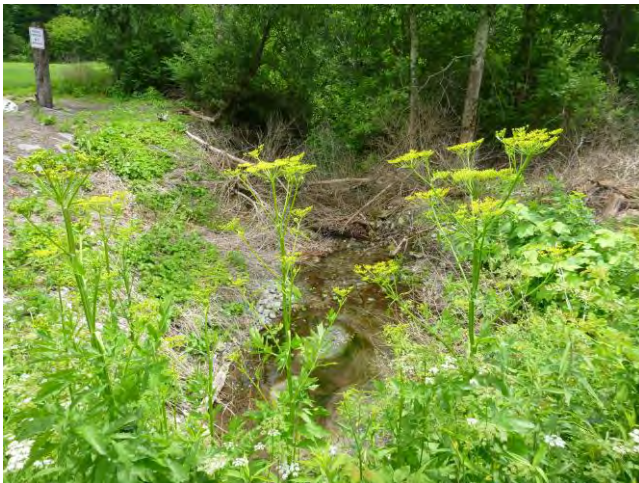
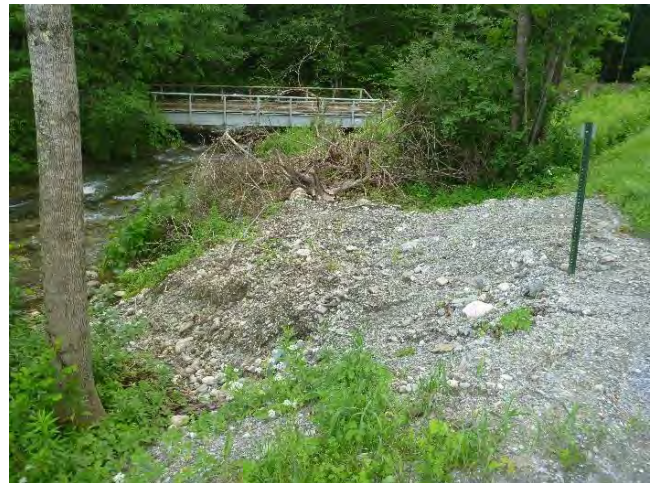
Figure 4: Ditch erosion at a culvert inlet along Woodcock Road (left) was one of the lowest scoring projects (DC-9). Large piles of loose sediment along Sandgate Road (right) following recent culvert and road work were the highest scoring project due partly to its proximity to the stream (DC-14).

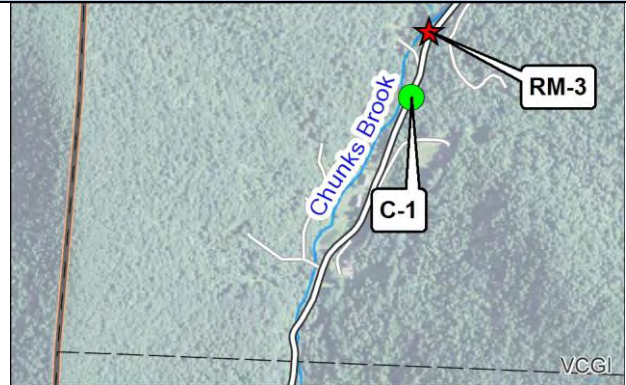
Site Description: An undersized squashed corrugated metal pipe is located on Chunks Brook Road to convey the flow from an unmapped perennial stream draining to Chunks Brook (Photo 1). The culvert capacity is estimated at 40.2 cfs, a flow that may conservatively be exceeded in the 10-year flood event. Additionally, the culvert is perched and there is erosion upstream of the culvert inlet increasing sediment load to Chunks Brook (Photo 2).

Photo 1: An undersized culvert on Chunks Brook Road.

BMP Description: Replace the undersized structure with a larger structure sized to convey the 25-year flow (e.g. a 6' wide, 4' tall squashed corrugated metal culvert with 1' of embeddedness).

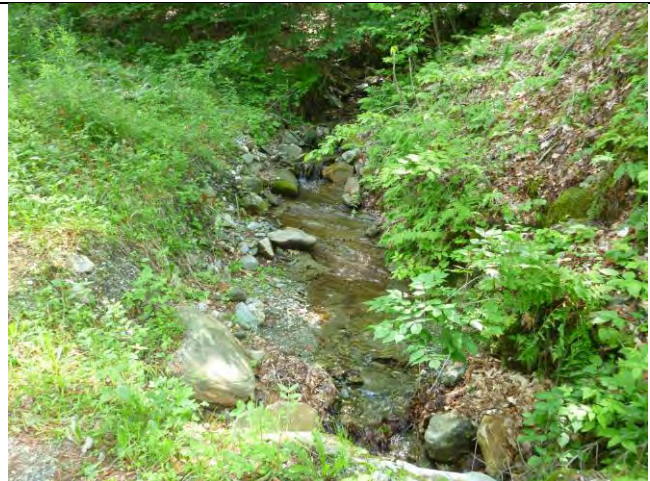
Photo 2: Some bank erosion is present upstream of an undersized culvert on Chunks Brook Road.

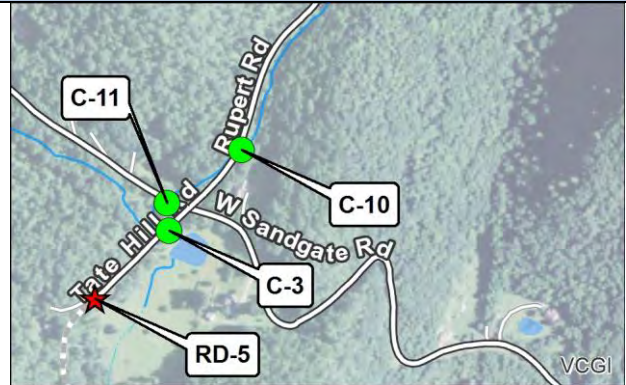
Site Description: An undersized round corrugated metal pipe is located on Rupert Road to convey the flow from a first order stream (Photo 1). The culvert capacity is estimated at 16.2 cfs, a flow that may conservatively be exceeded in the 10-year flood event. Additionally, there is some erosion upstream and downstream of the culvert inlet acting as a sediment source to the first order stream (Photo 2).

Photo 1: Some bank erosion is present upstream of an undersized culvert on Rupert Road.

BMP Description: Replace the undersized structure with a larger structure sized to convey the 25-year flow (e.g. a 6' wide, 4' tall squashed corrugated metal culvert with 1' of embeddedness).

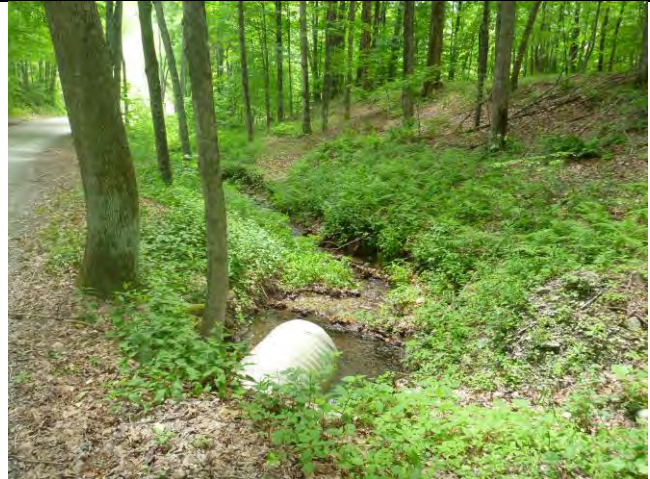
Photo 2: Some bank erosion is present downstream of an undersized culvert on Rupert Road.

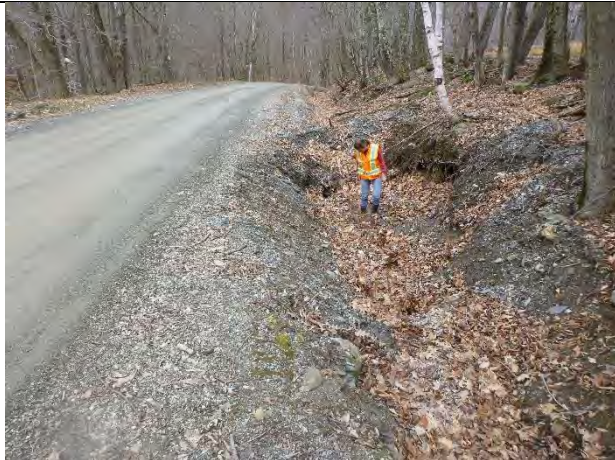
Site Description: 18" diameter corrugated steel culvert under Rupert Road delivers sediment and stormwater to Sandgate Brook. The inlet to the cross-culvert and ditch immediately upstream of the crossing are severely eroded (Photo 1). Additionally, loose gravel is piled alongside the channel downstream of the outlet (Photo 2).

Photo 1: Eroded and unstable ditch upstream of cross-culvert inlet.

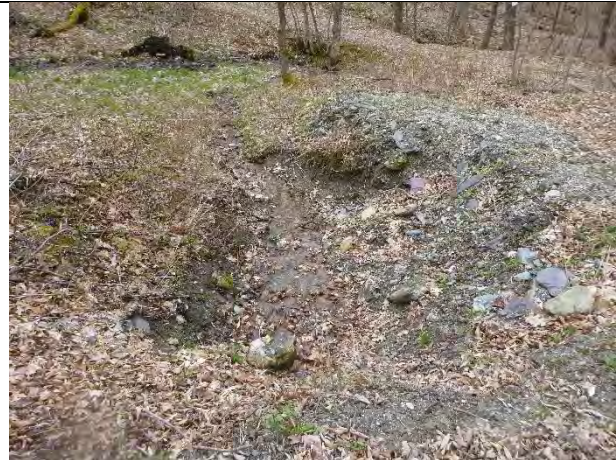
Photo 2: Cross-culvert outlet with gravel dumped alongside channel flowing toward Sandgate Brook.

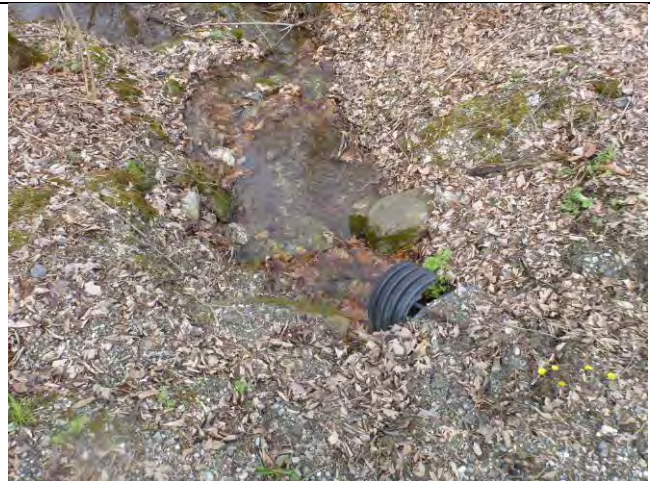
Photo 2: Broken Snow Road cross culvert outlet.

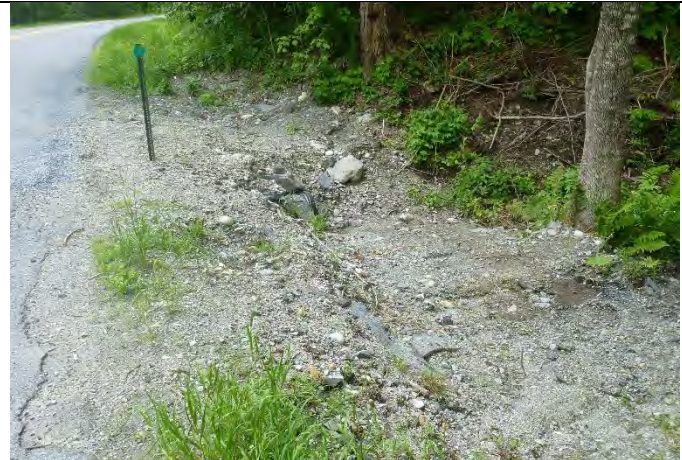
Photo 2: Unstable sediment at a Sandgate Road cross-culvert-inlet.

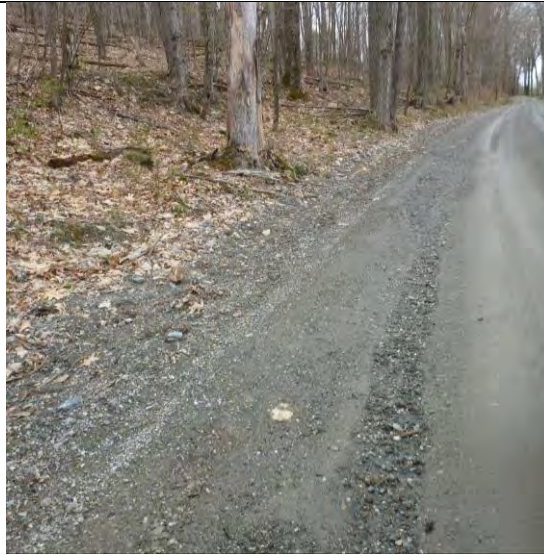
Site Description: A long (1,000ft) section of West Road is set between a steep forested bank and a tall grader berm with mature trees. The ditch along the west side is undersized and there are few opportunities for runoff to leave the road, leading to large areas of rill erosion. (Photo 1).

Photo 1: Rill erosion along the side of West Road.

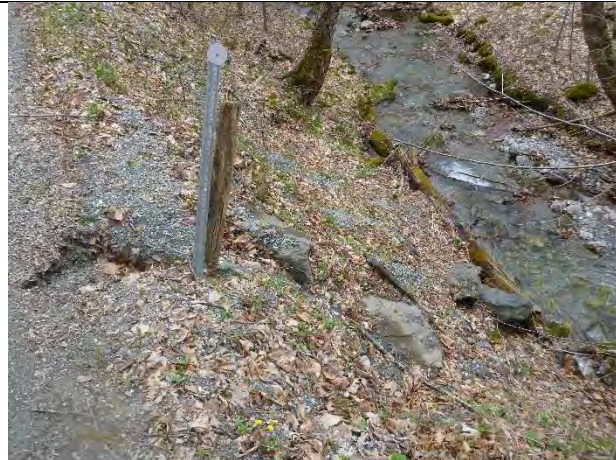
Photo 2: Erosion along the road edge at the cross-culvert outlet adjacent to a second order tributary to the Green River.

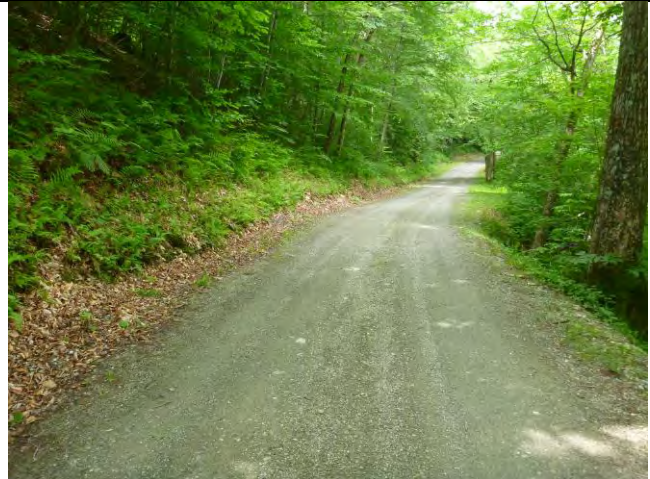
Photo 2: Water currently flowing over the road and eroding the road embankment may be directed into a ditch constructed on the opposite side of the roadway.

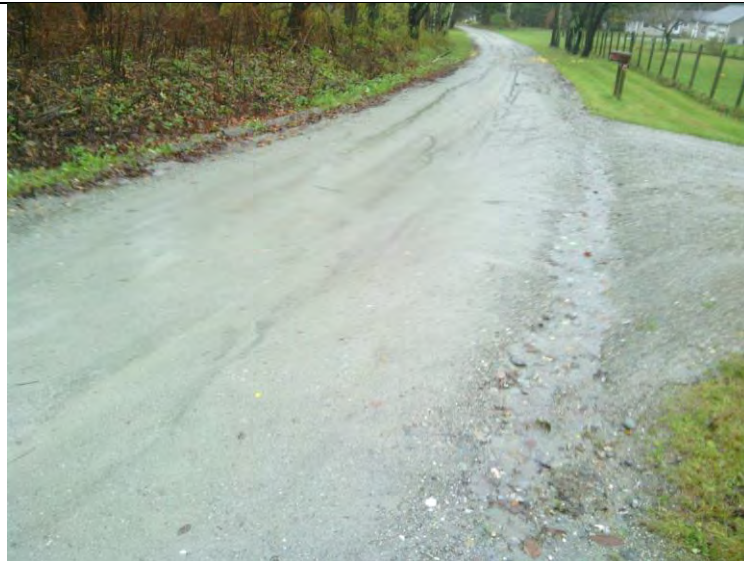
Site Description: Sandgate Road lacks a good crown and drainage ditches (Photo 1). The road elevation sits below adjacent properties in many locations, leading to rilling along the road edge and washouts during spring runoff and heavy rain storms. One existing turnout to the stream is unstable and contributing sediment to the channel. A 15" metal cross culvert is undersized and in fair condition, and has been plugged in the past per RPC culvert inventory data.

Photo 1: Upper section of Sandgate Road at Woods Gift Lane. Runoff is running along the road edge causing rilling and sedimentation downhill.

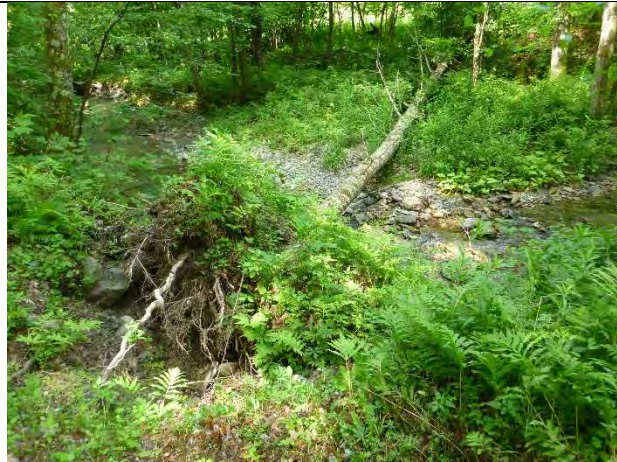
Site Description: A tree is down across Chunks Brook alongside Chunks Brook road (Photo 1). This creates an erosion hazard for the road by destabilizing the embankment and potentially directing flow toward the road (Photo 2).

Photo 1: Tree down across Chunks Brook.

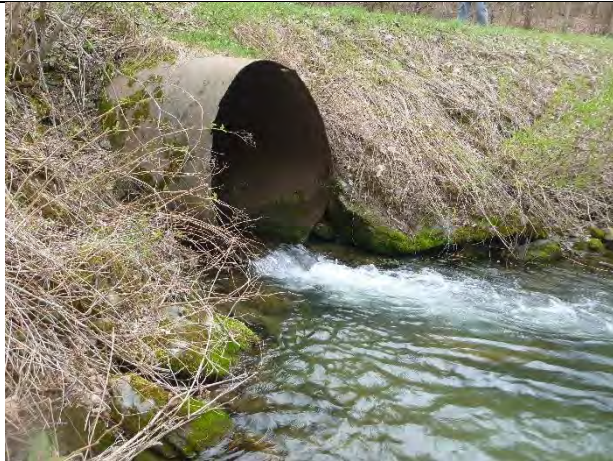
Site Description: 5.3' diameter rusted repurposed steel tank culvert perched 0.35' above downstream pool, resulting in reduced Aquatic Organism Passage (AOP) (Photo 1). Additionally, the culvert is hydraulically undersized for the 2.68 mi² watershed.

Photo 1: Outlet drop from Baldwin Brook culvert at West Sandgate Road.

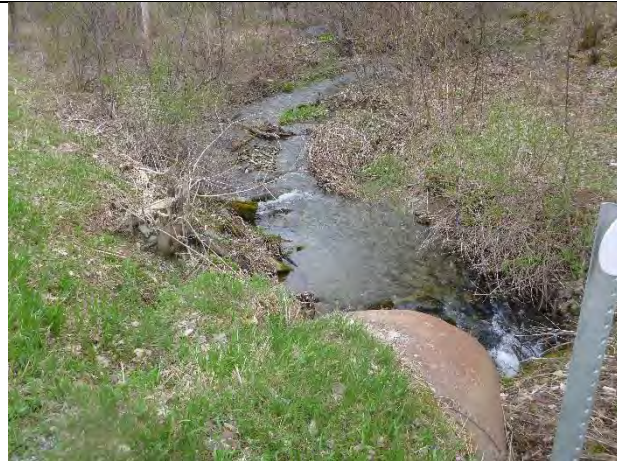
Photo 2: View of downstream channel from roadway. Location of proposed boulder veins to raise tailwater control.

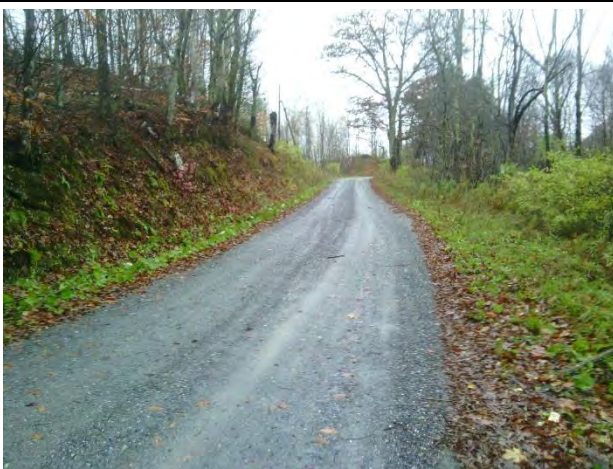
Photo 1: Steep section of upper Wuerslin Road needing stone in ditches and additional cross culverts.

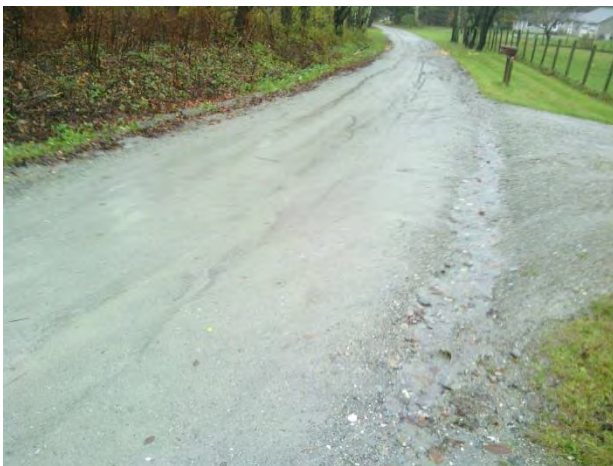
Photo 1: Upper section of Sandgate Road at Woods Gift Lane. Runoff is running along the road edge causing rilling and sedimentation downhill.

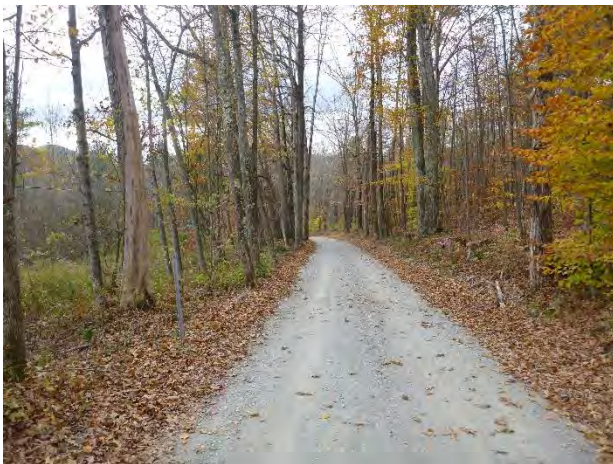
Photo 1: The road has a near continuous tall grader berm (with large trees) along the east side and an undersized and shallow ditch along the west side.

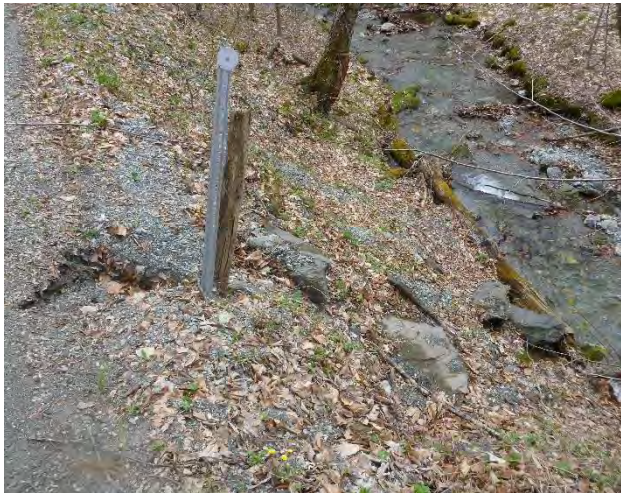
Figure 2: Rilling along the road edge and erosion of the Wilcox Hollow Road cross culvert outfall.
