Stormwater Master Plan Town of Sunderland, Vermont

December 29, 2017

Fitzgerald Environmental Associates, LLC.
18 Severance Green, Suite 203
Colchester, VT 05446

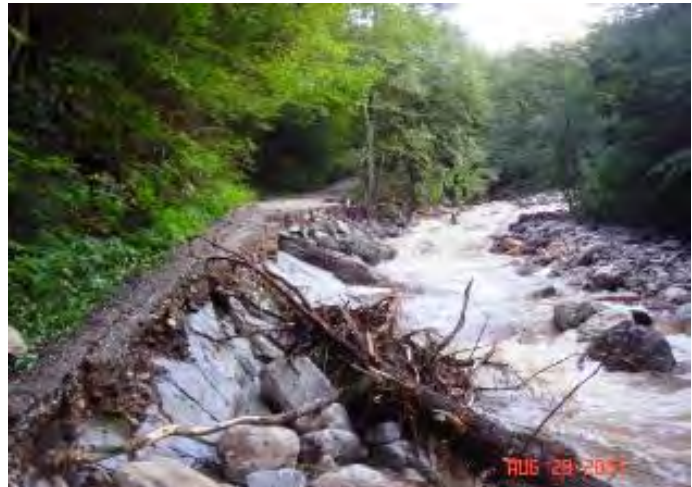
Figure 2: Washout along Kelley Stand Road after Tropical Storm Irene. Photo courtesy of BCRC.

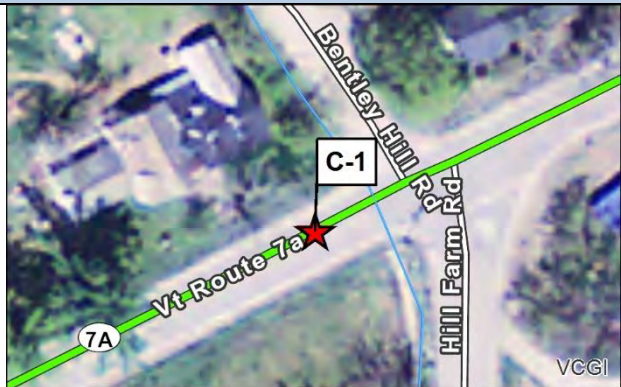
Photo 1: Steep channel approaching the culvert.

Site Description: The small stream along Bentley Hill Road flows through a narrow roadside ditch channel before crossing under Route 7a through an extremely undersized concrete box culvert. The channel along Hill Farm Road to the south is also undersized and is filling with sediment.

BMP Description: Replace the culvert with an appropriately sized concrete box culvert and enlarge the upstream and downstream channels to improve conveyance of floodwaters and sediment transport. Based on an HY-8 culvert sizing analysis, we recommend a 6ft by 8ft box culvert embedded 1ft into the channel bottom.

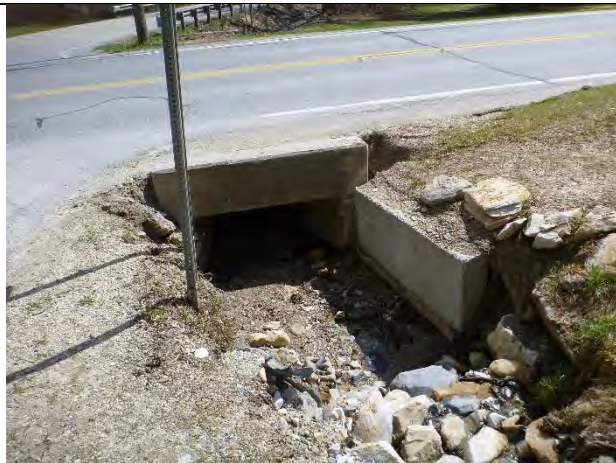
Photo 2: Inlet of the undersized box culvert at Route 7a

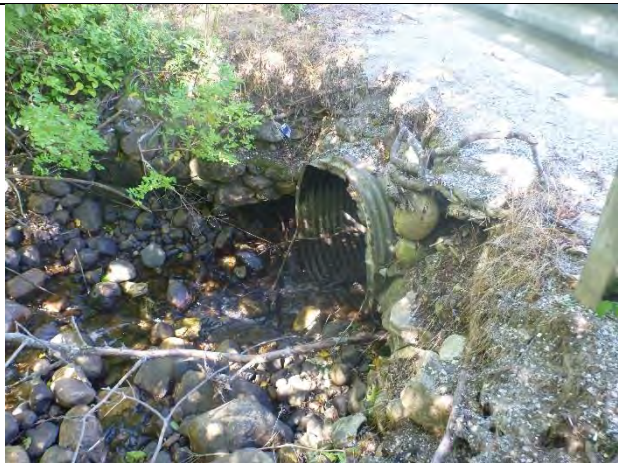
Site Description: The existing 4' culvert is extremely undersized, rusted, and is too short with a very steep embankment and erosion on the inlet side (Photo 1). The steep upstream channel has a high load of coarse sediment (Photo 2).

Photo 1: An undersized culvert under Sunderland Hill Road, with a steep embankment and erosion at the inlet.

BMP Description: Replace the culvert with an appropriately sized concrete box culvert. Based on an HY-8 culvert sizing analysis, we recommend a 6ft by 8ft box culvert embedded 1ft into the channel bottom.

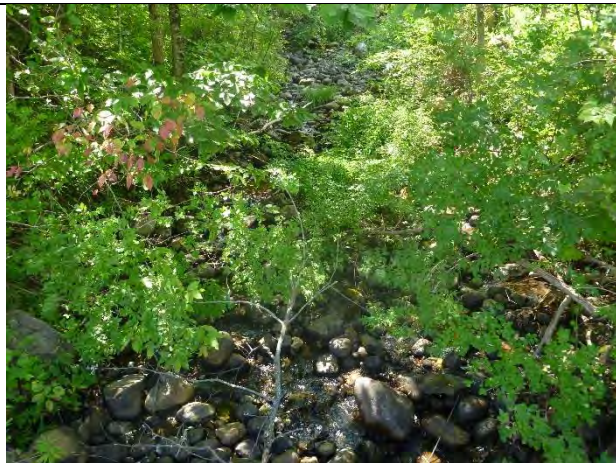
Photo 2: Upstream channel with a high coarse sediment load.

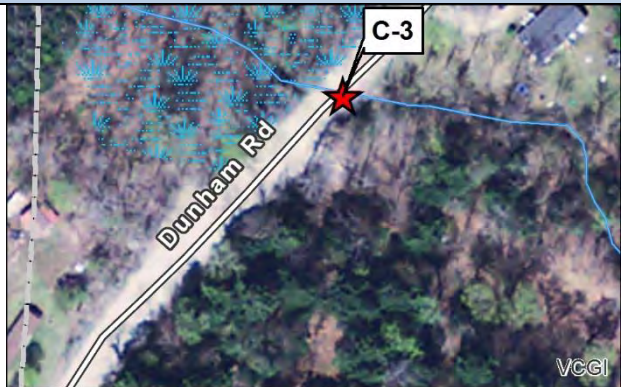
Site Description: A small stream crosses under Dunham Road through a 36" CMP culvert. The road washed out in TSI and severed an important transportation link within the Town. The channel slope decreases at the culvert leading to sediment deposition. The culvert inlet orientation is at a moderate angle to the channel approach.

Photo 1: A 36" CMP conveys a small stream under Dunham Road.

BMP Description: Replace the culvert with an appropriately sized concrete box culvert and improve the culvert orientation to better match the channel. VTrans hydraulic study recommends a 4ft by 8ft culvert embedded 1ft into the channel bottom.

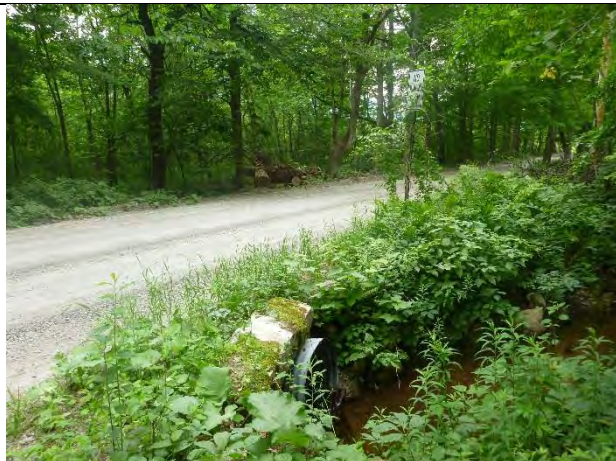
Photo 2: Dunham road washed out in Tropical Storm Irene.

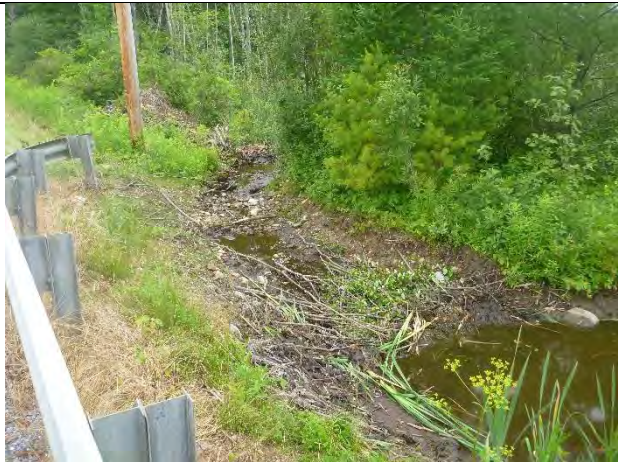
Site Description: A 36" CMP culvert under Bacon Hollow Road is fully backwatered due to downstream beaver dams (Photos 1 & 2). The culvert is rusted and needs to be replaced. Frequent maintenance is required to keep the outlet channel along the road embankment cleared of beaver dams.

Photo 1: The culvert under Bacon Hollow Road is backwatered.

BMP Description: Replace the culvert with a larger structure and consider installation of beaver baffles to reduce flooding risk to road.

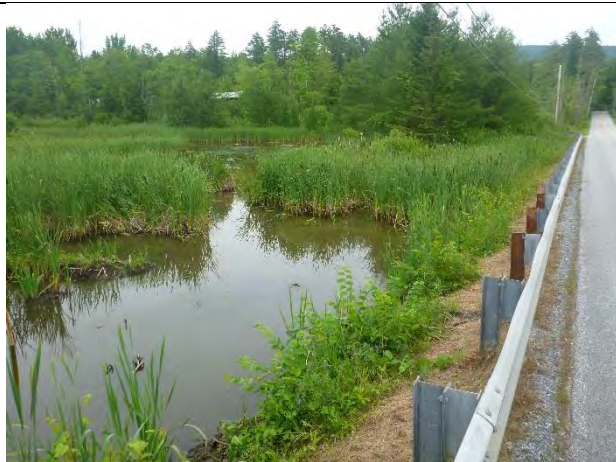
Photo 2: Downstream beaver dams backwater the channel.

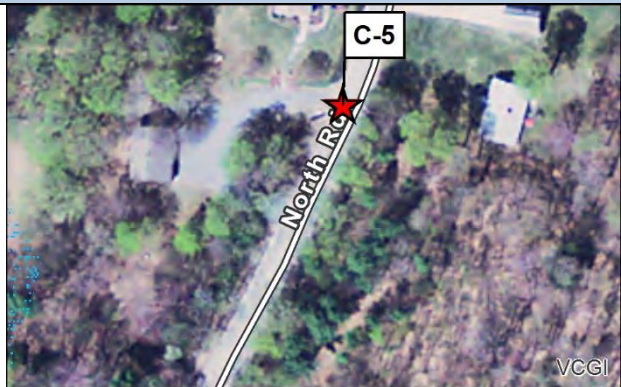
Site Description: Double 15" CPP under North Road require frequent maintenance to clear sediment, debris, and ice (Photos 1 & 2). Culvert slope is low and the inlet is slightly projecting.

Photo 1: Double culverts under North Road trap sediment, debris and ice.

BMP Description: Replace with a larger culvert or concrete box, increase culvert slope if possible to improve conveyance and reduce maintenance requirements. Based on an HY-8 culvert sizing analysis, we recommend a 24 inch culvert with an appropriate header.

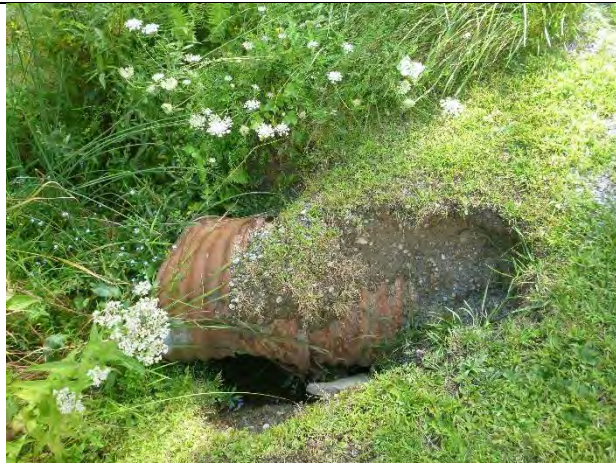
Site Description: The 24" CMP culvert under South Road near the driveway of the GMP facility is badly rotted and the inlet has collapsed (Photo 1). The embankment is eroding at both the inlet and outlet (Photo 2). The culvert is slightly undersized.

Photo 2: Erosion at the outlet of a cross culvert under South Road.

BMP Description: Replace with an appropriately sized culvert. Based on an HY-8 culvert sizing analysis, we recommend a 3ft diameter culvert with an appropriate headwall configuration.

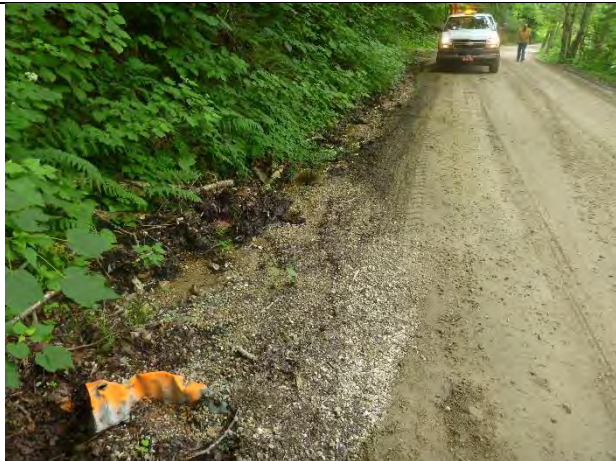
Site Description: Three 24" CMP cross-culverts are exposed and badly damaged by vehicle and grader traffic (Photo 1). Ditches are filled in and the shoulder is very wet (Photo 2). **Culverts were replaced in 2017.**

Photo 1: Exposed and damaged cross culverts on Kelley Stand Road.

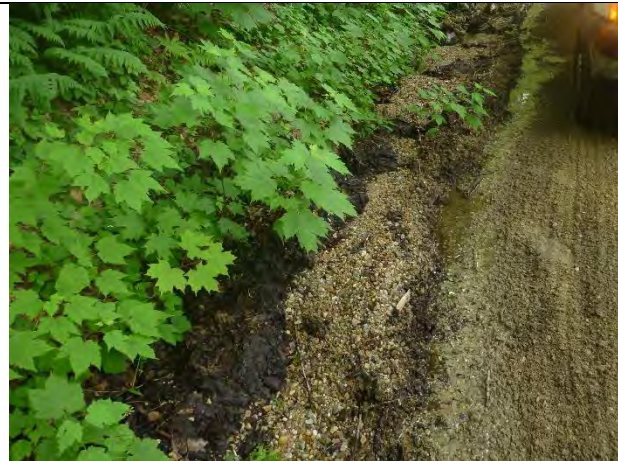
Photo 2: Ditches are filled in along a section of Kelley Stand Road.

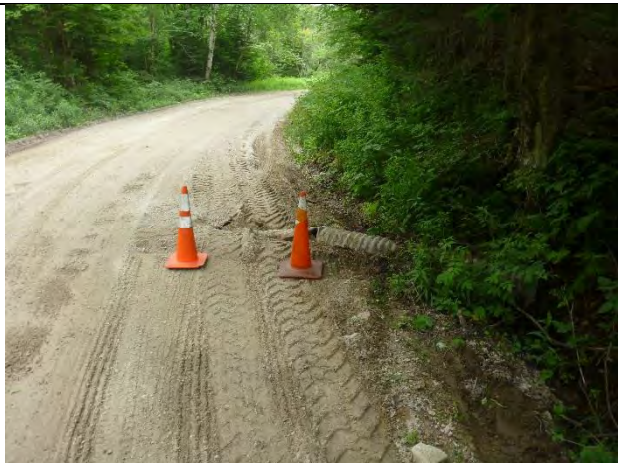
Site Description: A 24" CMP cross culvert is badly damaged by vehicle and grader traffic. The inlet is exposed and crushed, **Sunderland Highway Department completed this work in 2017.**

Photo 1: Location of a damaged cross culvert along Kelley Stand Road.

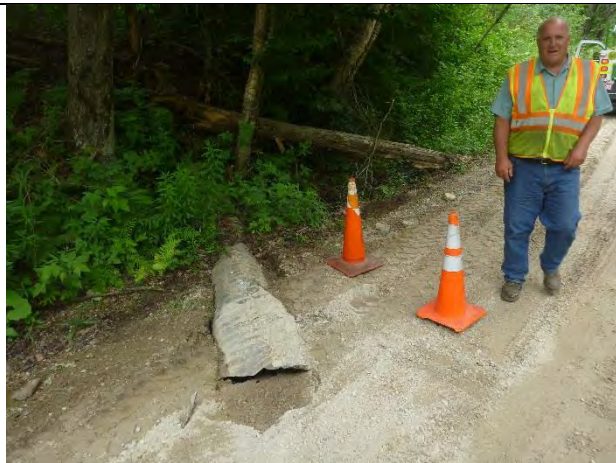
Photo 2: The culvert inlet is damaged and exposed.

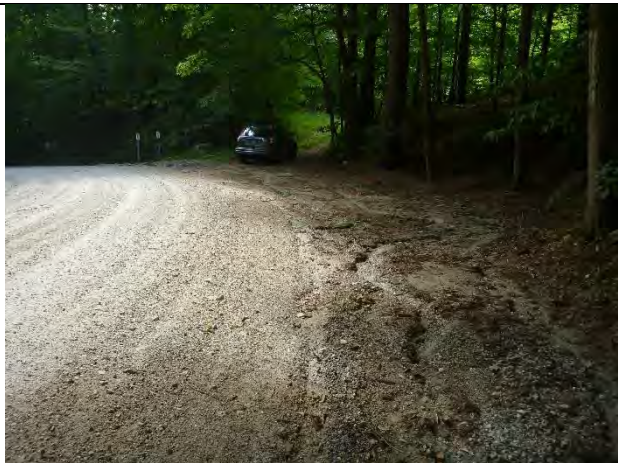
Site Description: Significant erosion along the ditches and steep road embankment was observed along the steep stretches of the Road from Route 7A to the town line (Photo 1). Ditches were typically undersized, shallow, and not stone lined (Photo 2).

Photo 1: Erosion along Bentley Hill Road.

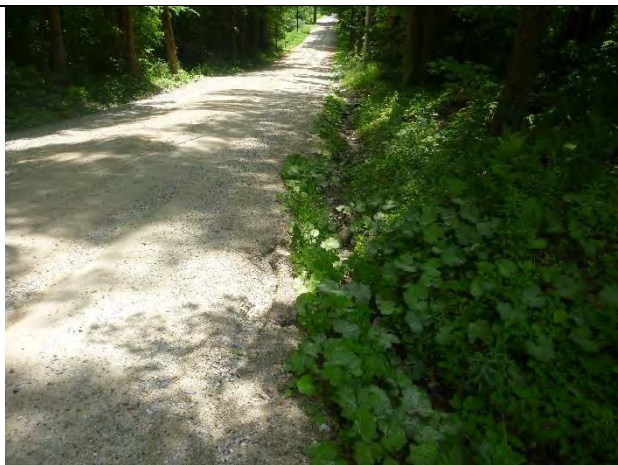
Site Description: The ditches along the north side of Flynn Hollow Road and the west side of North Road join and flow through a pipe under North Road. Both ditches are wide and flat and carry a large volume of sediment (Photos 1 & 2). Large vehicles turning on to Flynn Hollow repeatedly damage the road shoulder and increase erosion. **Sunderland Highway Department completed this work in 2017.**

Photo 1: Ditches along Flynn Hollow Road and North Road carry a large volume of sediment.

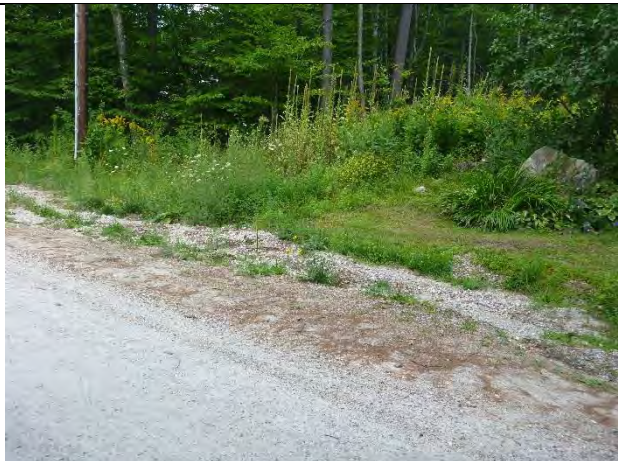
Site Description: Short section of road with no ditch along the northern side, moderate gully erosion (Photos 1 & 2). Cable lines are shallowly buried in the ditch complicating site improvements. **Sunderland Highway Department completed site repairs in 2017.**

Photo 1: A section of Shady Pines Road has no ditch.

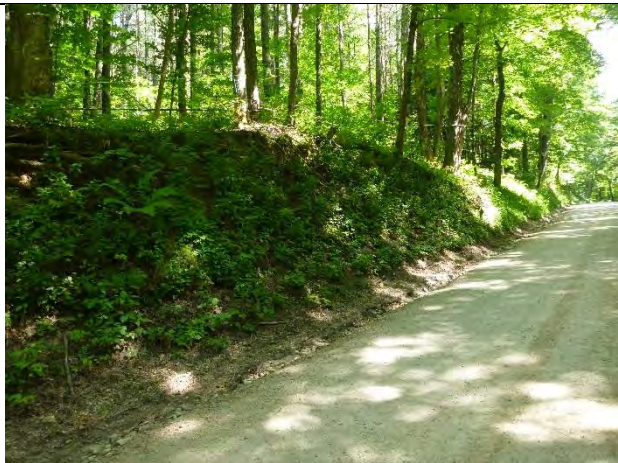
Site Description: The ditch along the north side of the road is undersized and poorly defined with several areas of severe gully erosion (Photo 1). The ditch on the eastern side of the stream crossing is deeply incised and is delivering large volumes of sediment and gravel to the stream channel (Photo 2). **Sunderland Highway Department completed ditch repairs in 2017.**

Photo 1: Poorly defined ditch with gully erosion along Laver Road.

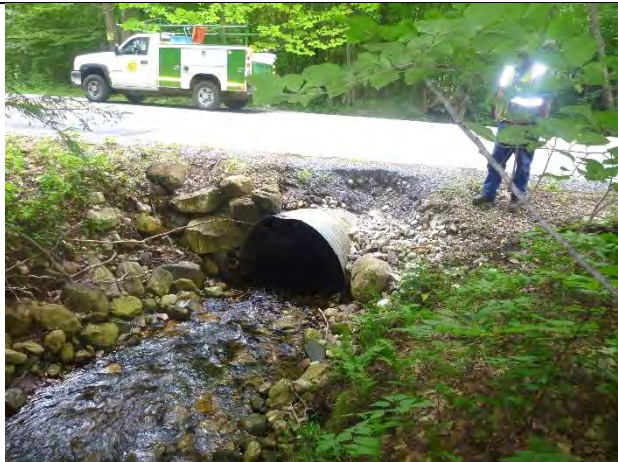
Site Description: Cole Brook passes under North Road through a 48" CMP (Photo 1). This culvert was overtopped in Irene and significant flooding and damage occurred along the road to the north. The upstream channel is incised and has a significantly larger capacity than the culvert (Photo 2).

Photo 1: An undersized culvert conveys Cole Brook under North Road.

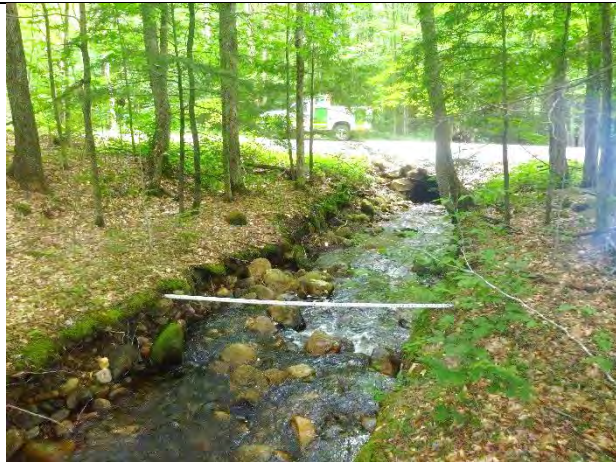
Photo 2: The Cole Brook channel upstream of North Road is deeply incised.

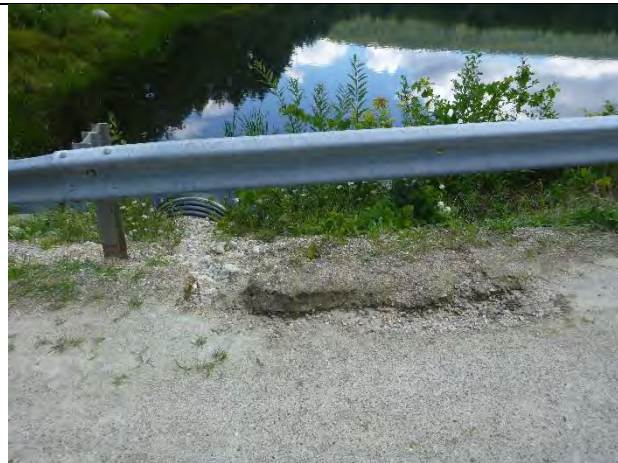
Photo 2: Erosion along the edge of South Road at the culvert outlet.

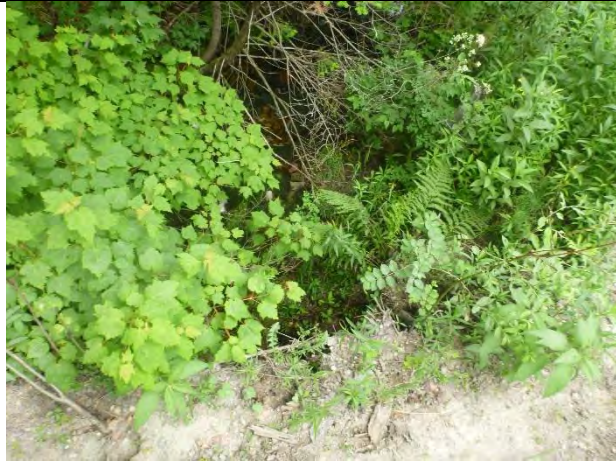
Site Description: Small tributary crosses under Kelley Stand Rd through a 48" CMP that is slightly perched. The culvert is short, and the embankments are near vertical with a stacked river rock header that is prone to erosion.

Photo 2: Vertical embankments at the culvert along Kelley Stand Road are prone to erosion.

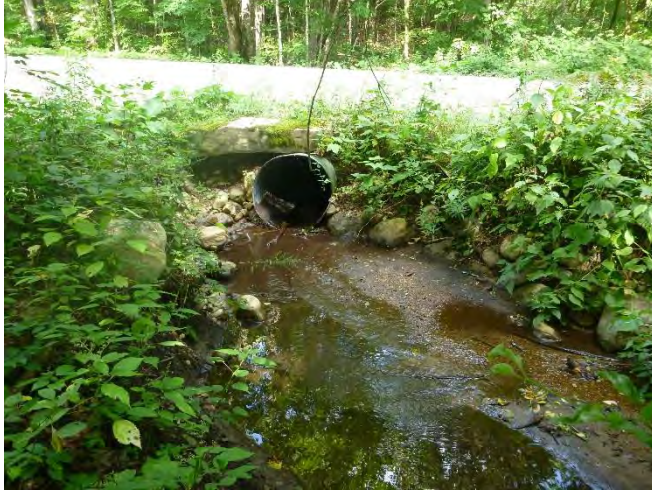
Figure 2: Sand and gravel deposition in the channel upstream of the culvert inlet.

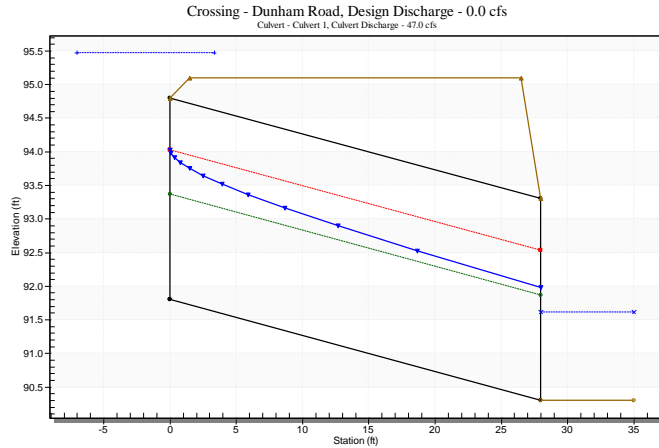
Figure 4: HY-8 plot of the 10-year flow exceeding the existing culvert and overtopping Dunham Road.

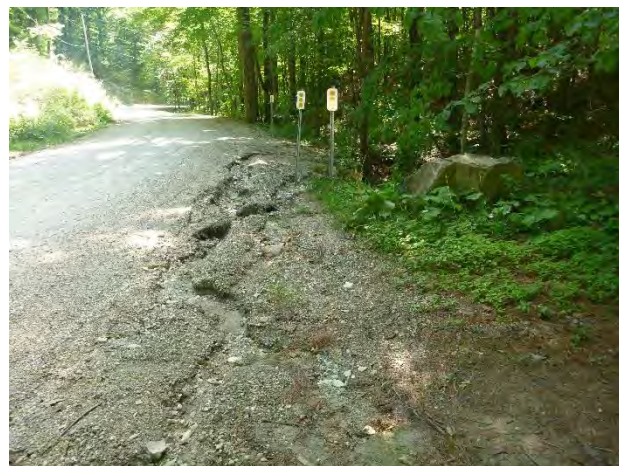
Photo 1: Severe erosion along Bentley Hill Road at the stream crossing location where the ditch spills onto the road at the private driveway.

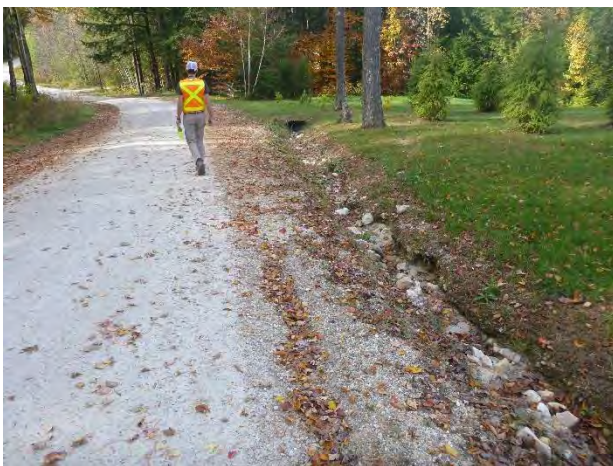
Photo 1: Severe erosion of undersized ditch leading to cross-culvert.

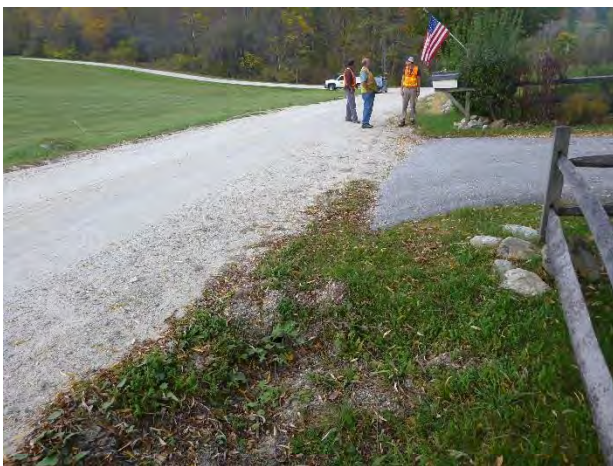
Photo 1: Location of proposed driveway culvert.

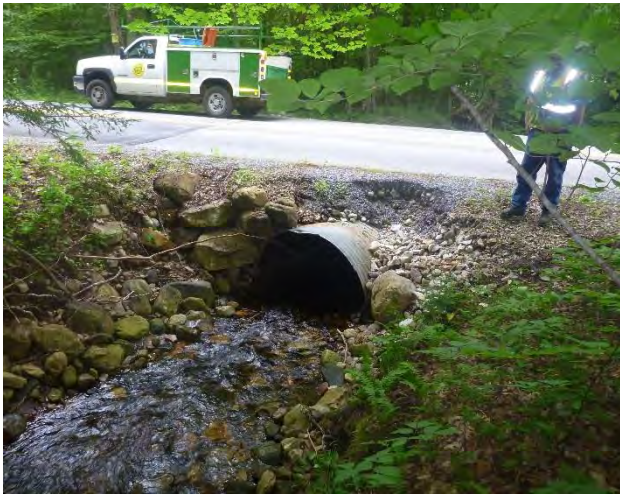
Figure 1: Embankment erosion at the culvert inlet.

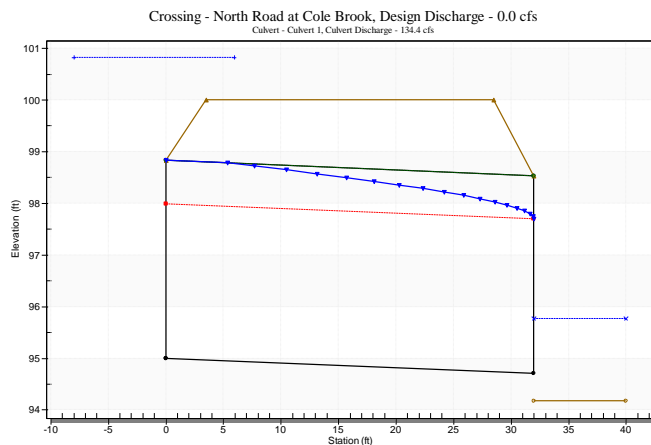
Figure 3: HY-8 plot of the 10-year flow exceeding the existing culvert and overtopping North Road.
