Channel Management and River Corridor Protection Plan

Walloomsac River and Roaring Branch, Bennington County, Vermont

December, 2007

GOMEZ AND SULLIVAN
Engineers, P.C.

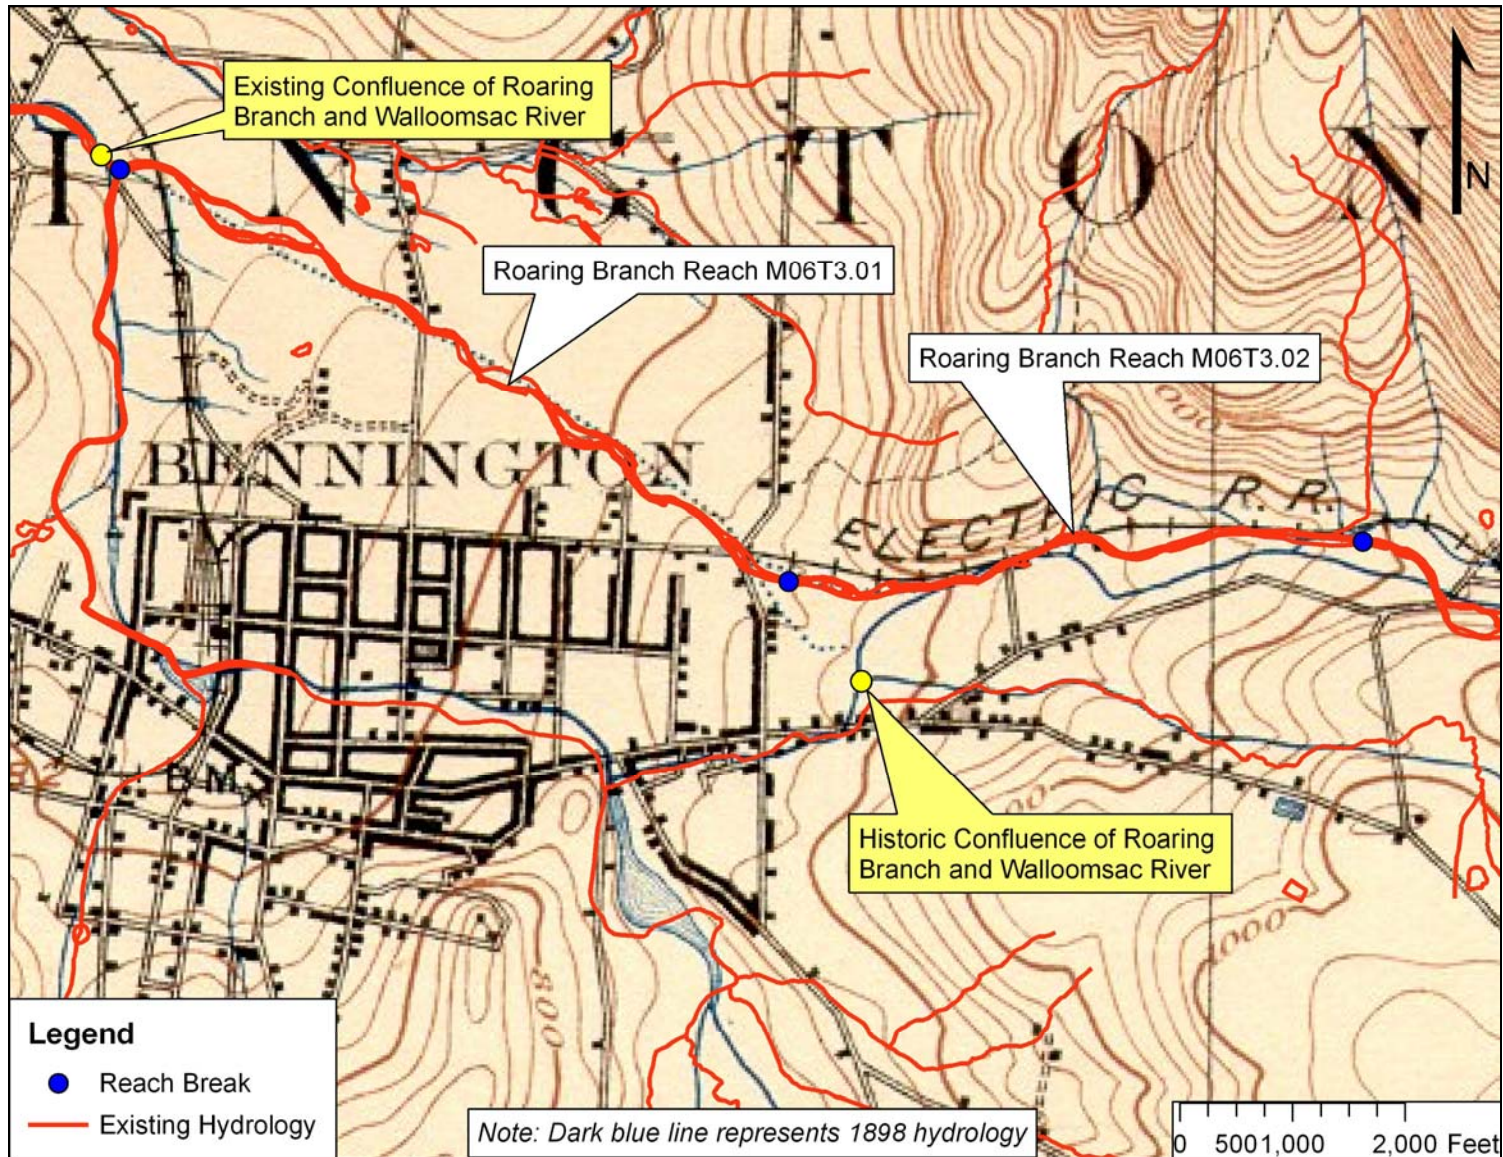
Figure 2-2: M06T3.01 and M06T3.02 Existing and Historic (1898) Channels.

The extent of historic manipulation of the Roaring Branch further complicates the definition of stream reference conditions, particularly in the lower reaches. There, the absence of a historic reference condition means one must predict the channel condition that was likely to form were it allowed to stabilize without anthropogenic manipulation and control, given the geology, flow regime, topography and natural controls. Although the historic condition (last 100 years) of the lower reaches of the Roaring Branch appear to be multi-thread, we believe the reference condition would be that of a single-thread channel, with meso-scale bed forms of riffles and pools in the lower reaches and possibly steps and pools as seen in some parts of the upper reaches where the gradient is fairly high.

The equilibrium of flow and sediment transport of these reaches remains unbalanced to the present day. This imbalance continues to cause the river to shift its planform and create multiple channels under larger flood events in attempts to regain equilibrium between flow and sediment load. This process should be expected to continue, and any further dredging, channelization, or encroachment into the river corridor—without due consideration of natural adjustment processes—will exacerbate the rate of change and the potential for further damage.

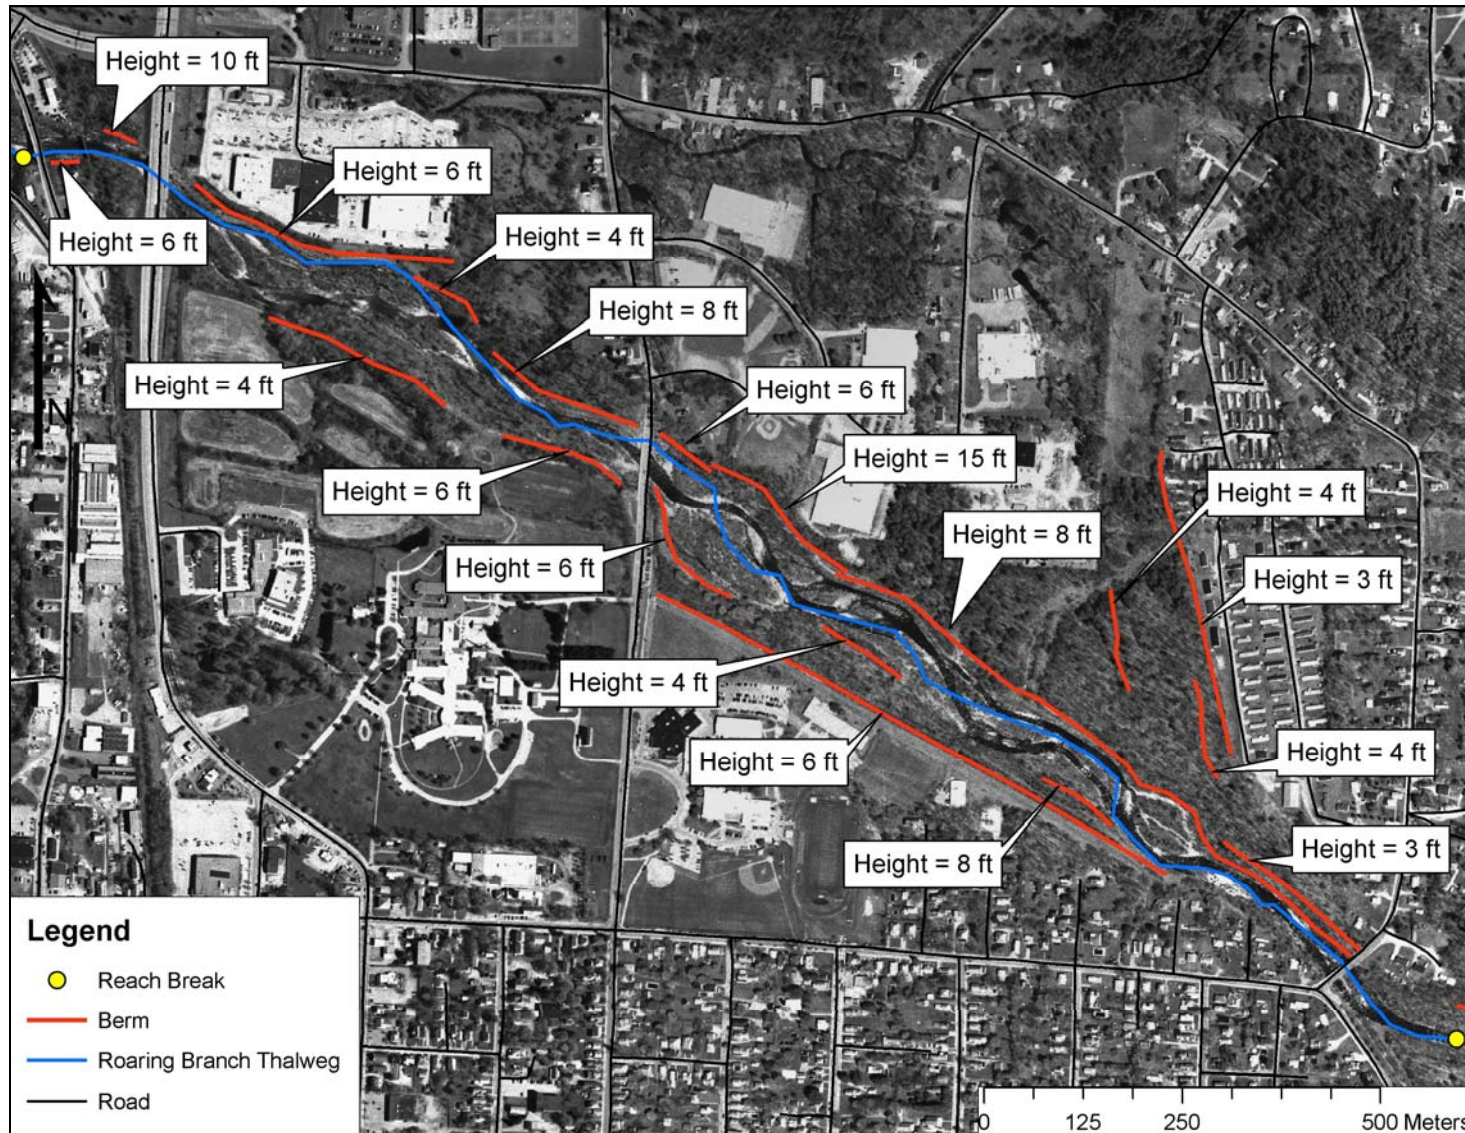
Figure 3-2: Berm Network along Roaring Branch Reach M06T3-01.

The extensive berming and flood protection structures along the Roaring Branch have contributed to a loss of river-floodplain connection, thereby increasing stream power. This has resulted in areas of channel incision through both down-cutting of the bed and build-up of the floodplain with artificially high banks and berms. Some of these banks are starting to severely erode, such as the right bank upstream of Park Street in Bennington ([Figure 3-5](#)). The levee rebuilt on Roaring Branch in 1987 is beginning to show signs of deterioration through bank undercutting and channel downcutting.

Note: Berm heights are approximate and were obtained from LiDAR data.

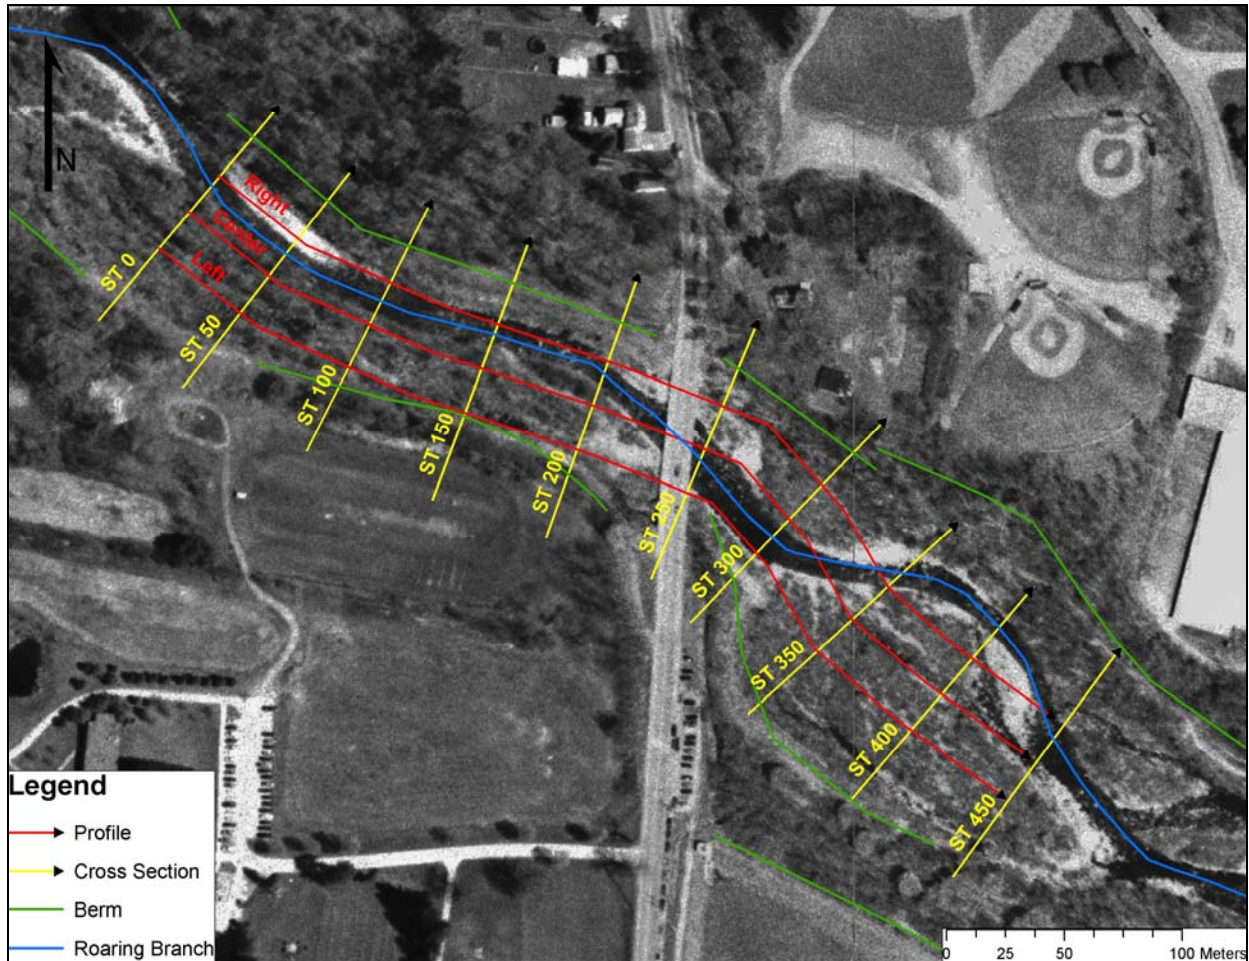
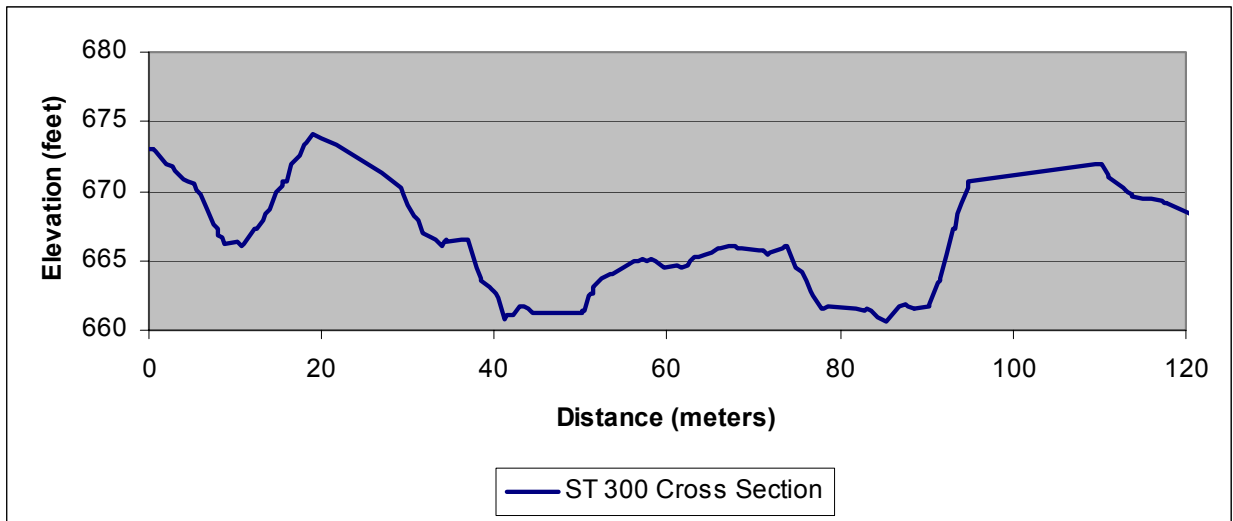
Figure 3-3: Park Street Bridge and Typical Channel Cross-Section.

The channel constrictions at the bridges (Brooklyn, Park Street, and Route 7) in Reach M06T3.01 are causing large amounts of sediment deposition throughout the reach. These areas of deposition are currently being degraded as evidenced by headcutting through the coarse alluvial material. This cycle of deposition and degradation is expected to continue, and is reset during larger flood events that re-deposit significant amounts of cobble and boulders in these regions. The channel also contains substantial amounts of large woody debris and bank erosion, and the reshaping of island formations within the channel is apparent.

Station 300 – Note dual thalweg. Additional cross-sections located in [Appendix B](#). X-axis in meters.

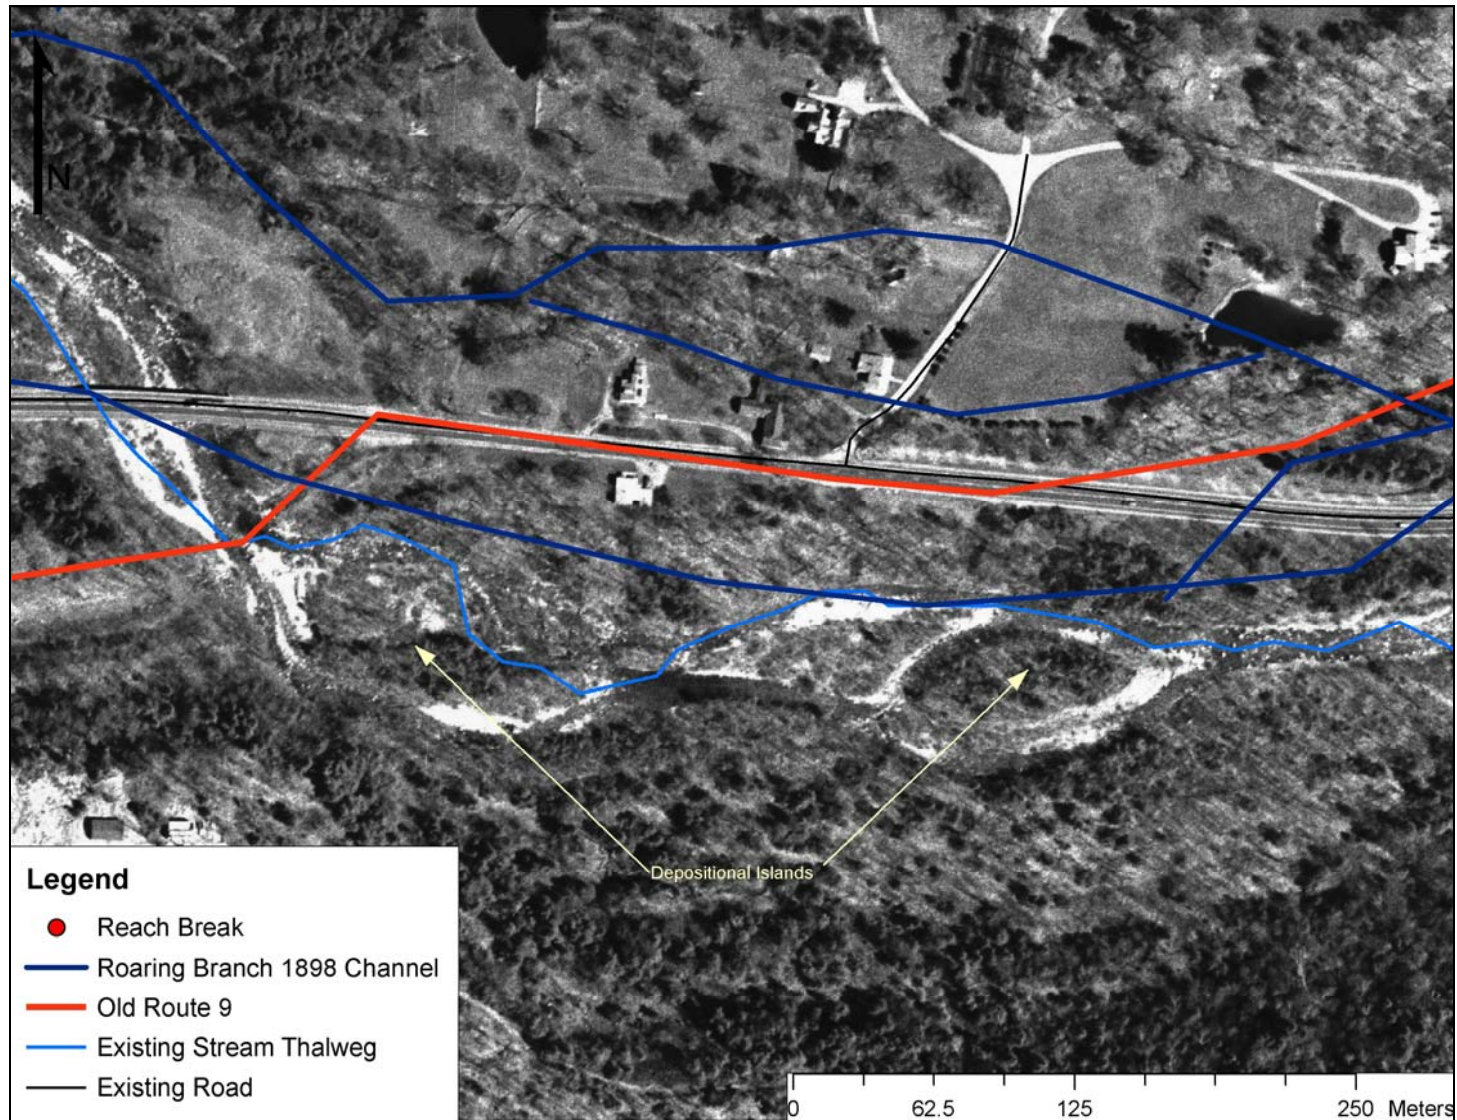
Figure 3-4: Sediment Deposition Upstream of Old Route 9 Bridge.

In addition to existing bridges, an old bridge constriction has caused sediment accumulation in the Roaring Branch as well. Just upstream of the Route 9 bridge in Reach M06T3.03, remnants of an old

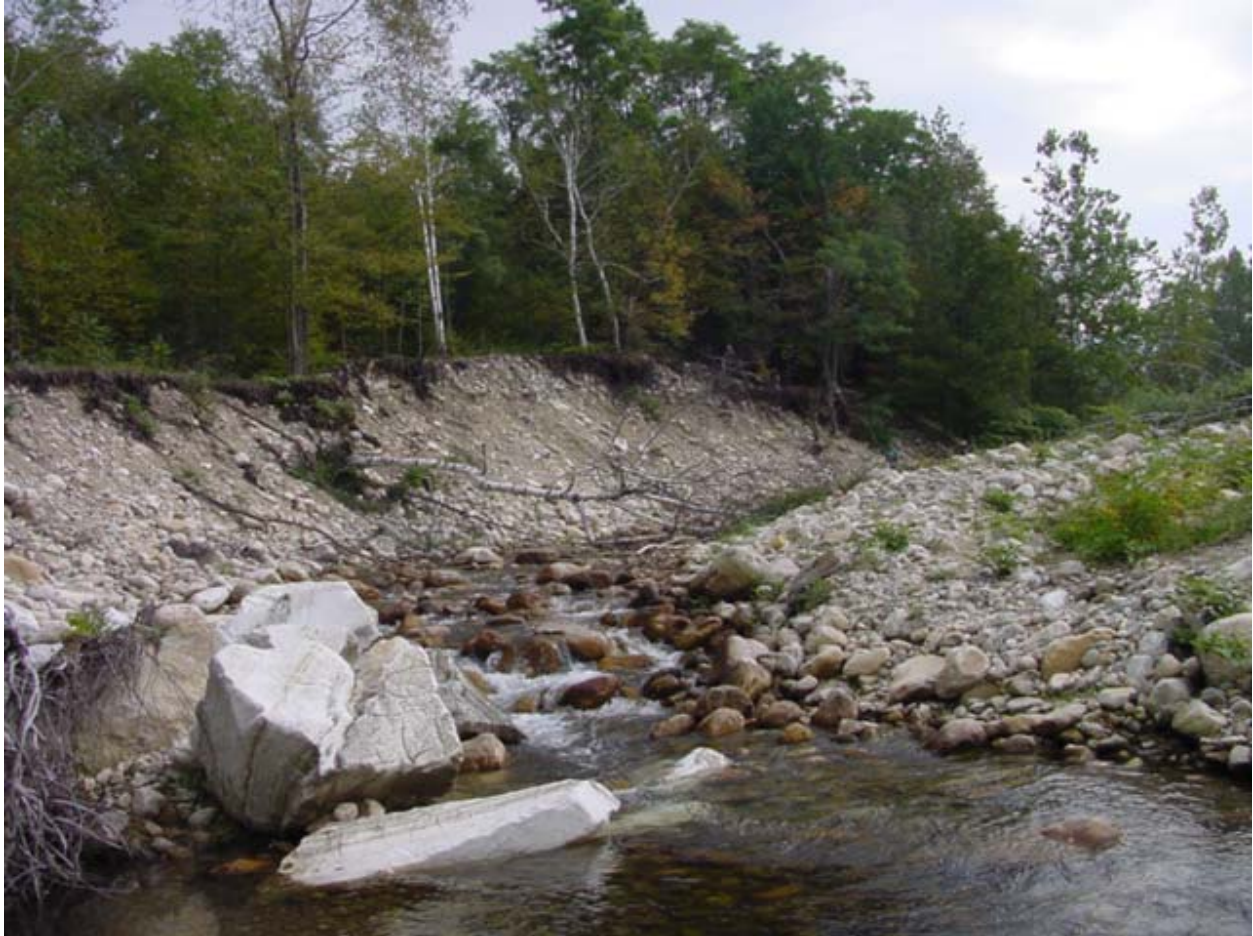
Figure 3-5: Bank Erosion Upstream of Park Street.

Date of Photo: 9/19/2006, facing upstream.

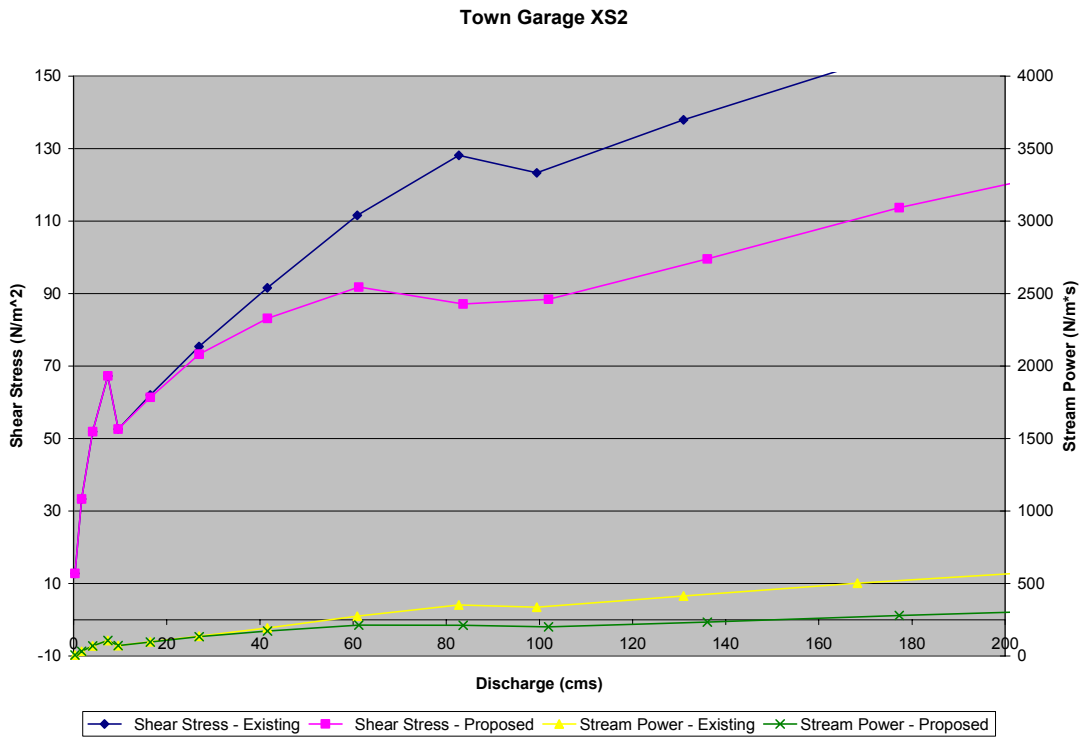
Figure 5-3: Hydraulics Comparison for ST 2 with and without Riverside Berm.

A comparative hydraulic analysis was conducted to demonstrate the effectiveness of berm removal on decreasing stream power, shear stress, and energy in the channel during flood events. Existing versus post-restoration hydraulics are presented in [Figures 5-3](#) and [5-4](#) for cross-section 2 (ST2) and cross-section 4 (ST4), respectively. Both areas demonstrate a significant decrease in stream power and shear stress from the existing to post-restoration conditions. Under berm removal conditions, at flows around 50 cubic meters per second (1,765 cubic feet per second), the river will spill over the new bank into the floodplain and thus decrease stream power and shear stress, at the same time allowing for sediment storage out of the channel.

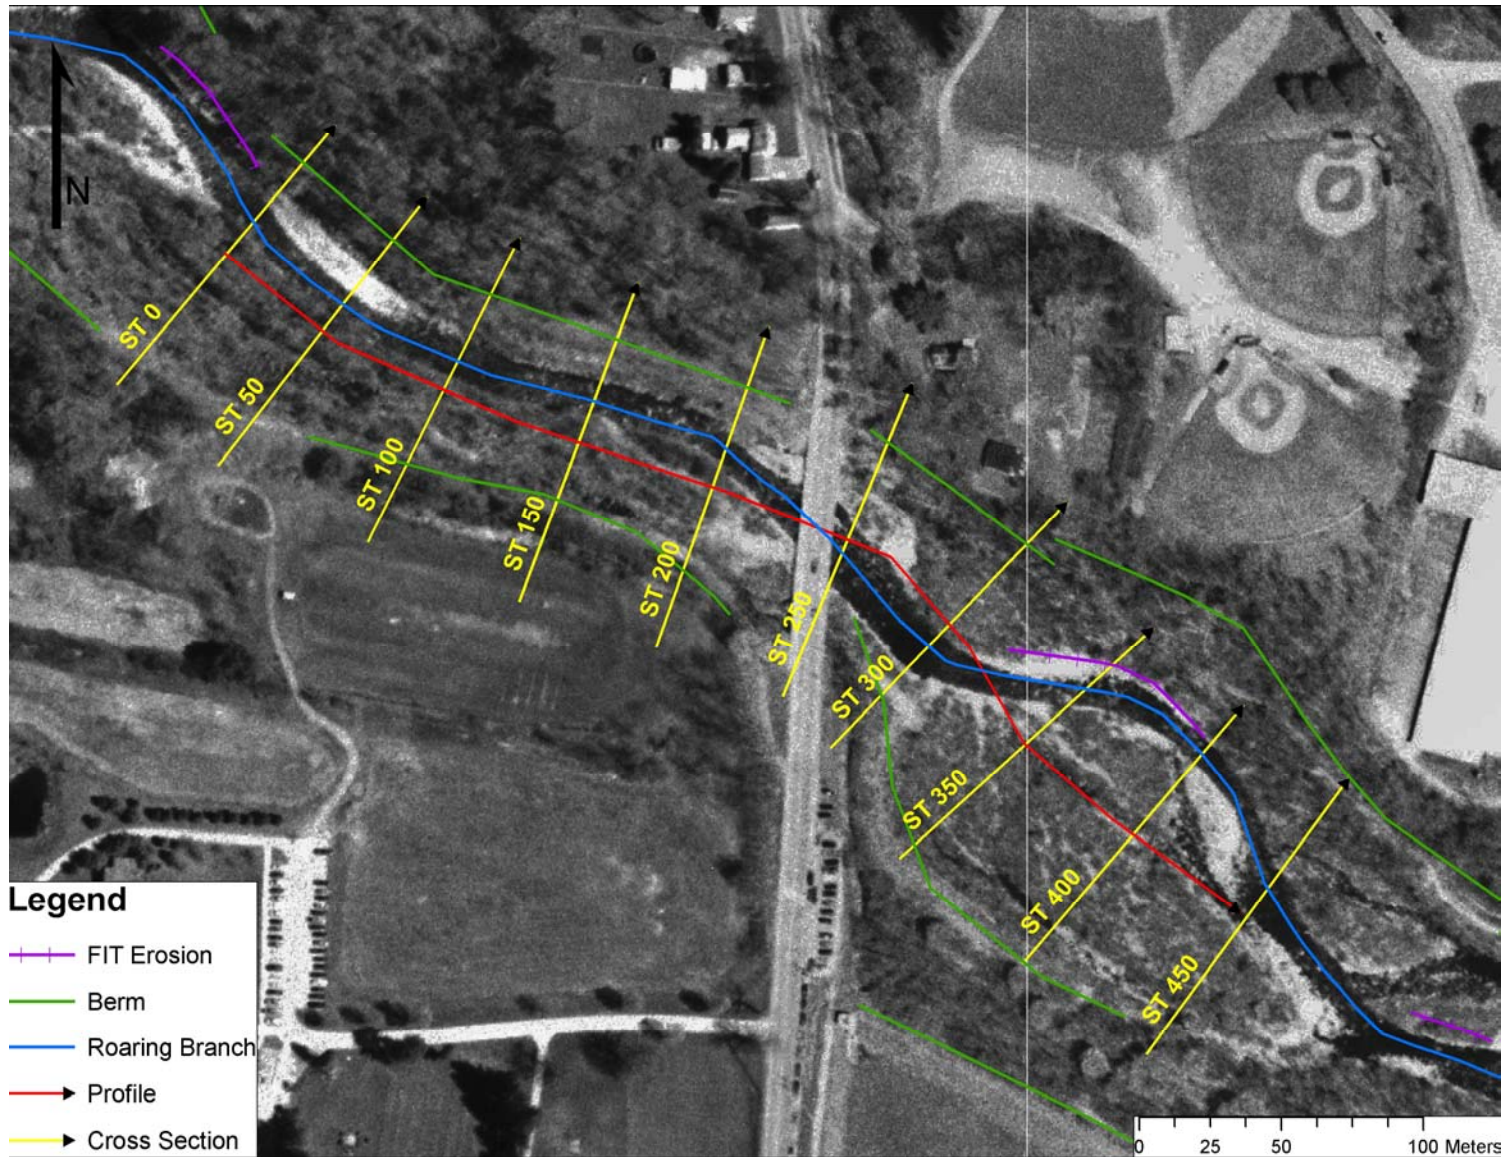
Figure 5-5: Eroding Bank Upstream of Park Street Bridge.

The Park Street bridge constricts the corridor of the Roaring Branch and has caused considerable aggradation of gravel, cobble, and boulder-sized material upstream of the bridge. The accumulated sediments have formed a large mid-channel bar and have forced the thalweg (deepest part of the channel) to move toward the margins of the channel and form a split path around the bar under flood conditions. The primary channel is now on the north bank and is rapidly eroding the bank. The eroding bank at this site is actually an old berm made primarily of dredged river material, so it is a very tall bank with respect to the much lower historic floodplain elevation.

The goal of restoration at this site would be consistent with the identified process-based restoration actions for the reach, primarily to restore aggrading and avulsing conditions, and to increase boundary resistance required to maintain a thalweg away from the toe of the bank towards the center of the channel. The project would involve the stabilization of approximately 260 feet of eroding bank. In addition, the project should also include the relocation and reconstruction of approximately 1,000 feet of a single-

thread channel capable of transporting sediment through the site. [Figure 5-6](#) shows existing and conceptual cross-sections upstream of the Park Street bridge. Adjustment of the channel grade will also be necessary to mitigate the aggraded condition of the reach.

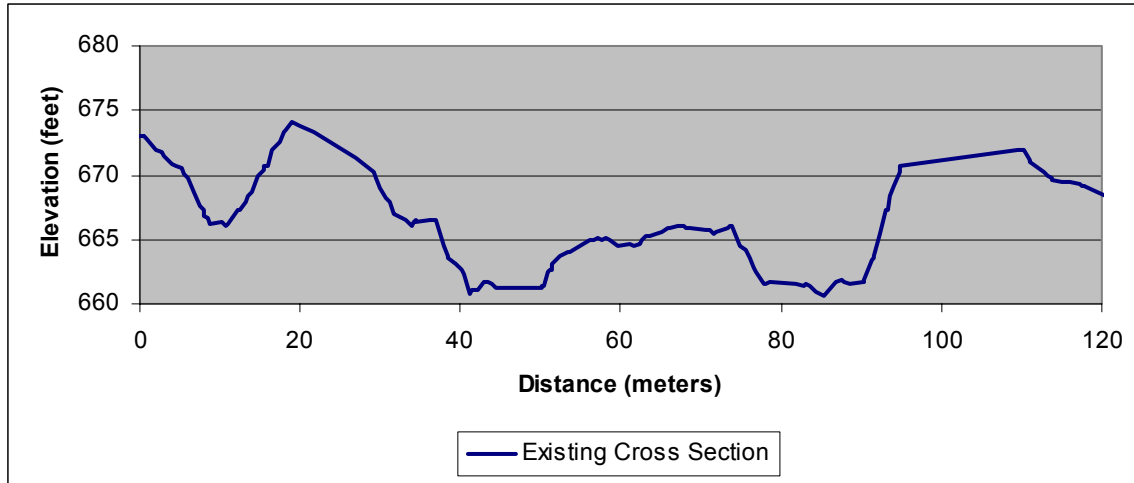
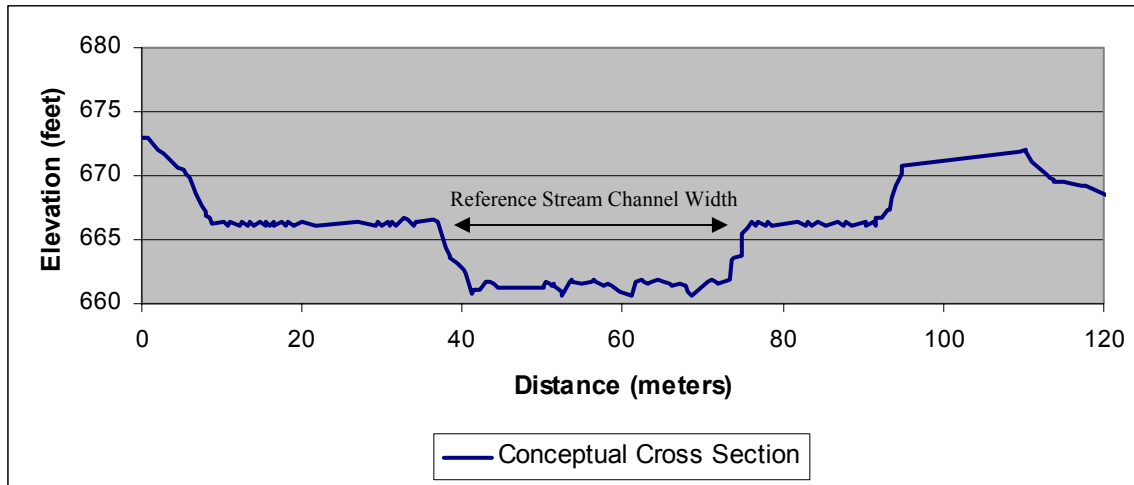
Figure 5-8: Park Street Bridge – Existing and Conceptual Cross-Section upstream of Bridge Opening (Station 300).

Note: X-axis in meters. See also [Figure 5-5](#).

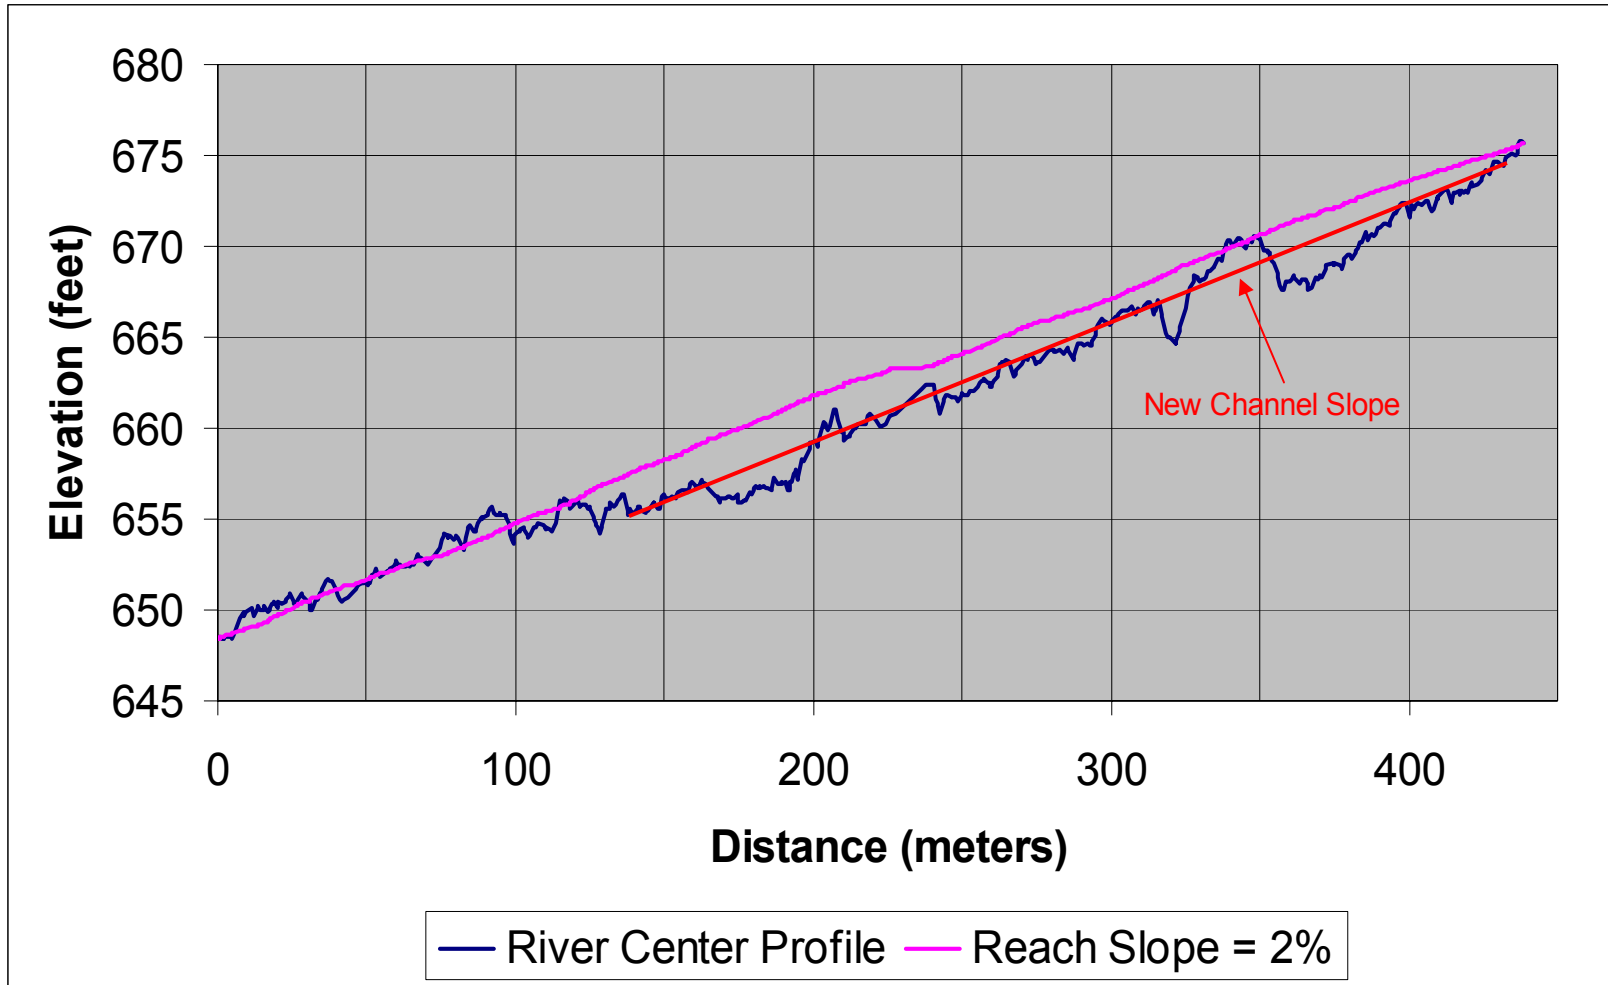
Figure 5-9: Existing and Conceptual Slope of Stream Channel through the Park Street Bridge.

Note: The LiDAR data provided channel slopes through the project area which allowed for an estimate of the upstream extent of the depositional features influenced by the bridge. Conceptual profile adjustments are shown in red above.
