# Village of North Bennington Hazard Mitigation Plan

December 2022

North Bennington, Vermont

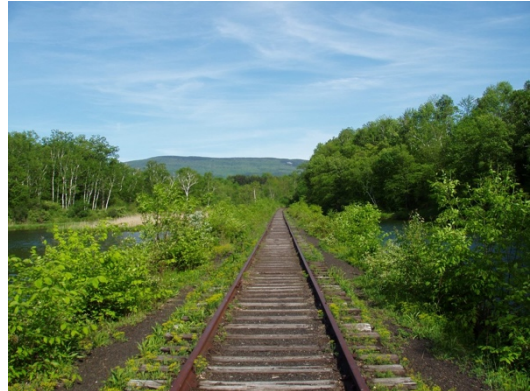
Figure 1: Railroad through North Bennington (Source: North Bennington Village Plan 2018)

A railroad from New York passes through the northern end of the village on its way to Rutland. The track splits in the village with the southern track passing just south of Lake Paran to an area where rail cars are stored on the track. Approximately 20 rail cars are stored at a time. The rail cars are filled with propane and/or natural gas. Beyond this area, the track continues on to Bennington, but that portion of the track is no longer in use.

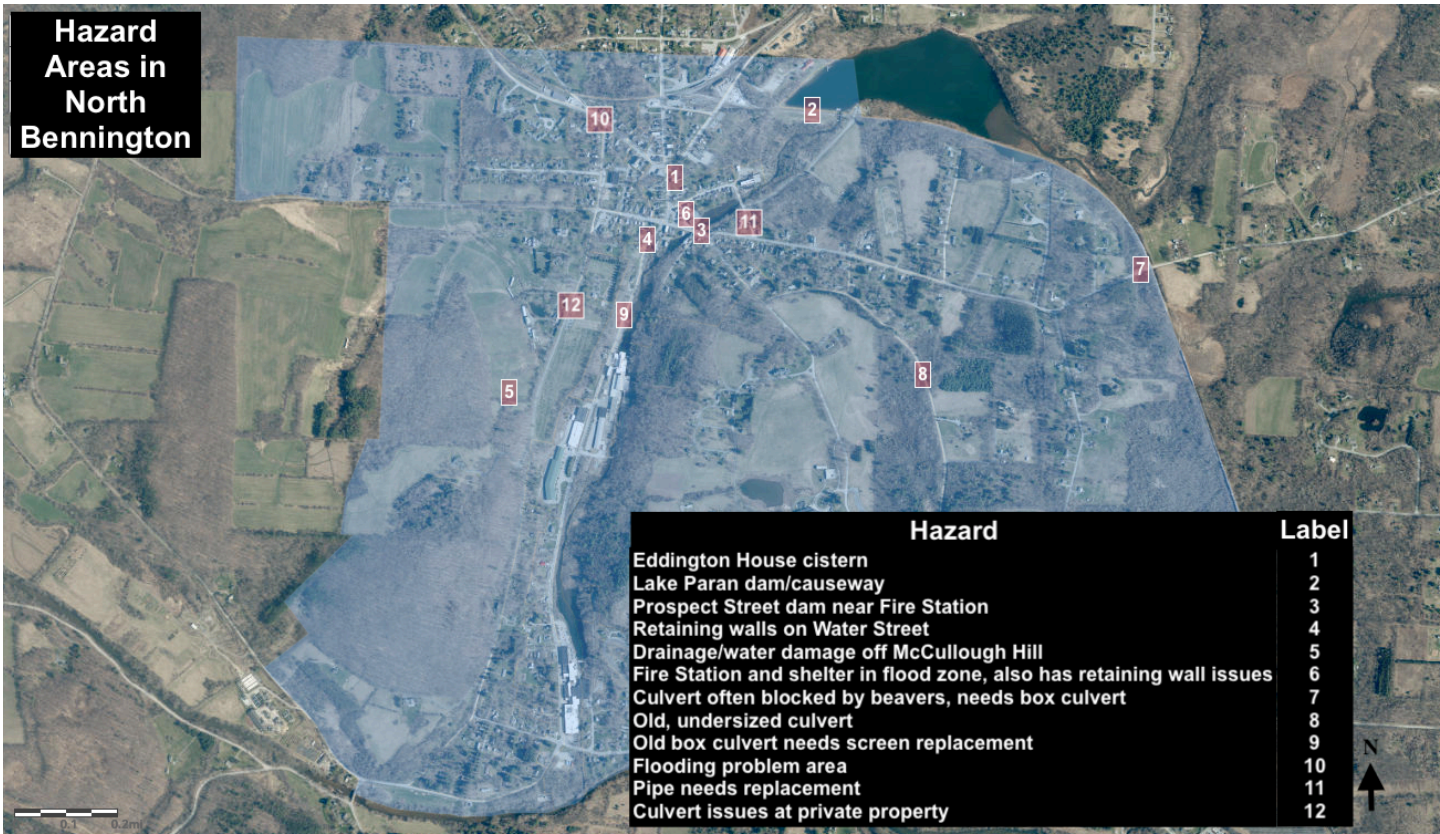
Map 8: Identified hazard areas in North Bennington by the Planning Team (Source: Planning Team, ArcGIS Online)

Map 8 is a composite map showing areas identified by the planning team as vulnerable to flooding, steep grades, and areas needing major culvert upgrades. Other priority hazards were not mapped either as adequate surveys have not been completed, or they could affect the entire village. Table 21 lists the hazard areas, shown on Map 8.

Table 21. Hazard areas identified by the planning team
Eddington House cistern
Lake Paran dam/causeway
Prospect Street dam near Fire Station
Retaining walls on Water Street – potential slide
Drainage/water damage off McCullough Hill over Park Street and down Water Street
Fire Station and shelter in flood zone, also has retaining wall issues
Culvert often blocked by beavers, needs box culvert
Old, undersized culvert
Old box culvert needs screen replacement – if blocked, will flood Route 67A
Flooding problem area – roadside needs reshaping
Pipe needs to be replaced
Culvert issues at private property on Park Street
