**River Corridor Plan for Tubbs and Ladd Brook in Pownal  
and Bennington, Vermont**

**December 14, 2017**

**Fitzgerald Environmental Associates, LLC.**  
18 Severance Green, Suite 203  
Colchester, VT 05446

**Bennington County Regional Commission**  
111 South Street, Suite 203  
Bennington VT, 05201

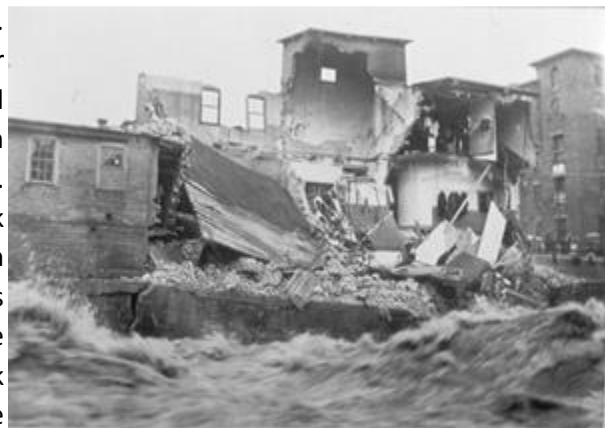
**Figure 1.5:** Buildings along the Hoosic in North Adams MA were destroyed in the 1948 flood (photo: P. Marino).

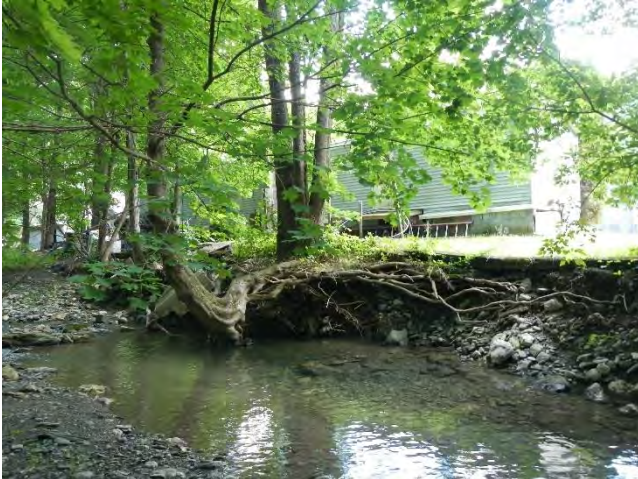
- High bank erosion in segment: M01T1.04D. Moderate bank erosion in segments: M01T1.01, M01T1.02, M01T1.04S1.01, M05S1.01 (Figures 4.13 and 4.14).

**Figure 4.13:** Bank erosion and buffer impacts in reach M01T1.01.

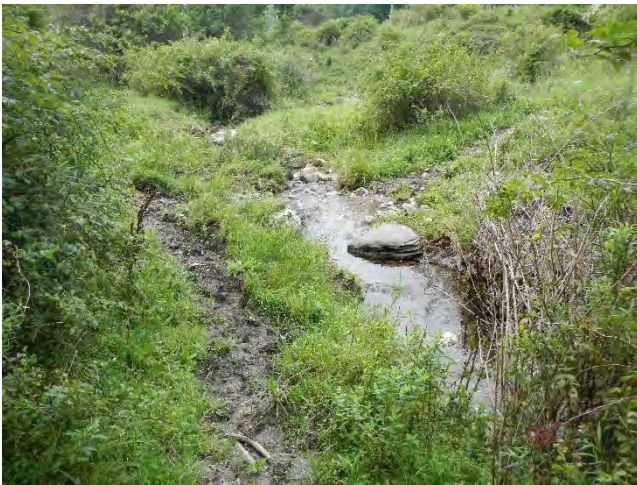
**Figure 4.27:** Cattle path along floodplain and across channel on M01T1.04.D.
