Stormwater Master Plan Town of Sandgate, Vermont

December 29, 2017

Prepared by:

Fitzgerald Environmental Associates, LLC.
18 Severance Green, Suite 203
Colchester, VT 05446

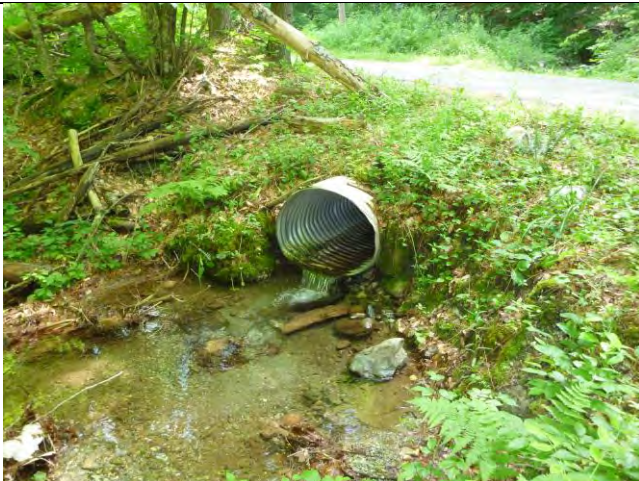
Site Description: An undersized squashed corrugated metal pipe is located on Chunks Brook Road to convey the flow from an unmapped perennial stream draining to Chunks Brook (Photo 1). The culvert capacity is estimated at 40.2 cfs, a flow that may conservatively be exceeded in the 10-year flood event. Additionally, the culvert is perched and there is erosion upstream of the culvert inlet increasing sediment load to Chunks Brook (Photo 2).

Photo 1: An undersized culvert on Chunks Brook Road.

BMP Description: Replace the undersized structure with a larger structure sized to convey the 25-year flow (e.g. a 6' wide, 4' tall squashed corrugated metal culvert with 1' of embeddedness).

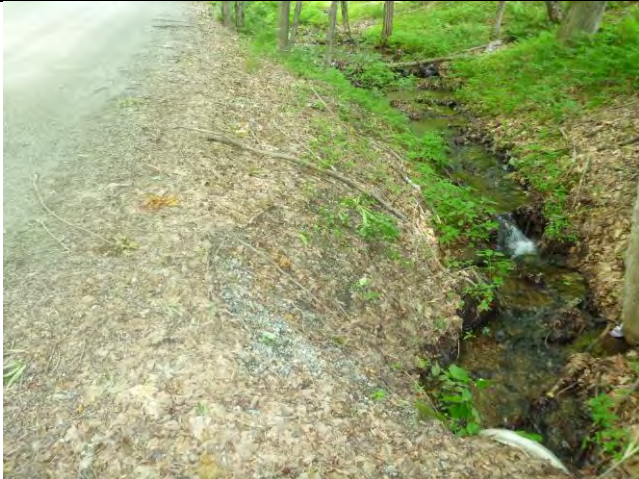
Site Description: An undersized round corrugated metal pipe is located on Rupert Road to convey the flow from a first order stream (Photo 1). The culvert capacity is estimated at 16.2 cfs, a flow that may conservatively be exceeded in the 10-year flood event. Additionally, there is some erosion upstream and downstream of the culvert inlet acting as a sediment source to the first order stream (Photo 2).

Photo 1: Some bank erosion is present upstream of an undersized culvert on Rupert Road.

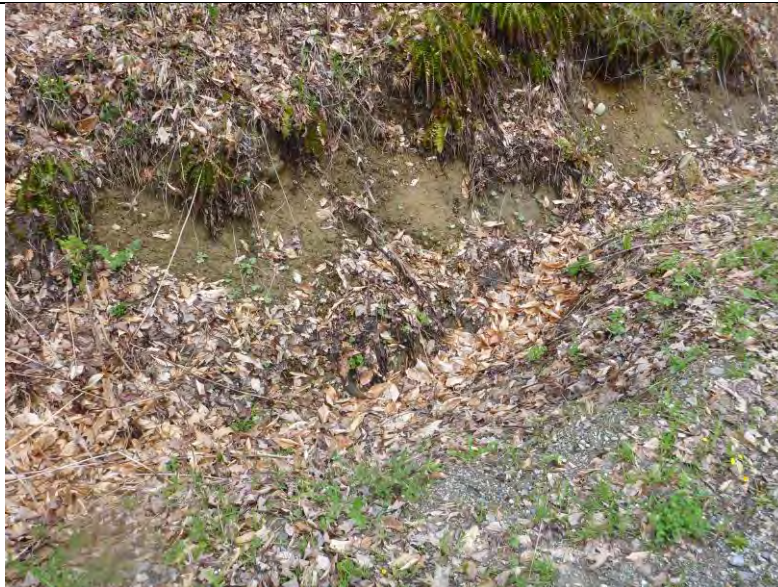
Site Description: Inlet of cross-culvert is eroded with an active headcut in the upstream ditch. The runoff collected in the ditch is directed toward nearby Sandgate Brook (Photo 1).

Photo 1: Erosion and a headcut in the Rupert Road ditch upstream of a cross culvert inlet.

BMP Description: Monitor inlet and add armor as needed to reduce erosion. Grade road ditch at inlet to remove the headcut and line ditch with 8" minus stone.

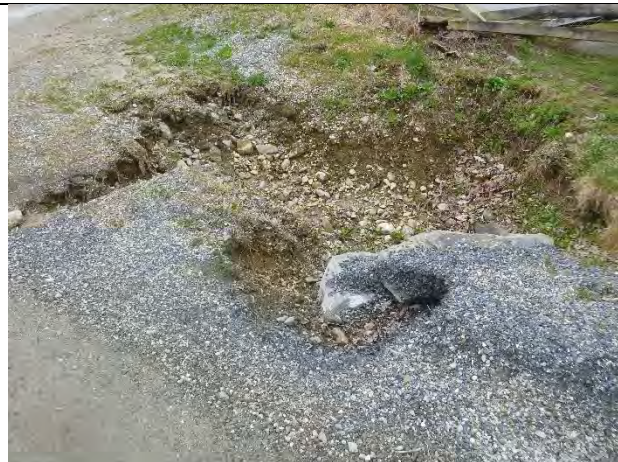
Site Description: Roadside ditch along West Sandgate Road is filled with sediment, causing runoff to scour around the edge of the roadway at the inlet of an 18” corrugated plastic cross-culvert. Severe gully erosion is present at the culvert inlet and along the road edge (Photos 1 & 2).

Photo 1: Severe gully erosion along the road edge and at the cross-culvert inlet.

BMP Description: Clean out ditch upstream of cross-culvert and crown road to direct water into the ditch. Stabilize erosion areas.

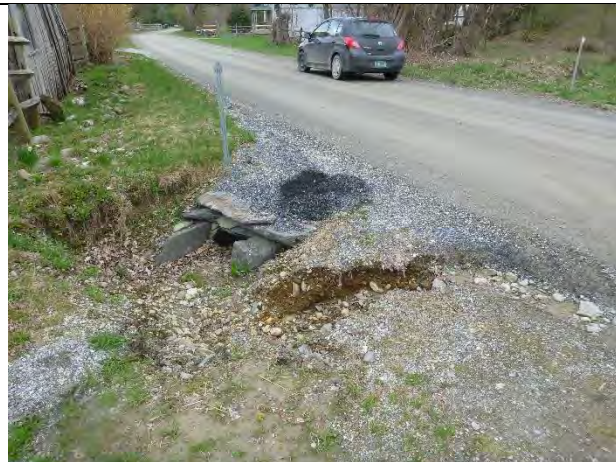
Photo 2: Filled in, poorly defined ditch with erosion where runoff flows along the road over the culvert inlet.

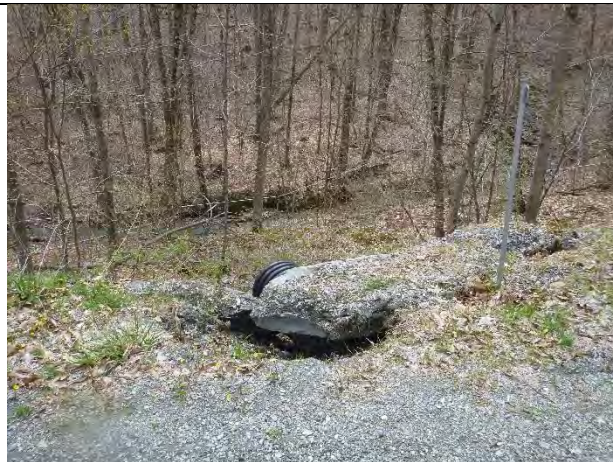
Site Description: Severe road erosion is present behind the headwall of a cross-culvert outlet adjacent to a second order tributary to the Green River (Photo 1).

Photo 1: Severe road erosion around the headwall of a cross-culvert outlet on Wilcox Hollow Road.

BMP Description: Crown the road to direct water into the ditch upstream of the cross-culvert inlet. Stabilize cross-culvert outlet as needed.

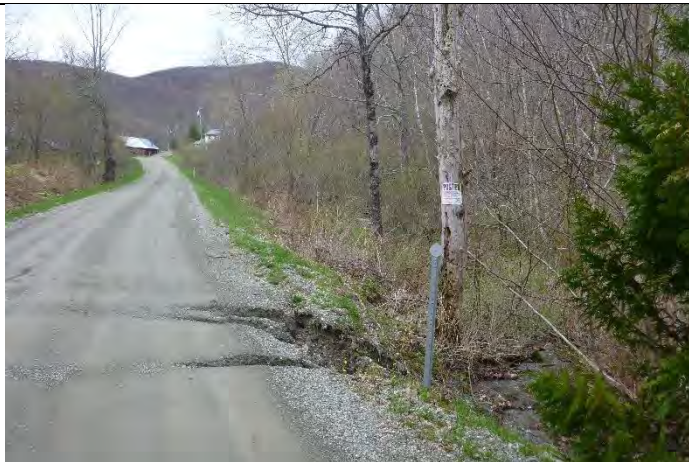
Site Description: Severe erosion of the roadway is present at a cross-culvert outlet on Wuerslin Road (Photo 1). The road crown does not effectively direct water into ditch on the south side of the road, causing water to flow over the road toward Pruddy Brook.

Photo 1: Severe road erosion near a cross-culvert outlet on Wuerslin Road.

BMP Description: Crown road to direct water into ditch on the south side of the road. Stabilize the cross-culvert outlet as needed.

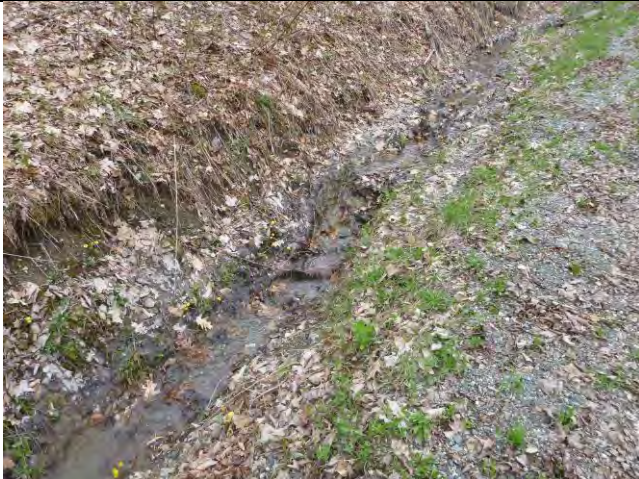
Site Description: Inlet of a West Road cross-culvert and ditch upstream are eroded with an active headcut (Photo 1). Outlet is eroded with a 3' perch and drains to a second order tributary to Baldwin Brook (Photo 2).

Photo 1: A headcut and erosion in the ditch upstream of a West Road cross culvert.

BMP Description: Stabilize culvert inlet and outlet with coarse material. Stabilize road ditch with of 12" minus stone. Grade road ditch at inlet to remove headcut. Improve armor at the culvert outlet to reduce scour.

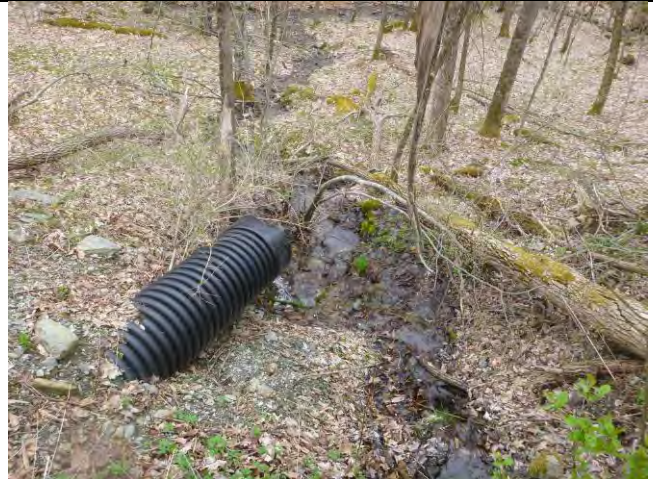
Photo 2: Erosion at the perched outlet of a West Road cross culvert.

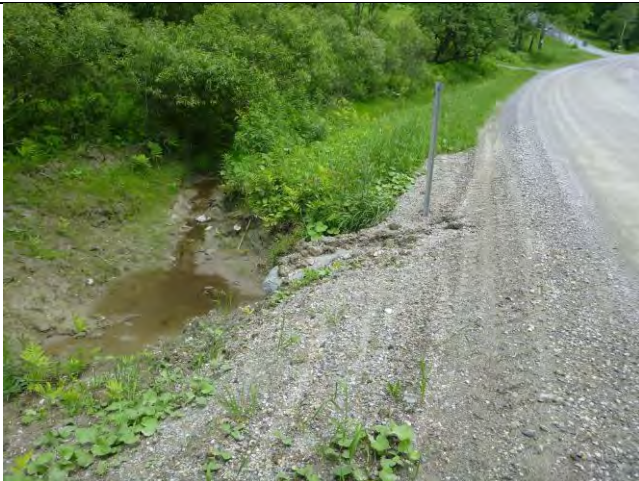
Site Description: Water exits roadway at a drainage culvert near the gravel-pavement transition on Sandgate Road, eroding the road embankment and pushing sediment into a wetland upstream of the culvert (Photo 1) and the Green River (Photo 2).

Photo 1: Water flowing over Sandgate Road is causing erosion at a cross culvert inlet, acting as a source of sediment to a roadside wetland.

BMP Description: Crown the road to direct water into ditches upstream of the cross-culvert inlet. Vegetate area upstream and downstream of cross culvert. Install a stone lined turnout near the culvert if necessary.

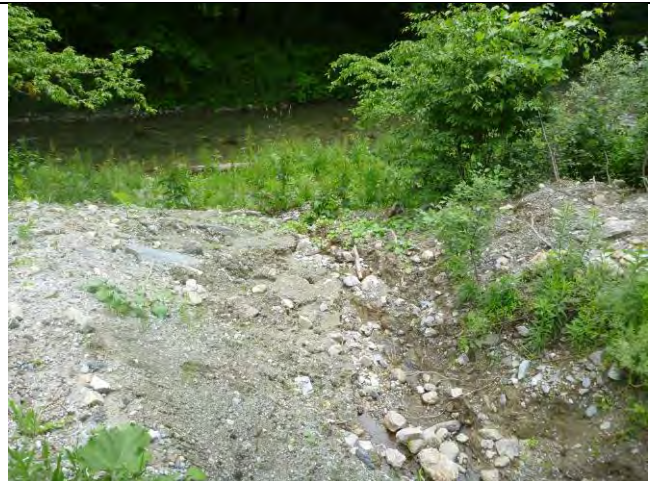
Photo 2: Erosion at a Sandgate Road cross culvert outlet is acting as a source of sediment to the Green River directly downstream.

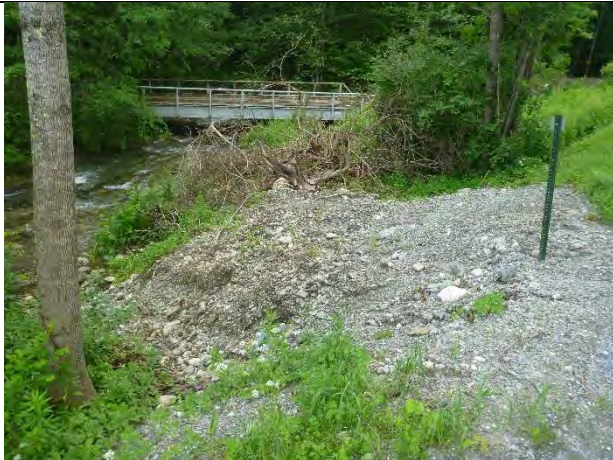
Site Description: Unstable sediment associated with a series of culvert installations along Sandgate Road is piled alongside the Green River, a potential contributor to sediment loading (Photo 1). Sediment is also piled along the upstream side of the drainage culverts, which may plug the culverts (Photo 2).

Photo 1: Sediment piled on a road embankment adjacent to the Green River.

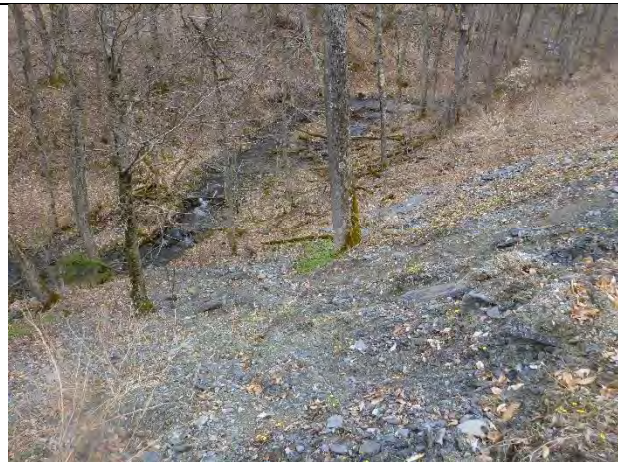
Site Description: The road crown along a portion of Rupert Road, directs water away from the ditch to a steep slope on the northwest side of the road above Terry Brook. Road runoff has eroded an approximately 50'-tall gully that conveys sediment from the road toward the brook and threatens the road (Photo 1).

Photo 1: Massive gully conveying sediment toward Terry Brook.

BMP Description: Crown the road into the existing ditch and 18" corrugated steel cross-culvert on the southeast side of the road (Photo 2). Enlarge the ditch. Install log terraces and stone to stabilize road embankment slope as needed.

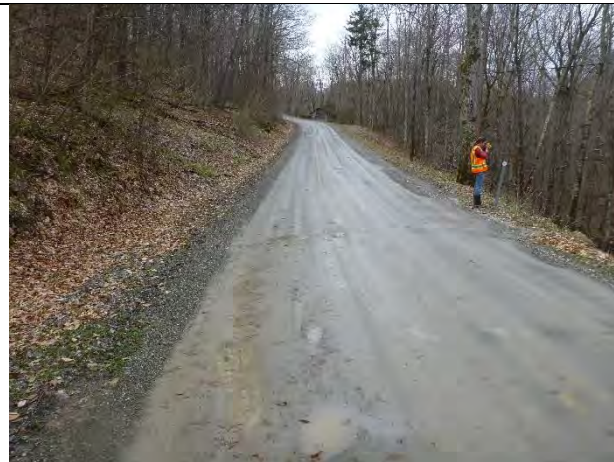
Photo 2: Road grade conveying runoff toward the steep slope and brook, rather than the existing ditch and cross-culvert.

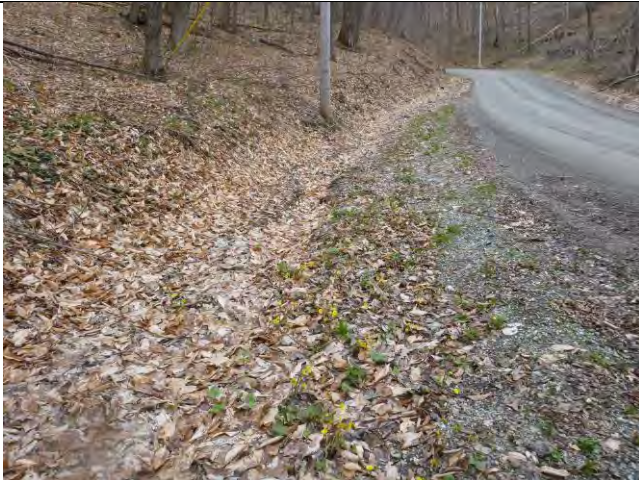
Site Description: The road crown along a section of Rupert Road does not effectively direct water into the roadside ditch (Photo 1) and the ditches are poorly formed and eroding (Photo 2). The erosion is located near a first order tributary to Baldwin Brook.

Photo 1: The road crown on a section of Rupert Road is not effectively directing water into the roadside ditches.

BMP Description: Crown road to direct water into ditch. Enlarge ditch and line with 8" to 12" minus stone.

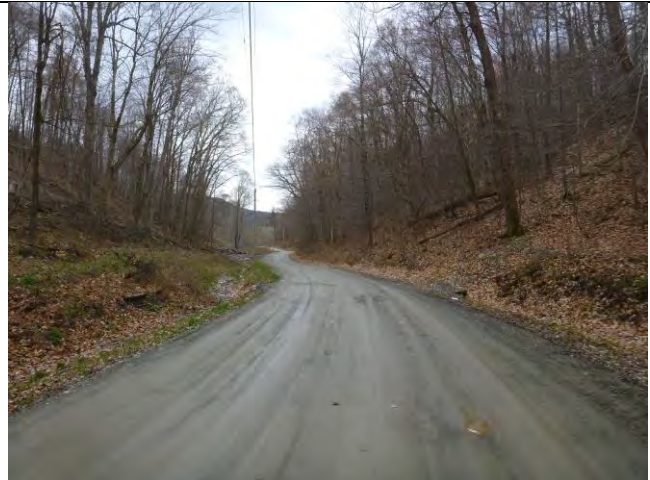
Photo 2: Ditches along a section of Rupert Road are poorly formed and eroding.

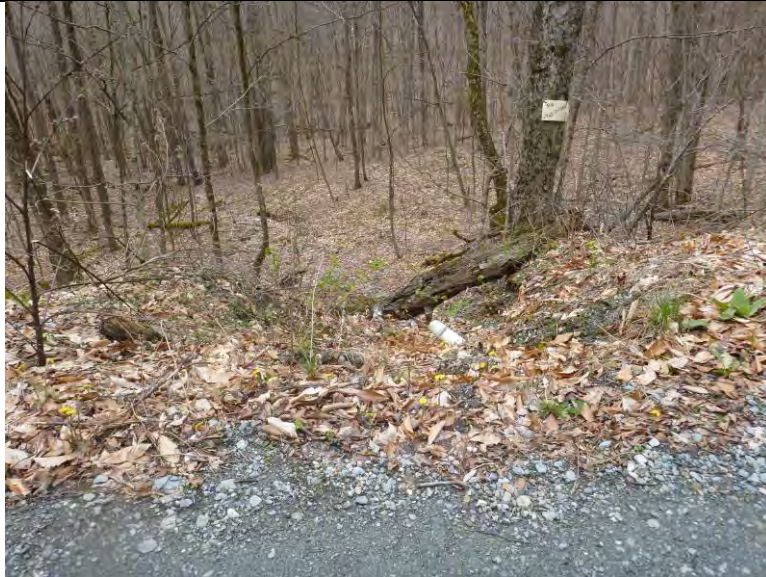
Site Description: Road crown does not effectively direct water into ditch, causing rutting where water runs down the road. Ditches spill across the road, eroding the roadway and embankment (Photo 1).

Photo 1: Erosion and sediment loss along a steep section of road embankment upslope of a tributary to Baldwin Brook.

BMP Description: Improve road crown and enlarge the ditch.

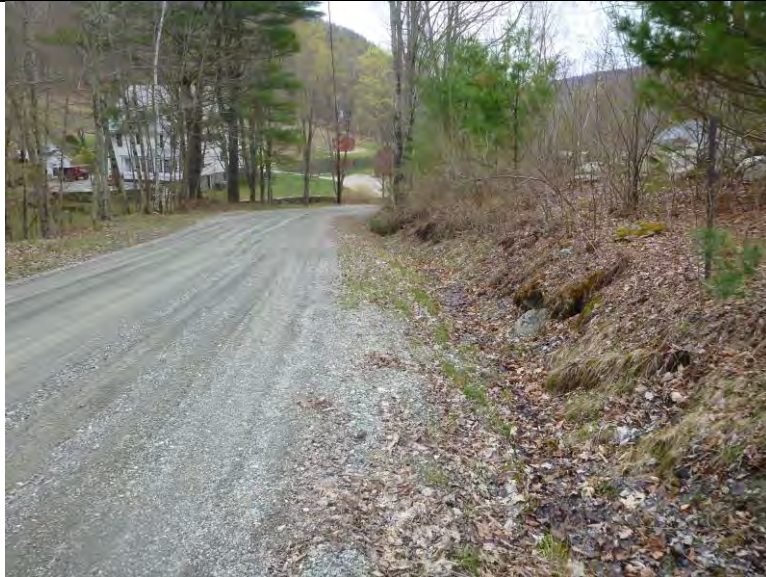
Site Description: Road crown does not effectively direct water into ditch, causing rutting where water runs down this steep section of road (Photo 1).

Photo 1: Erosion along a steep section of Southeast Corner Road.

BMP Description: Crown road to direct water into the existing ditch. Clean out ditch, stabilize the side slope, and line the ditch with 12" minus stone.

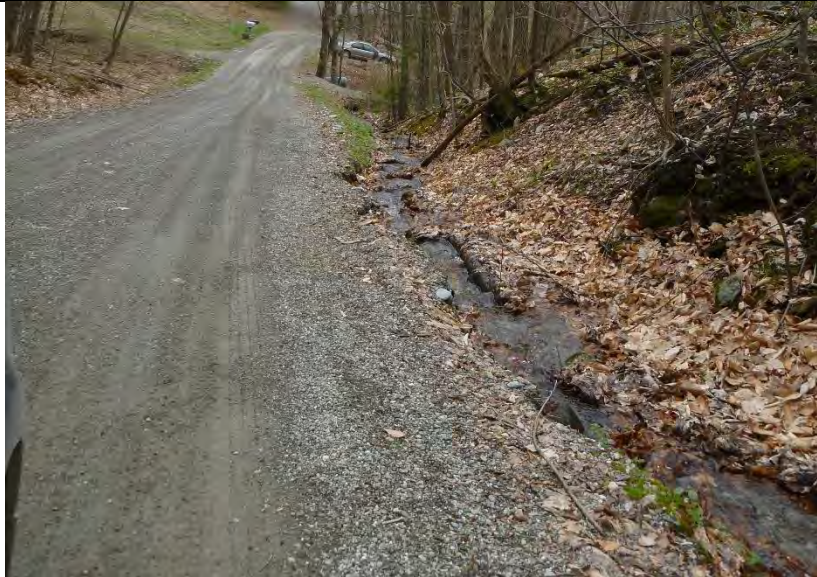
Site Description: Erosion along the edge of a steep section of Southeast Corner Road due to an unstable ditch that is relatively full of material. A first order tributary to a third order Green River tributary runs alongside the road (Photo 1).

Photo 1: Erosion of steep section of Southeast Corner Road.

BMP Description: Clean out ditch and stabilize with a minimum of 6-8" minus stone. Steeper ditch sections require 12" minus stone.

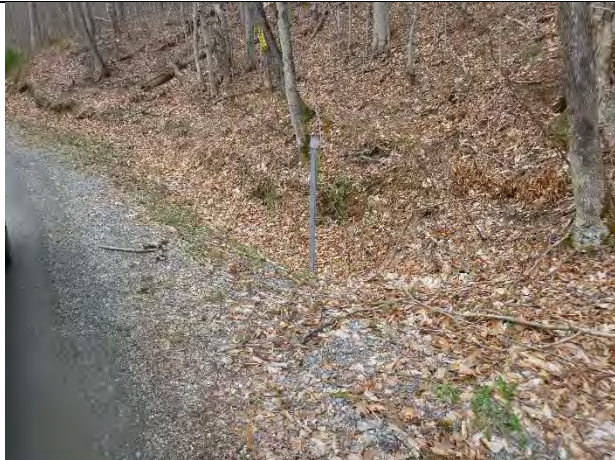
Site Description: A cross-culvert along Wilcox Hollow Road is undersized and eroding at the outfall. The 15" corrugated metal pipe conveys water toward a second-order tributary to the Green River. The culvert outlet drops 8-9 feet down the steep road embankment to a second-order tributary to the Green River, causing erosion and sedimentation in the channel (Photo 2).

Photo 1: Ditch upstream of cross-culvert inlet on Wilcox Hollow Road is filled in, causing water to follow the road.

BMP Description: Replace cross-culvert with an 18" at a higher slope to reduce outlet drop. Stabilize the road edge and add an appropriate header and footer at the culvert outlet, stabilize the outflow channel to stream.

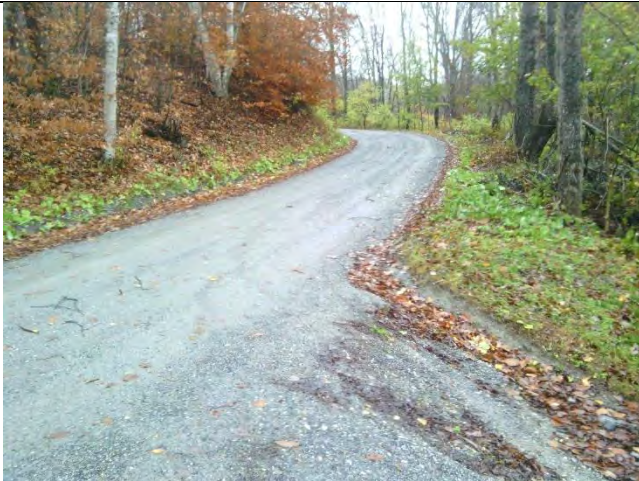
Site Description: The ditches along the steep section of Wuerslin Road show signs of erosion and sedimentation and require stone to meet the MRGP standards. There is no room for a ditch along the west side of the lower road, requiring a new cross culvert. The spur of Wuerslin Road is used infrequently by vehicles and is an ideal location for a stormwater treatment feature. This area is a nuisance maintenance problem for the road foreman. Runoff from the lower part of Wuerslin Road spills onto Sandgate Road causing erosion problems where conveyance features are lacking.

Photo 1: Runoff down a steep portion of Wuerslin Road is causing erosion at the secondary turn to Sandgate Road.

BMP Description: Improve ditches along Wuerslin Road and install a stormwater treatment feature along the side of the road at the spur.

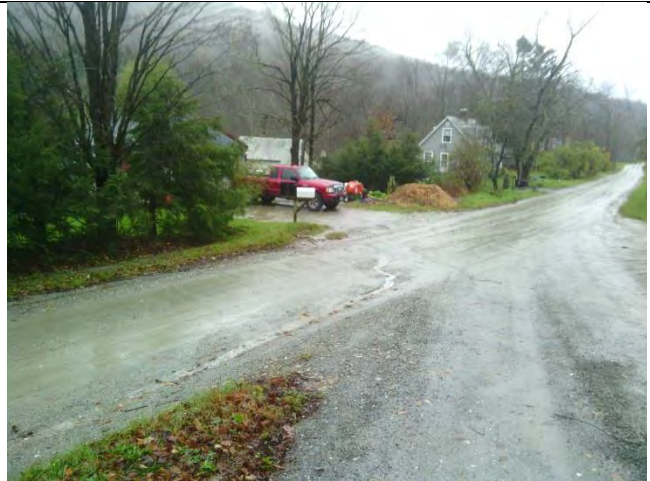
Photo 2: Runoff from Wuerslin Road causing significant erosion as it crosses Sandgate Road.

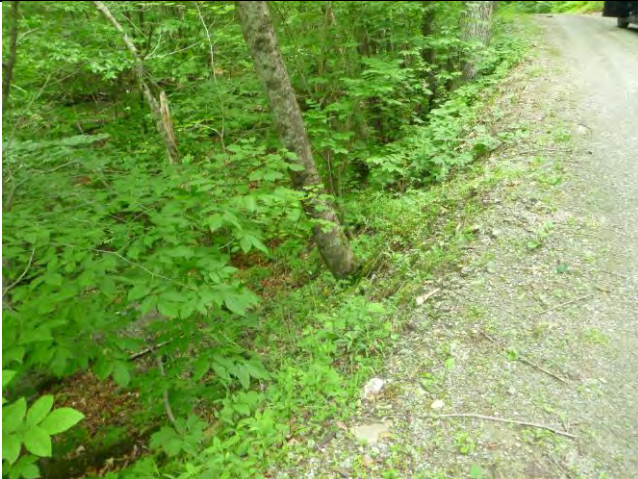
Site Description: Water flows along Tate Hill road, causing erosion along steep road embankments adjacent to Chunks Brook (Photo 1).

Photo 1: Erosion of a steep road embankment along Tate Hill Road.

BMP Description: Install a ditch on the opposite side of the road (Photo 2) and crown the road to direct water into the ditch. At least one cross-culvert is recommended.

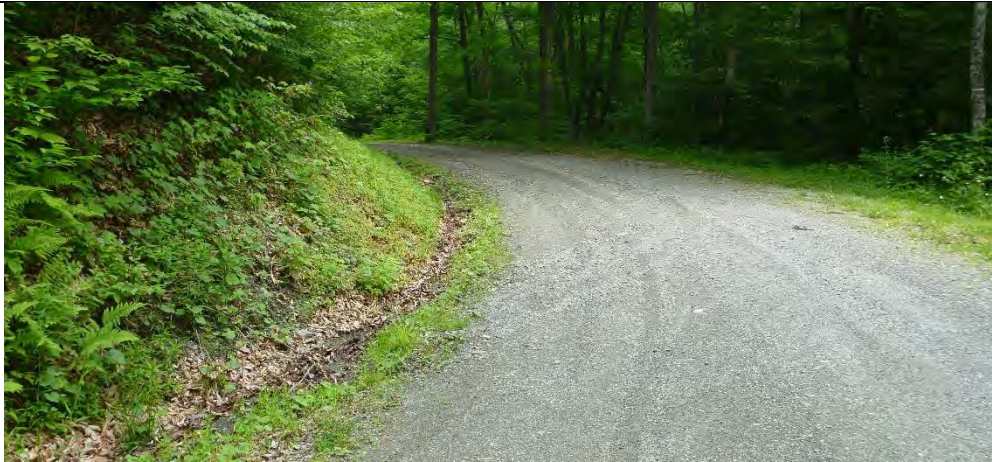
Site Description: Water flows across a steep section of Tate Hill Road, eroding the roadway (Photo 1).

Photo 1: Erosion of steep section of Tate Hill Road.

BMP Description: Clean out ditches and line with stone, crown road to direct water into ditches.

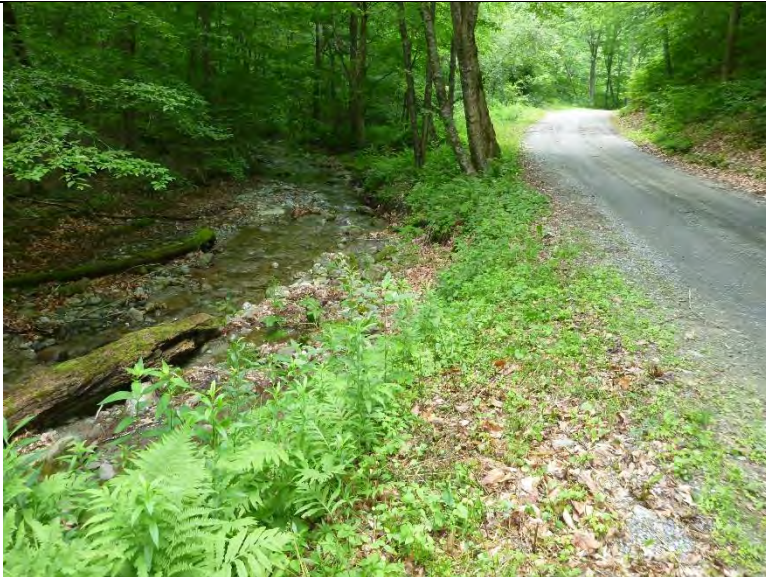
Site Description: Chunks Brook flows alongside Tate Hill Road with no buffer, eroding the stream bank and road embankment (Photo 1).

Photo 1: Erosion where Chunks Brook flows alongside the Tate Hill Road embankment.

BMP Description: Armor the road embankment. Crown and ditch road to keep stormwater from flowing across the road to the streambank.

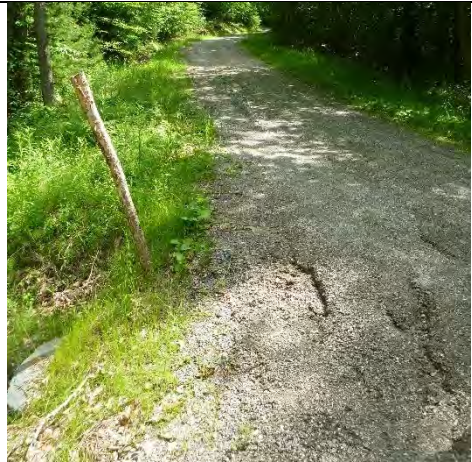
Site Description: Water flows along a steep section of Tate Hill Road eroding the surface and directing sediment toward a culvert where Chunks Brook crosses the road (Photos 1 & 2).

Photo 1: Road erosion to a conveyance at a Chunks Brook stream crossing.

BMP Description: Crown road to direct water into ditches. Excavate and stabilize ditches with stone as needed.

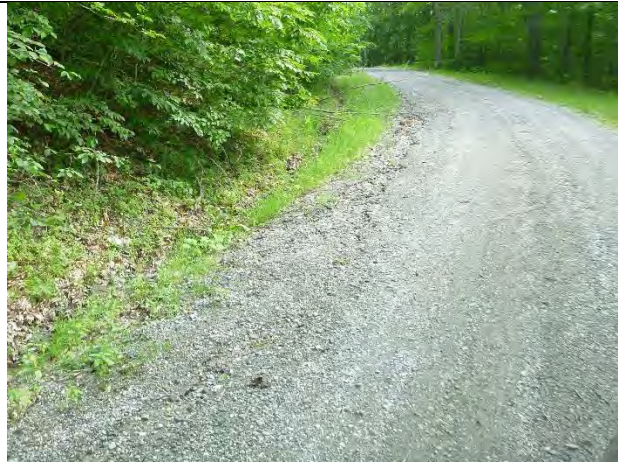
Photo 2: Road erosion along a steep section of Chunks Brook Road.

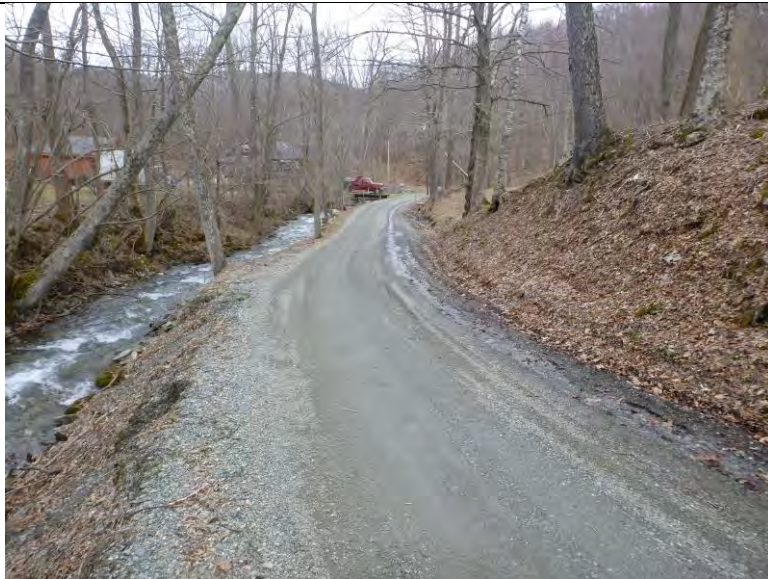
Site Description: Limited space along north side of road for drainage from Merritt residence down along Hopper Brook. Road erosion and rilling along the road leading to sedimentation in brook (Photo 1).

Photo 1: Narrow road with Hopper Brook on left and limited space for a ditch on the east side of road.

BMP Description: Consider installing larger cross culvert below Merritt property. Install ditch along north side of road across from Hopper Brook. This may involve significant cutting of the slope to install an adequate ditch.

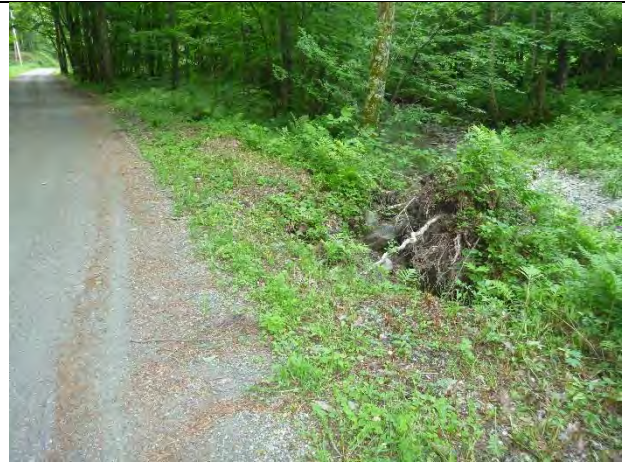
Site Description: A tree is down across Chunks Brook alongside Chunks Brook road (Photo 1). This creates an erosion hazard for the road by destabilizing the embankment and potentially directing flow toward the road (Photo 2).

Photo 2: Exposed embankment along Chunks Brook road.

BMP Description: Remove tree from channel and armor road embankment. This project requires further review by the ANR River Management Engineer.

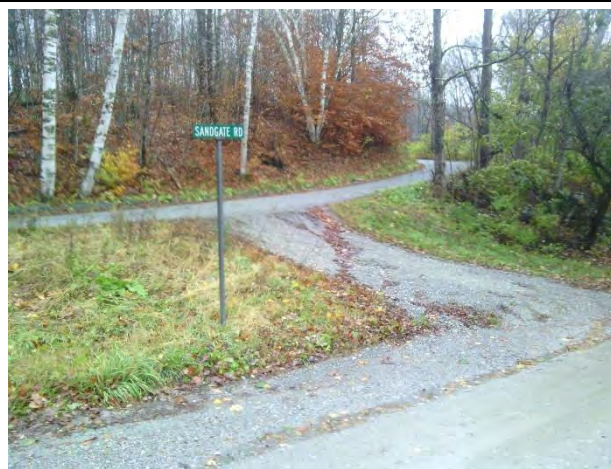
Photo 2: Area of Wuerslin Road to be abandoned for vehicle traffic and turned into a stormwater treatment feature.

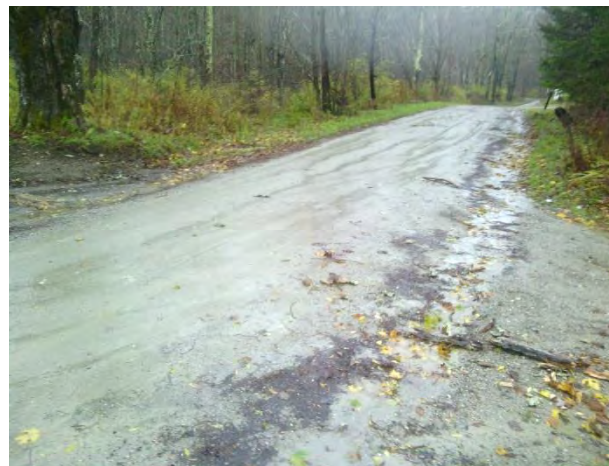
Photo 2: Lower section of Sandgate Road. Runoff is running along the road edge causing rilling and sedimentation downhill.

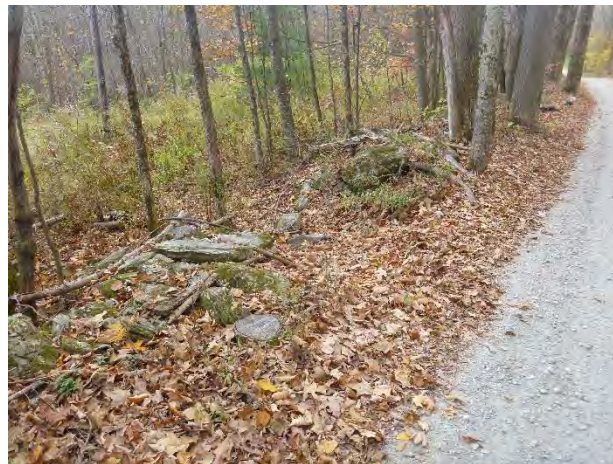
Photo 2: Existing armored turnouts are only partially accessible due to accumulation of road bed material.

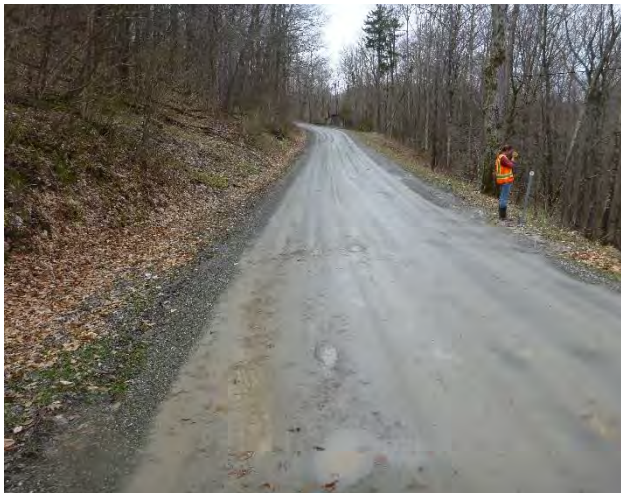
The road crown along a portion of Rupert Road directs water away from the ditch to a steep slope on the northwest side of the road above Terry Brook (Figures 1 & 2). Road runoff has eroded an approximately 50'-tall gully that conveys sediment from the road toward the brook and threatens the road (Figure 3). The slope of the embankment down to the stream is approximately 75%. A small grader berm on the west side of Rupert Road prevents water from sheeting off the road before it reaches the gully.

Figure 2: The road crown does not direct water into the existing ditch and cross culvert along a section of Rupert Road.

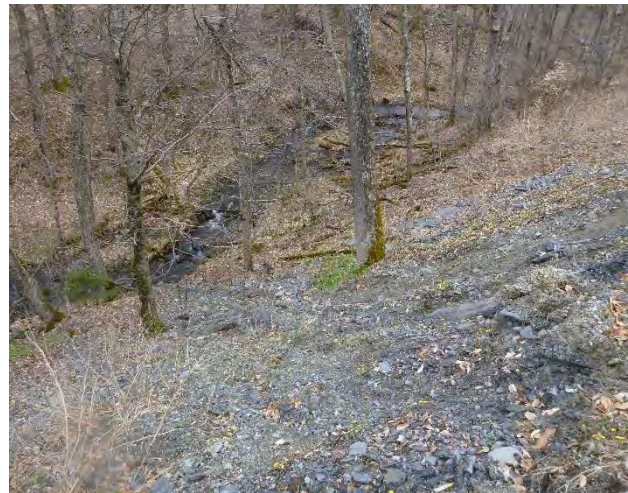
Figure 3: Gully erosion along the steep Rupert Road embankment.

This gully is likely a major sediment source to Terry Brook. The gully erosion threatens Rupert Road, which could require costly maintenance. For instance, FEA observed a failed guardrail that appeared to have slid down the embankment as it eroded. Additionally, the cross-culvert outlet was partially blocked by sediment from the erosion.

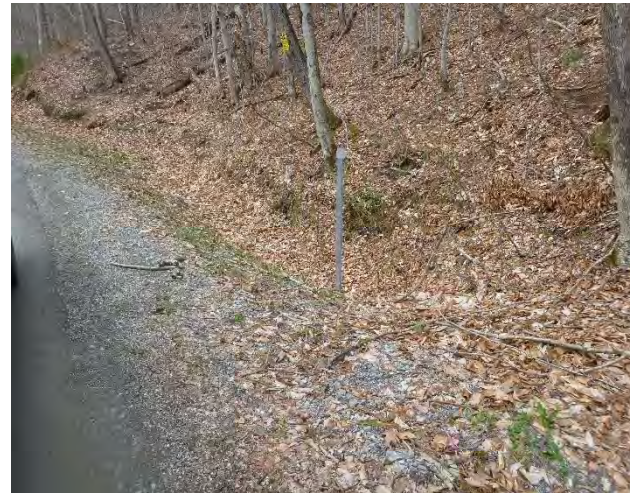
Figure 3: Filling in of the ditch upstream of the culvert may be causing water to spill out of the ditch onto the roadway.

on the area from the header to the edge of the road to prevent rilling of the road edge and erosion of the header. Ensuring the road is crowned and upstream ditch is cleaned out will help direct water into the cross-culvert and may reduce rilling of the road edge (Figure 3).
