Stormwater Master Plan Town of Sunderland, Vermont

December 29, 2017

Fitzgerald Environmental Associates, LLC.
18 Severance Green, Suite 203
Colchester, VT 05446

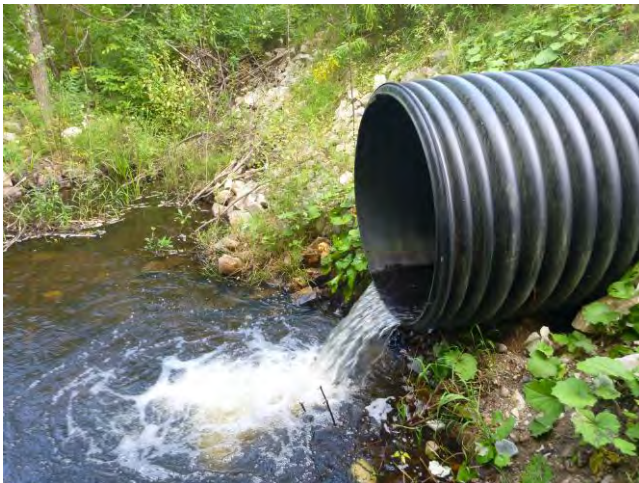
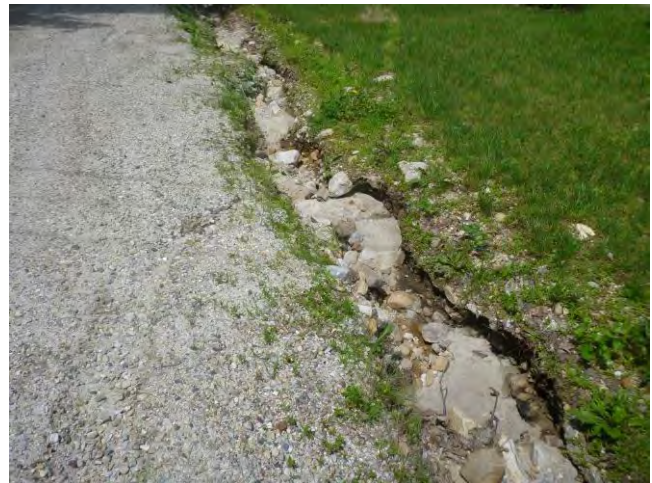
Figure 4: The AOP barrier created by a perched 48" culvert along South Road (left) was the lowest scoring projects (SC-2). The extreme erosion along the edges of Barney Orchard Road (right) was the highest scoring project (RD-8).

- **RD-8:** Extreme ditch erosion along a steep section of Barney Orchard Road is causing significant sediment loading to a small stream.
- **RD-9:** The roadway drainage network along lower Prouty Hill Road is complicated due to a missing driveway culvert, and severe ditch erosion and runoff across the road is causing significant sediment loading to the Fayville Branch.

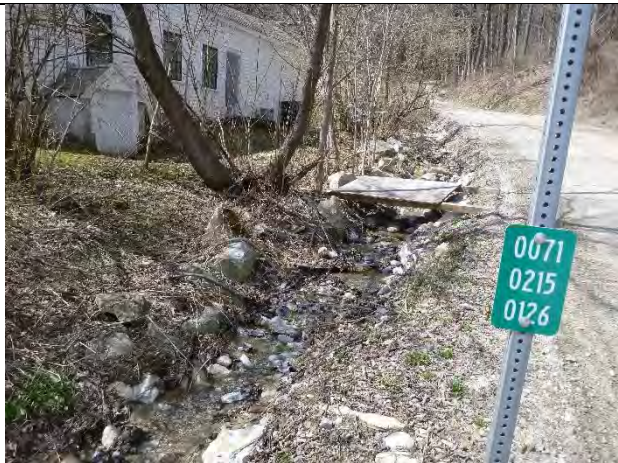
Site Description: The small stream along Bentley Hill Road flows through a narrow roadside ditch channel before crossing under Route 7a through an extremely undersized concrete box culvert. The channel along Hill Farm Road to the south is also undersized and is filling with sediment.

Photo 1: Steep channel approaching the culvert.

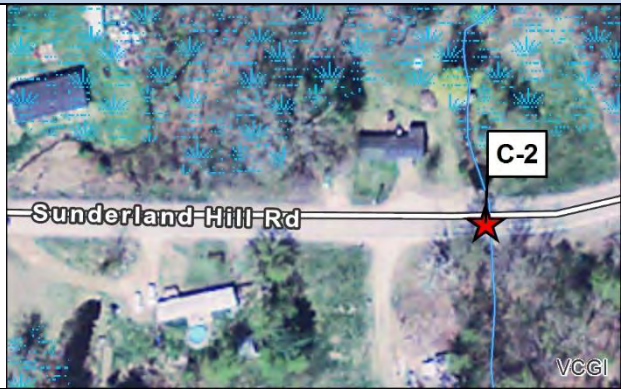
Site Description: The existing 4' culvert is extremely undersized, rusted, and is too short with a very steep embankment and erosion on the inlet side (Photo 1). The steep upstream channel has a high load of coarse sediment (Photo 2).

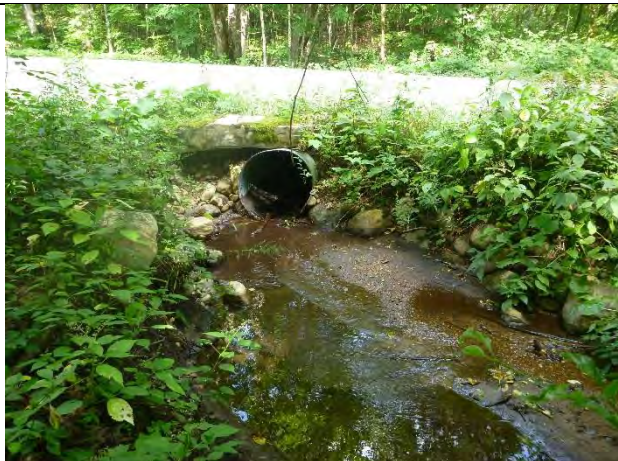
Site Description: A small stream crosses under Dunham Road through a 36" CMP culvert. The road washed out in TSI and severed an important transportation link within the Town. The channel slope decreases at the culvert leading to sediment deposition. The culvert inlet orientation is at a moderate angle to the channel approach.

Photo 1: A 36" CMP conveys a small stream under Dunham Road.

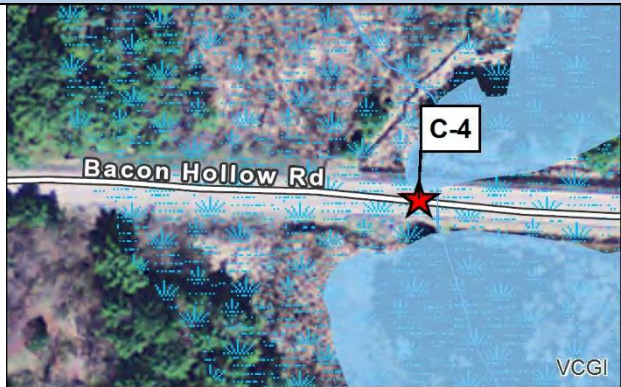
Site Description: A 36" CMP culvert under Bacon Hollow Road is fully backwatered due to downstream beaver dams (Photos 1 & 2). The culvert is rusted and needs to be replaced. Frequent maintenance is required to keep the outlet channel along the road embankment cleared of beaver dams.

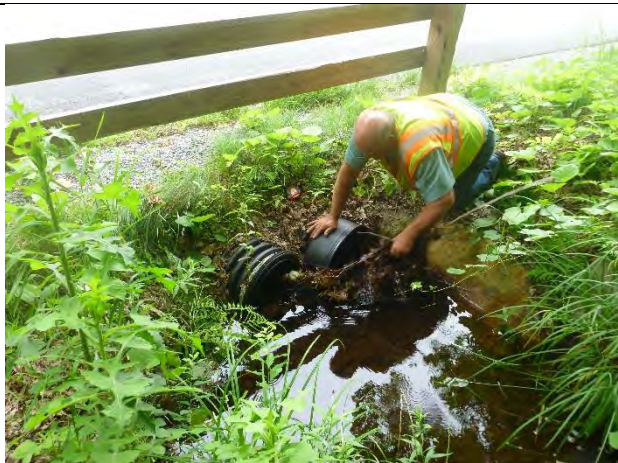
Site Description: Double 15" CPP under North Road require frequent maintenance to clear sediment, debris, and ice (Photos 1 & 2). Culvert slope is low and the inlet is slightly projecting.

Photo 1: Double culverts under North Road trap sediment, debris and ice.

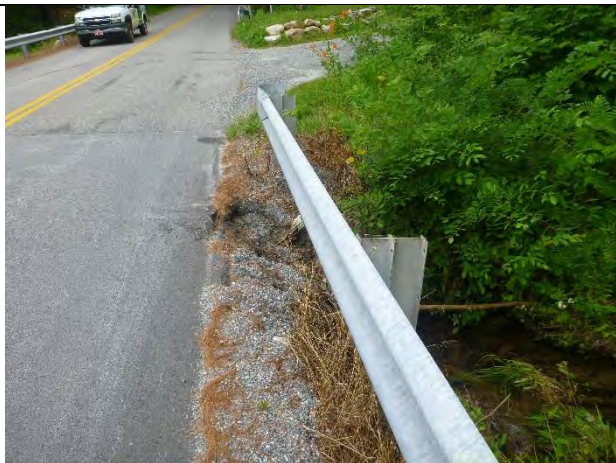
Site Description: 36" CMP under North Road is too short for the crossing resulting in a vertical bank on both sides of the road (Photo 1). The road shoulder is eroding and may undermine the edge of the pavement (Photo 2).

Photo 1: A culvert under North Road is too short causing erosion of the road shoulder at the culvert inlet.

BMP Description: Extend the culvert length to allow for a more stable embankment, improve culvert headers on both sides of the road.

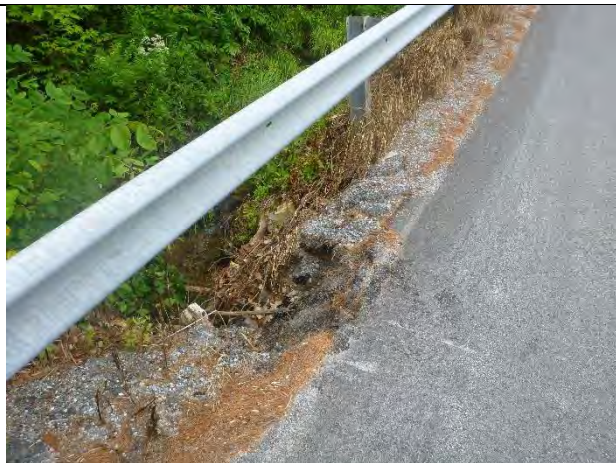
Photo 2: Erosion along the road shoulder due to the vertical banks at the culvert outlet.

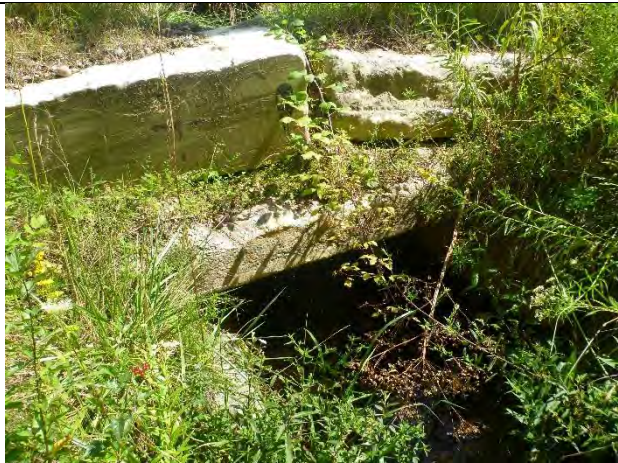
Site Description: The 24" CMP culvert under South Road near the driveway of the GMP facility is badly rotted and the inlet has collapsed (Photo 1). The embankment is eroding at both the inlet and outlet (Photo 2). The culvert is slightly undersized.

Photo 1: Location of a collapsed inlet to a cross culvert under South Road.

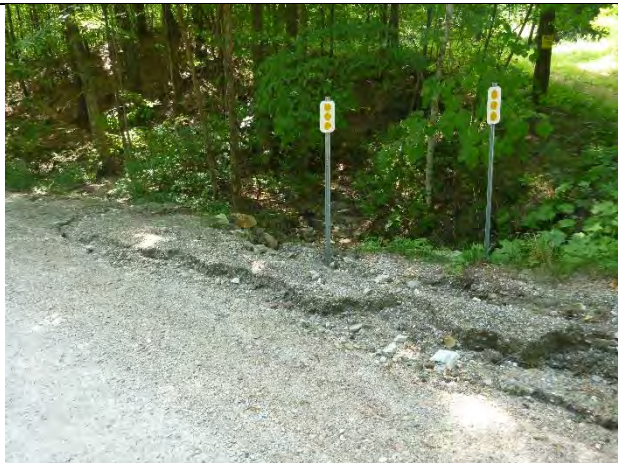
Site Description: A driveway located at the stream crossing does not have a culvert, causing the western ditch to spill across the road with significant rill erosion along the road and gully erosion at the stream culvert outlet (Photos 1 & 2). The ditch should be extended to minimize the length of culvert.

Photo 1: Major gully erosion along Bentley Hill Road.

BMP Description: Extend the west roadside ditch and install a culvert under the driveway with an outlet directly to the stream at the larger culvert outlet.

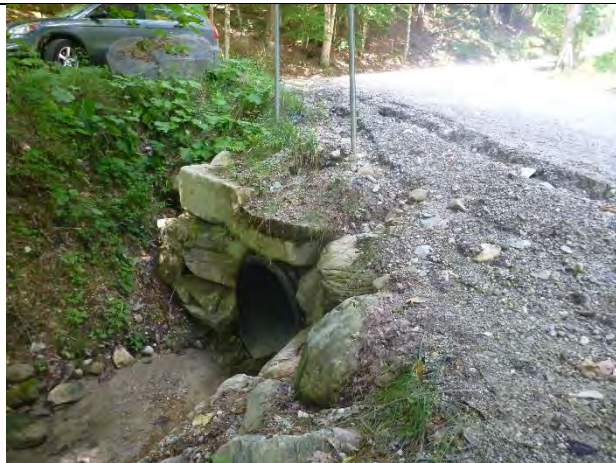
Photo 2: Sediment deposits at the stream culvert outlet from severe gully erosion along the road.

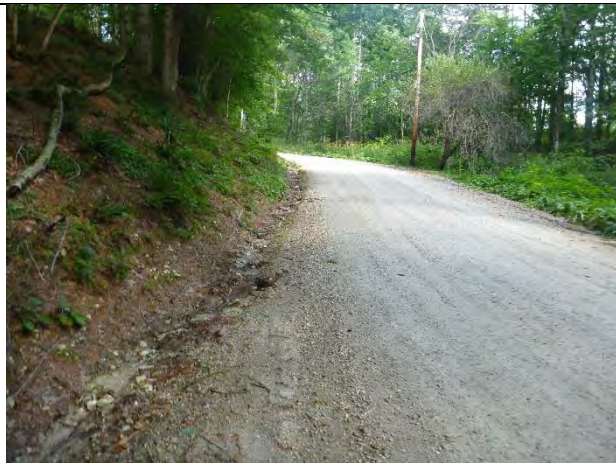
Site Description: Significant erosion along the ditches and steep road embankment was observed along the steep stretches of the Road from Route 7A to the town line (Photo 1). Ditches were typically undersized, shallow, and not stone lined (Photo 2).

Photo 2: Erosion along Bentley Hill Road, where ditches are shallow and undersized.

BMP Description: Enlarge and stone line the ditches with 6-8" minus in sections less than 10% slope and 12" minus stone in the sections approaching 10% slope. Stabilize gully erosion along the steep road embankment and improve road grading to reduce flow areas directly draining down the embankment. Ditch and road grading extents may approach 800-1,000 feet of roadway length. The entire project area is "hydrologically connected".

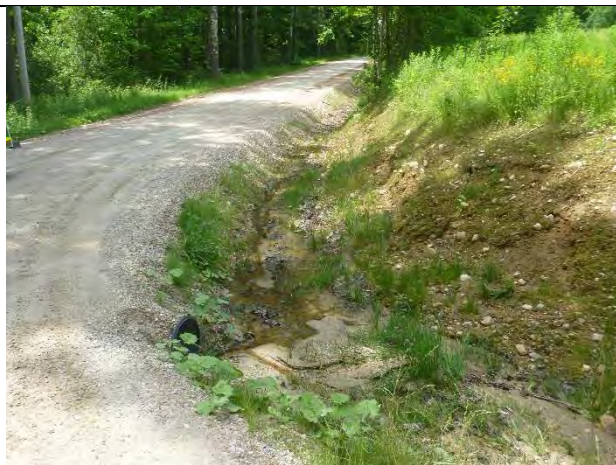
Site Description: The ditches along the north side of Flynn Hollow Road and the west side of North Road join and flow through a pipe under North Road. Both ditches are wide and flat and carry a large volume of sediment (Photos 1 & 2). Large vehicles turning on to Flynn Hollow repeatedly damage the road shoulder and increase erosion. **Sunderland Highway Department completed this work in 2017.**

Photo 2: Sediment at the inlet of the culvert under Flynn Hollow Road.

BMP Description: Stabilize the ditches and protect the road shoulder from erosion. Consider moving the culvert approximately 10' west to provide a larger turning area.

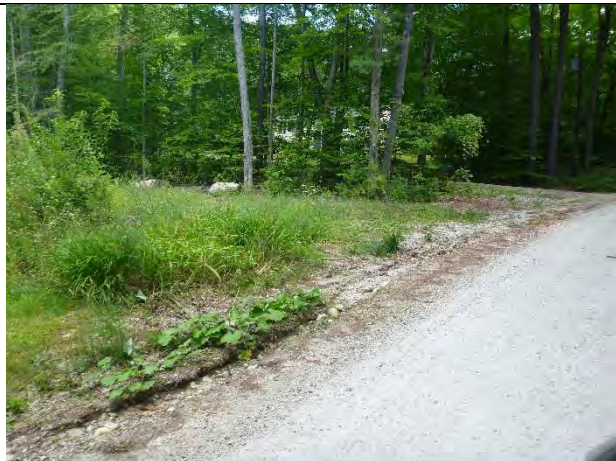
Site Description: Short section of road with no ditch along the northern side, moderate gully erosion (Photos 1 & 2). Cable lines are shallowly buried in the ditch complicating site improvements. **Sunderland Highway Department completed site repairs in 2017.**

Photo 2: Gully erosion along a section of Shady Pines Road with no ditch.

BMP Description: Install a grassed ditch and driveway culvert.

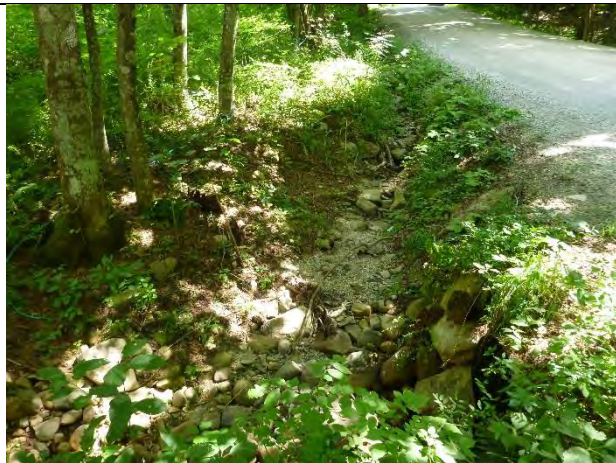
Site Description: The ditch along the north side of the road is undersized and poorly defined with several areas of severe gully erosion (Photo 1). The ditch on the eastern side of the stream crossing is deeply incised and is delivering large volumes of sediment and gravel to the stream channel (Photo 2). **Sunderland Highway Department completed ditch repairs in 2017.**

Photo 2: Incised ditch at the stream crossing is delivering large volumes of sediment and gravel.

BMP Description: Excavate and stone line ditches with 6-8" minus stone. Larger rock may be needed in the area east of the culvert inlet where the ditch is badly eroded. Most of the road segments are not "hydrologically connected".

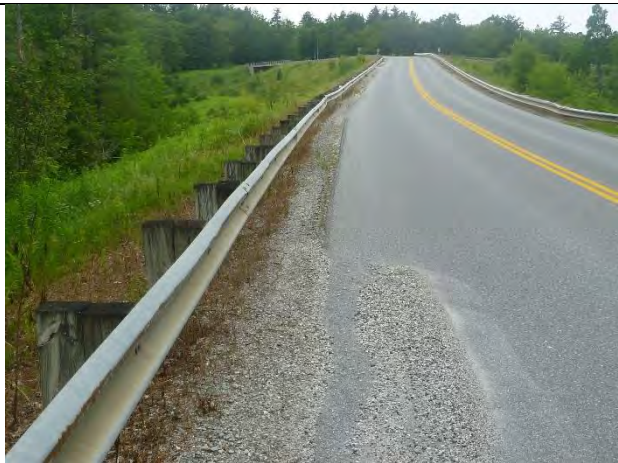
Site Description: West edge of road lacks a ditch and the shoulder is slightly elevated, stopping sheetflow. There is active erosion along the road shoulder, delivering sediment to Beaver Meadow Brook.

Photo 1: A section of North Road with no ditch.

BMP Description: Lower the road shoulder and/or install turnouts to allow for sheetflow off or road. Alternatively, install a narrow stone lined ditch with 6-8" minus stone along the edge of pavement.

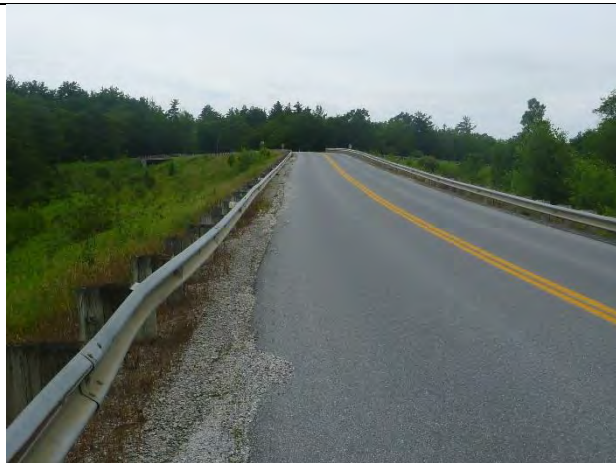
Photo 2: A section of North Road with active erosion is a sediment source to Beaver Meadow Brook.

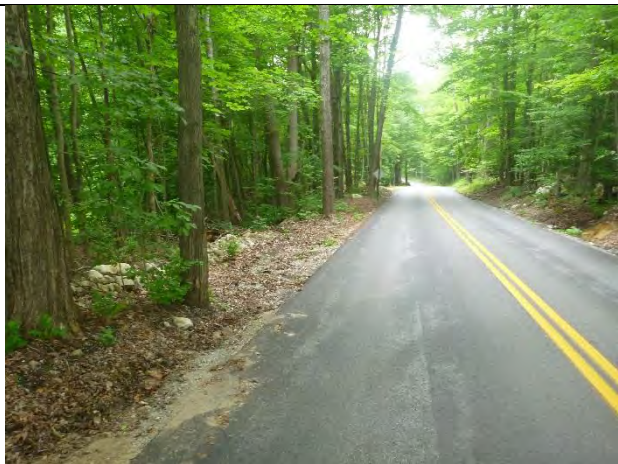
Site Description: Ditch on both sides of road is poorly defined and is eroding, culvert inlet on east side is very deep and pipe is too short, significant gully erosion at inlet (Photos 1 & 2). Tree clearing will be required to establish a ditch along the west side of the road.

Photo 1: Poorly defined and eroding ditch along North Road.

BMP Description: Extend the culvert inlet with a cut pipe section and enlarge both ditches and line with 6-8" minus stone.

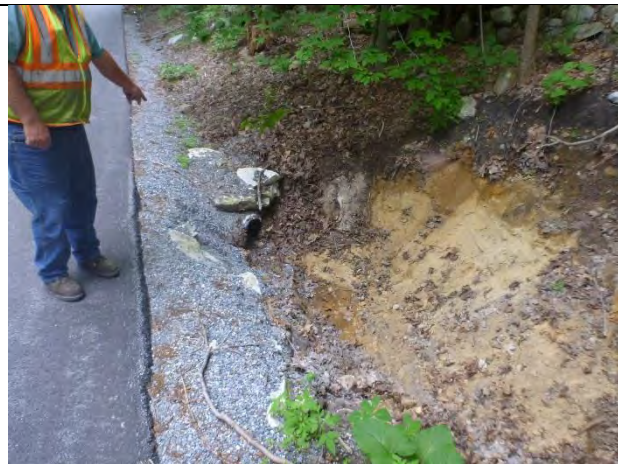
Photo 2: Gully erosion at the inlet to a cross culvert along North Road.

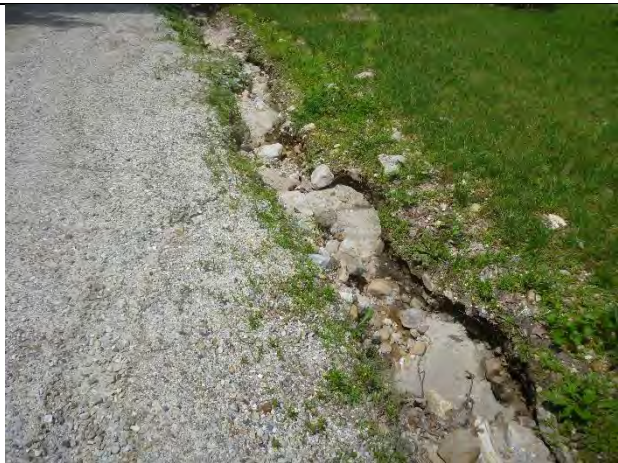
Site Description: The private road draining to the top of Barney Orchard Road is poorly crowned and lacking appropriate ditches, causing severe erosion and sediment transport to the municipal ditch and turnout. The ditches continuing along the road are undersized and are severely eroded. The large turnout at the bottom of the hill is filled with sediment, reducing effectiveness.

Photo 1: Eroded undersized ditch along Barney Orchard Rd.

BMP Description: Install a cross-culvert and stabilize ditches on the private road, excavate and stone-line the roadside ditches with 12" minus stone. Stabilize the cross-culvert outlet with large rock. Cleanout the sediment deposits along the stream bank and install a sediment trap.

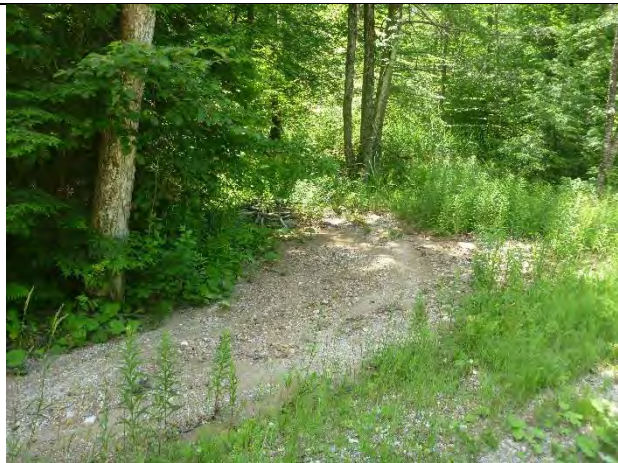
Photo 2: Sediment deposits at the bottom of the ditch near a small stream.

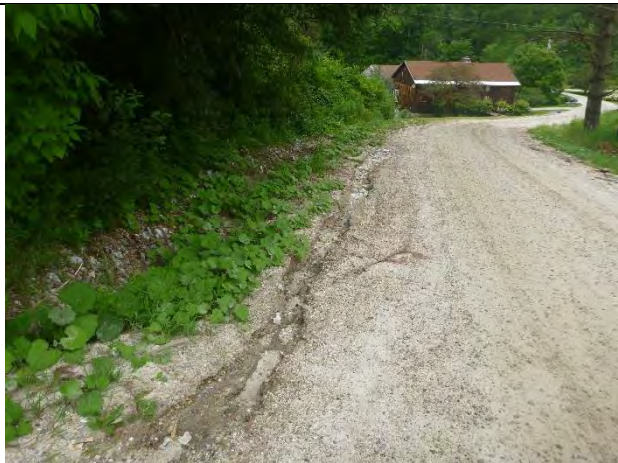
Site Description: The driveway for 185 Prouty Hill Rd does not have a culvert, the ditches have a very complicated path to direct flow across the road twice, increasing ditch and road erosion (Photo 1). Both ditches have areas of severe erosion and are carrying large volumes of sediment (Photo 2). Check dams and a sediment trap in the lower portion of the east ditch are filled with sediment.

Photo 1: Road erosion along Prouty Hill Road.

BMP Description: Install a driveway culvert to improve ditch conveyance. Remove three (3) cross-culverts and connect the ditches. Remove the grader berm along the western edge of the road. A culvert is likely needed under the driveway to the west. Line the ditches with 12" minus stone. Increase cleanout frequency for the existing check dams and sediment trap.

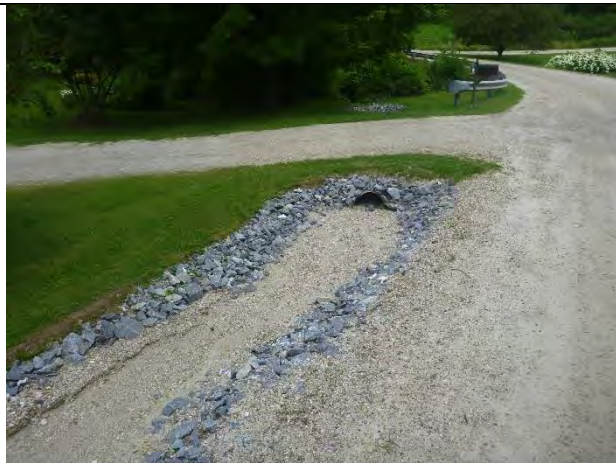
Photo 2: Check dams and a sediment trap along Prouty Hill road are filled with sediment from ditch and road erosion.

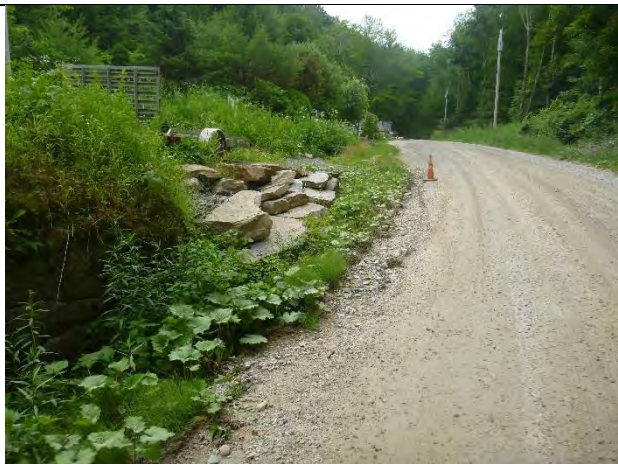
Site Description: A recently installed driveway culvert for a trailer parking spot along the road is poorly aligned and is interrupting flow through the ditch (Photo 1). Significant erosion is visible along the road edge and through the ditch (Photo 2).

Photo 1: A recently installed driveway culvert along Kelley Stand Road.

BMP Description: Reinstall the driveway culvert and stabilize the road edge with rock.

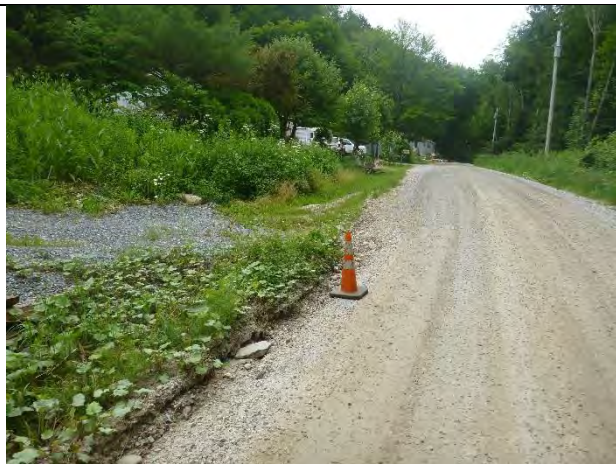
Photo 2: The poorly aligned culvert is interrupting flow and causing erosion along the road and ditch.

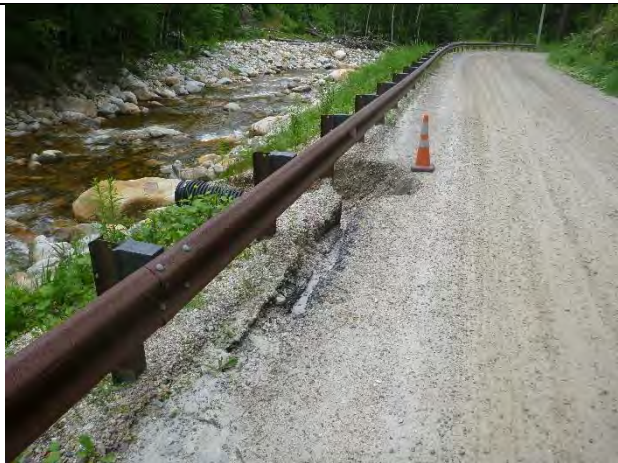
Site Description: Runoff along the east side of the road misses a small turnout to the river and is causing significant gully erosion (Photos 1 & 2). **Sunderland Highway Department completed this work in 2017.**

Photo 1: Gully erosion along Kelley Stand Road.

BMP Description: Improve the road crown and/or improve the inlet to the upslope turnout to better remove runoff from the road. Stabilize the gully erosion area with larger stone.

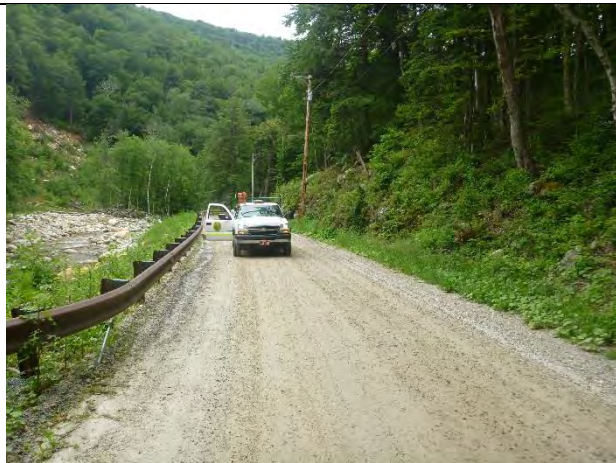
Photo 2: Erosion along the road delivers sediment to the adjacent river.

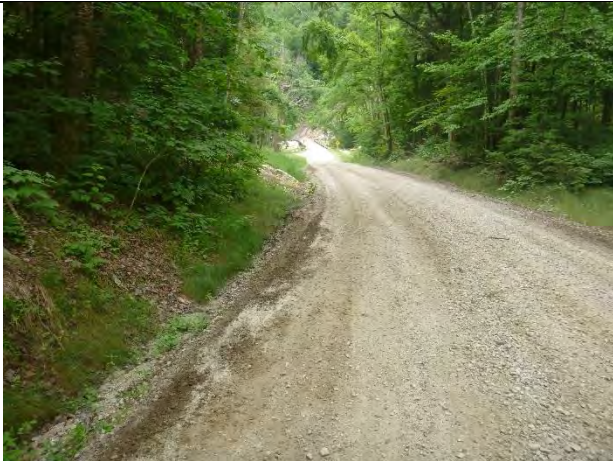
Site Description: The ditch along the south side of the road is very steep and eroding, small turnout at bridge traps some sediment (Photos 1 & 2).

Photo 1: A steep eroding ditch along Kelley Stand Road.

BMP Description: Construct a stone-lined ditch with 6-8" minus stone.

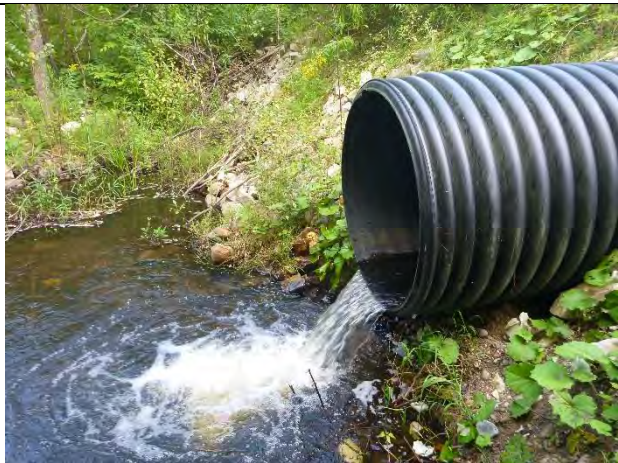
Site Description: New 48" culvert draining the pond is perched approximately 18" and is likely a complete AOP barrier (Photos 1 & 2).

Photo 1: The culvert under South Road is perched.

BMP Description: Based on an HY-8 culvert sizing analysis, we recommend a 5ft by 8ft box culvert embedded 1ft into the channel bottom. Large sediment retention baffles are likely required to maintain material, or provide step-pool formations throughout the steep culvert.

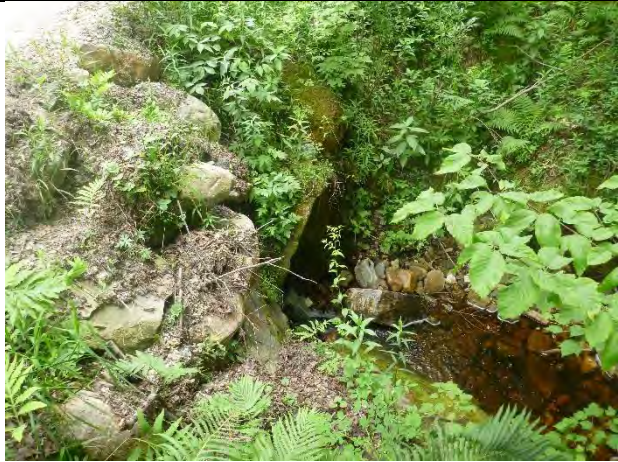
Site Description: Small tributary crosses under Kelley Stand Rd through a 48" CMP that is slightly perched. The culvert is short, and the embankments are near vertical with a stacked river rock header that is prone to erosion.

Photo 1: A culvert under Kelley Stand Road is short with near vertical embankments.

BMP Description: Extend or replace the culvert, install single piece headers on each side and either replace the culvert at a steep slope to match the channel profile or install a tailwater control structure to address the AOP barrier at the outlet drop.

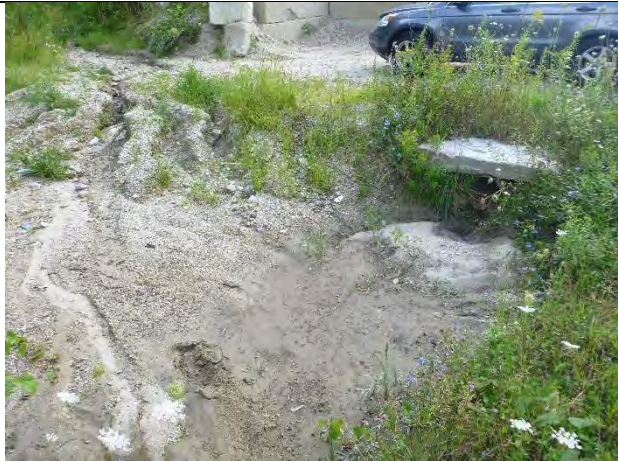
Site Description: The sand pit and salt shed area drain to a sediment trap along Dunham Rd that that may be undersized given the high sediment load (Photo 1). Erosion along the numerous flow paths is increasing sediment transport to the sediment trap (Photo 2). We did not observe any evidence of excess sediment loads leaving the site and reaching surface waters.

Photo 1: A sediment trap along Dunham Road that the Town sand pit and salt shed area drains to.

BMP Description: Enlarge the sediment trap and provide well defined armored flow paths for runoff to reduce additional erosion.

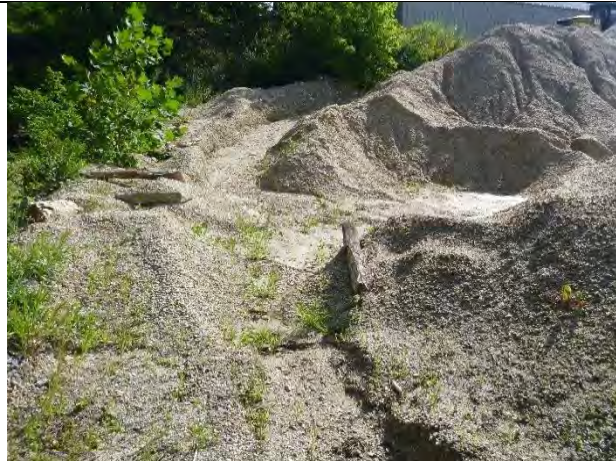
Photo 2: Erosion is overloading the sediment trap.

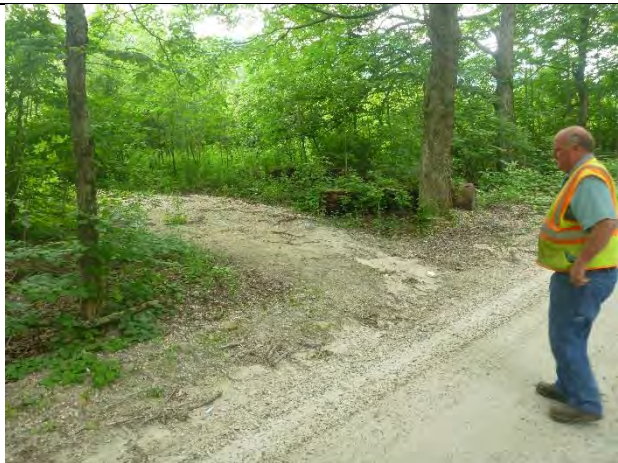
Site Description: An existing drainage turnout along Dunham Road is delivering large volumes of stormwater and sediment into a large wetland along the Battenkill River floodplain (Photos 1 & 2).

Photo 1: Turnout along Dunham Road.

BMP Description: Construct a sediment trap that can be easily cleaned from the roadway, stabilize the inlet and outlet of the trap to reduce erosion during large storms.

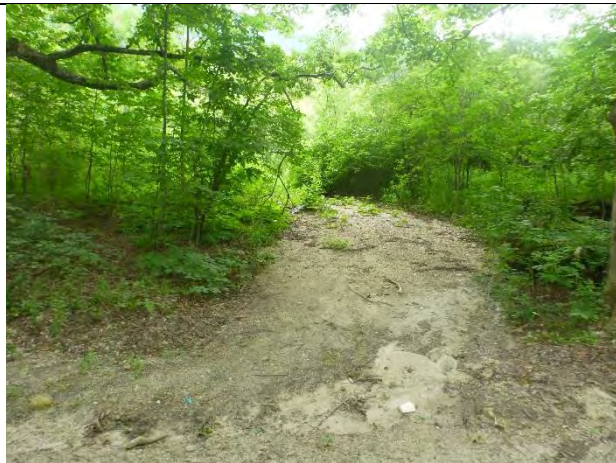
Photo 2: Sediment and stormwater in a large wetland along the Battenkill River floodplain.

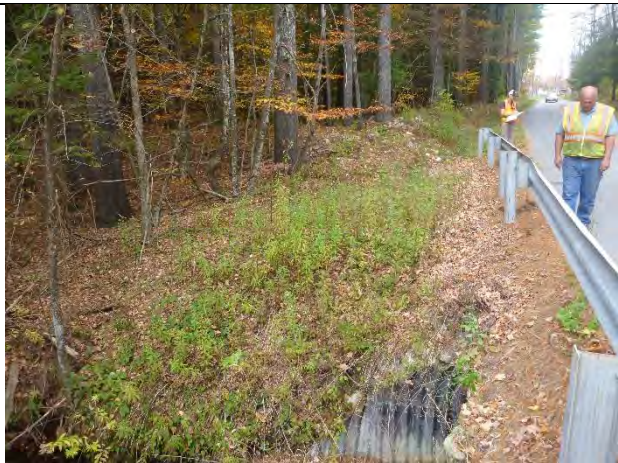
Site Description: Ditch draining a large portion of North Rd is fairly stable but drains directly in to a stream with minor gully erosion along the streambank (Photo 1). There is space for a BMP between the guardrail and the floodplain (Photo 2).

Photo 1: A ditch along North Road drains directly into a stream.

BMP Description: Install check dams in the lower portion of the ditch and install a sediment trap on top of the bank with an armored spillway into the channel.

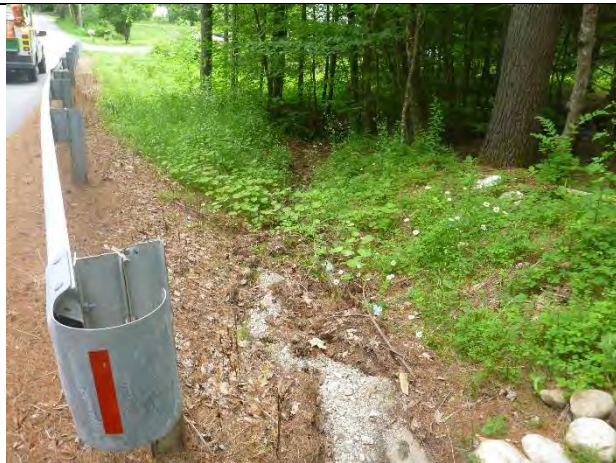
Photo 2: There is space for a BMP between the guardrail and floodplain to treat ditch runoff.

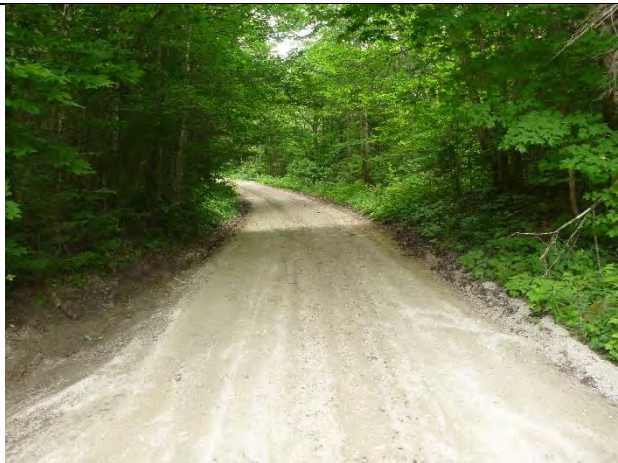
Site Description: A steep section of road drains to a small turnout along the edge of a wetland on the north side of the road (Photo 1). The ditch shows some active erosion and the turnout is filled with road sediment and with excess material stockpiled during road grading (Photo 2).

Photo 1: A steep section of Kelley Stand Road, with some active erosion in roadside ditches.

BMP Description: Enlarge the ditch and line with 12" minus stone. Install a sediment trap along the edge of the road with a stone lined overflow into the wetland. Ensure that road grading materials are stored in a location that does not drain to the wetland.

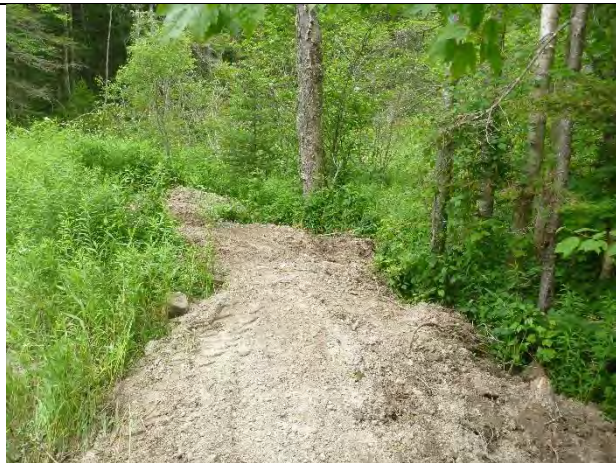
Photo 2: The turnout along the edge of a wetland is buried in sediment.

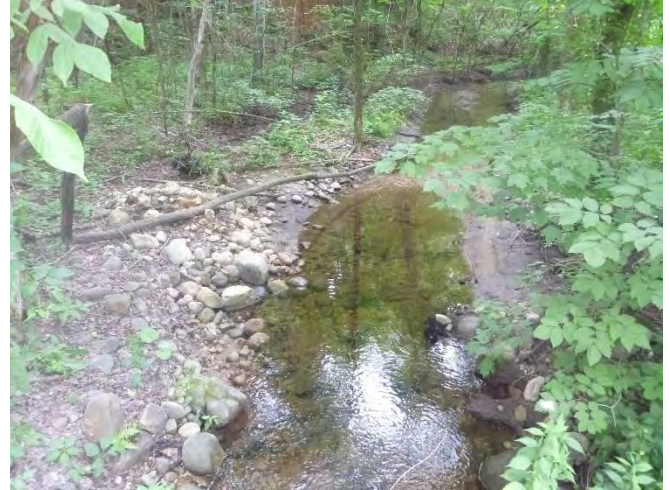
Figure 3: Wide and flat channel downstream of the crossing.

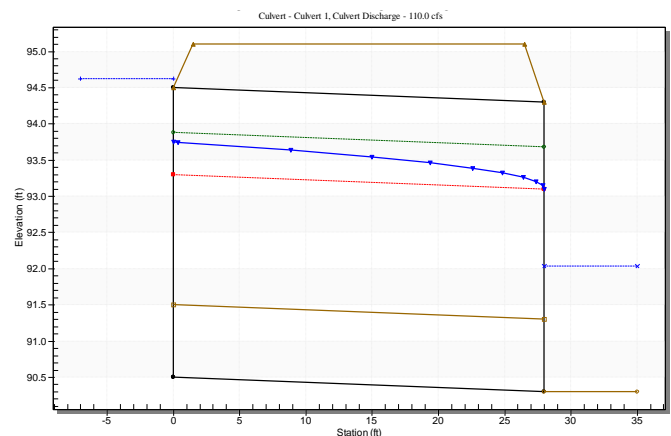
Figure 6: HY-8 plot of the 100-year flow (110cfs) filling the proposed culvert but not overtopping Dunham Road.

The hydraulic study recommends a 4ft tall by 8ft wide box culvert for a suitable replacement structure. This structure would tie in with the 8ft wide channel upstream of the crossing and is equal to the predicted bankfull channel width based on drainage area. The recommended box culvert includes 6-inch tall sediment retention baffles to ensure that native streambed material is continuous through the culvert. Assuming an additional 6-inches of deposition on top of the baffles, the culvert would have an effective opening of 3ft tall by 8ft wide. The proposed culvert bottom (with sediment retention) would be comparable to the existing culvert. The overall culvert slope will be lower, improving retention of bed material within the culvert and reducing downstream scour. This structure passes the Q25 with approximately 0.5ft of freeboard and does not overtop the road during the Q100. We included the VTrans specified culvert dimensions in the HY-8 model and the predicted water surface elevations were nearly identical to their results (Figures 5 and 6).

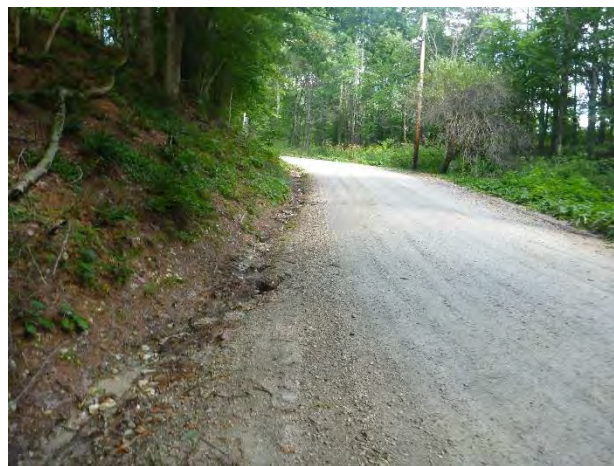
Existing Conditions Notes: The ditch along the western side of Bentley Hill Road is undersized and eroding. The ditch ends at a bend in the road approximately 60ft north of the driveway. Runoff spills on to the road and is causing severe gully erosion south of the driveway where it enters the stream near the conveyance culvert outlet. A turnout near the conveyance culvert inlet is unstable.

Photo 2: Undersized and eroded ditch along Bentley Hill Road draining to the stream crossing.

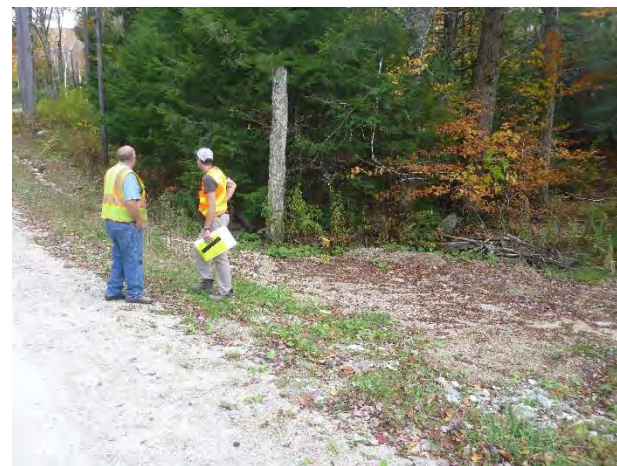
Existing Conditions Notes: The private road draining to the top of Barney Orchard Road is poorly crowned and is lacking appropriate ditches, causing severe erosion and sediment transport to the municipal ditch and turnout. The ditches along both sides of Barney Orchard Road are undersized and are severely eroded. The large turnout at the bottom of the hill is filled with sediment, reducing effectiveness.

Photo 2: Large turnout to floodplain is filled with road sediment.

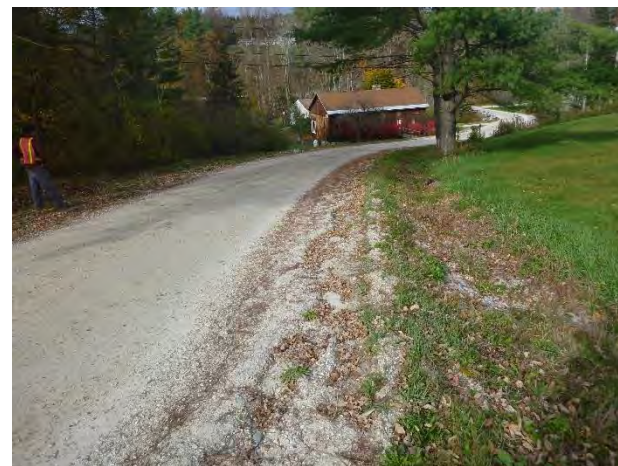
Existing Conditions Notes: The driveway for 185 Prouty Hill Road does not have a culvert requiring two cross-culverts with a junction to carry runoff down the road. Small grader berms are increasing rill erosion along the road edges. Ditches have moderate to severe gully erosion. Check dams at the bottom of the east ditch are trapping large volumes of sediment before reaching the sediment basin. The west ditch has a small sediment trap before emptying in to Fayeville Branch.

Photo 2: Severe erosion along the road edge where a small grader berm is preventing sheet flow into the ditch.

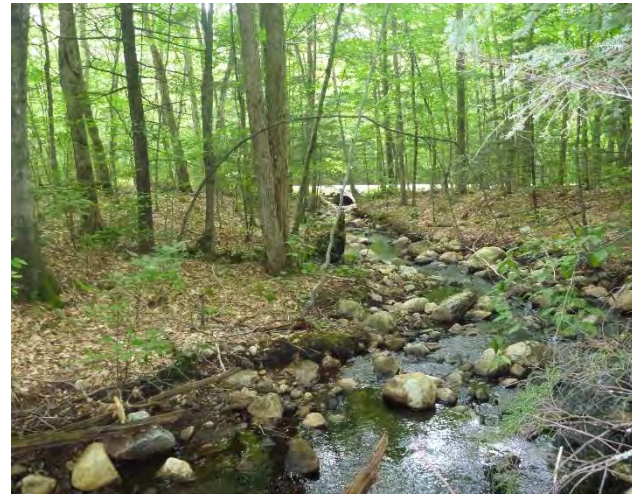
Figure 2: Incised channel upstream of the North Road culvert.

Cole Brook overtopped the culvert during the T.S. Irene flood in 2011 and caused severe damage to North Road. The floodwaters completely washed out the culvert and water spilled over the bank to the north and flowed along the road to the Beaver Meadow Brook crossing approximately 400ft to the north. The washed-out culvert was not damaged and was reset during flood recovery efforts. Total costs to repair the road and reset the culvert were close to \$20,000. The T.S. Irene flows likely scoured the upstream channel, decreasing floodplain accessibility during future floods.

The hydraulic study recommends a 6ft tall by 12ft wide box culvert for a suitable replacement structure. This structure would tie in with the 10-12ft wide channel upstream of the crossing and is only slightly narrower than the predicted bankfull width of 14ft based on drainage area. The recommended box culvert includes 6-inch tall sediment retention baffles to ensure that native streambed material is continuous through the culvert. Assuming an additional 6-inches of deposition on top of the baffles, the culvert would have an effective opening of 5ft tall by 12ft wide. The proposed culvert bottom (with sediment retention) would be approximately 1ft lower than the existing culvert. This structure passes the Q25 with approximately 0.7ft of available capacity and does not overtop the road during the Q100. We included the VTrans specified culvert dimensions in the HY-8 model and the predicted water surface elevations were nearly identical to their results (Figures 4 and 5).

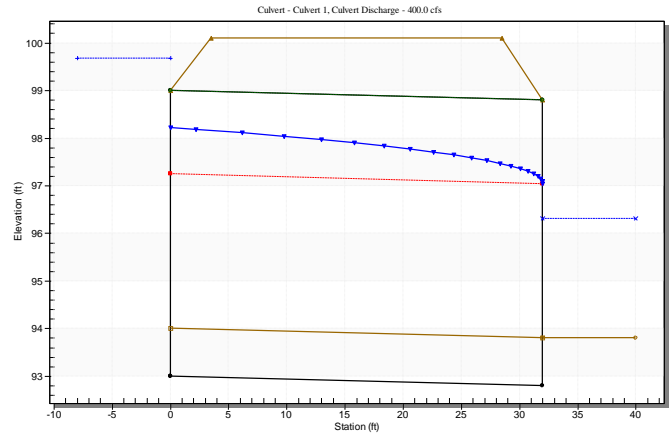
Figure 5: HY-8 plot of the 100-year flow (400cfs) filling the proposed culvert but not overtopping North Road.
