Town of Arlington Hazard Mitigation Plan

Arlington, Vermont

April 8, 2019
Revised May 23, 2019
Revised July 15, 2019
Adopted August 26, 2019

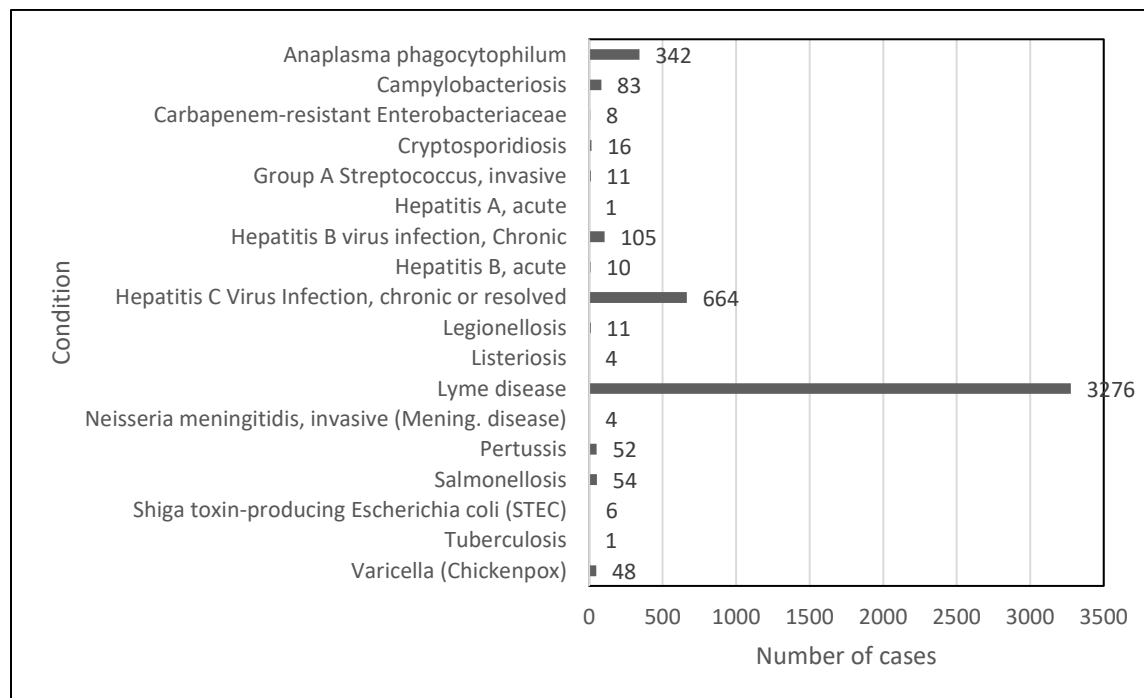
Figure 4. Disease cases in Bennington County from 2006 to 2017. Source: Veronica Fialkowski, Vermont Department of Health

The most prevalent infectious disease in Bennington County has been Lyme disease, carried by and transmitted by ticks. The symptoms can range from minor to very severe, and are a clear threat to anyone in the town. Figure 4 shows those diseases tracked by the Vermont Department of Health.
