# Town of Shaftsbury Hazard Mitigation Plan

## Shaftsbury, Vermont

Adopted May 17, 2021

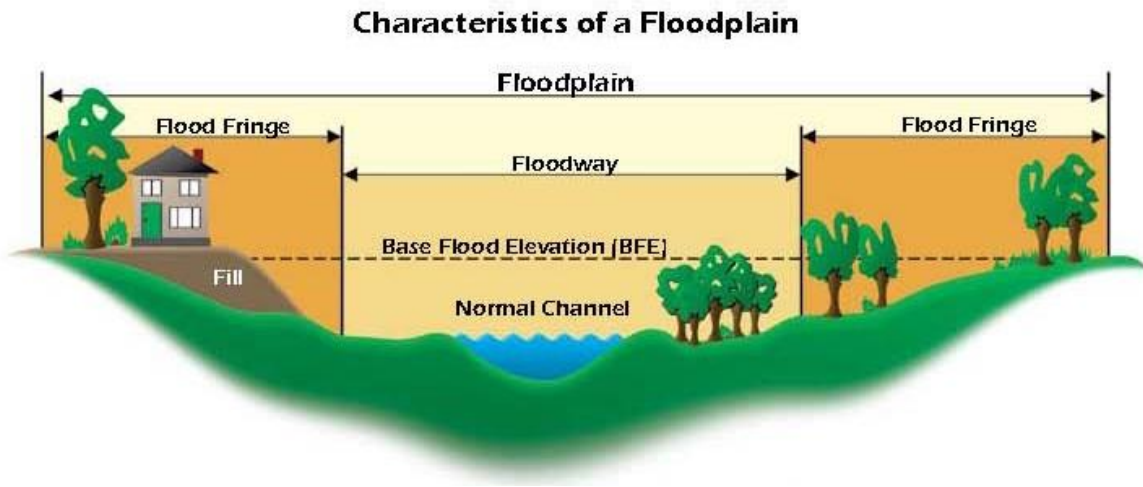
Figure 1. Typical floodplain

Special Flood Hazard Areas: these are areas mapped by FEMA and using the LIDAR derived zones that were adopted in late 2015. Table 6 shows the number of structures, by type, in the special flood hazard and river corridors, and both areas are shown in Map 5. Figure 1 below shows the parts of a typical floodplain.

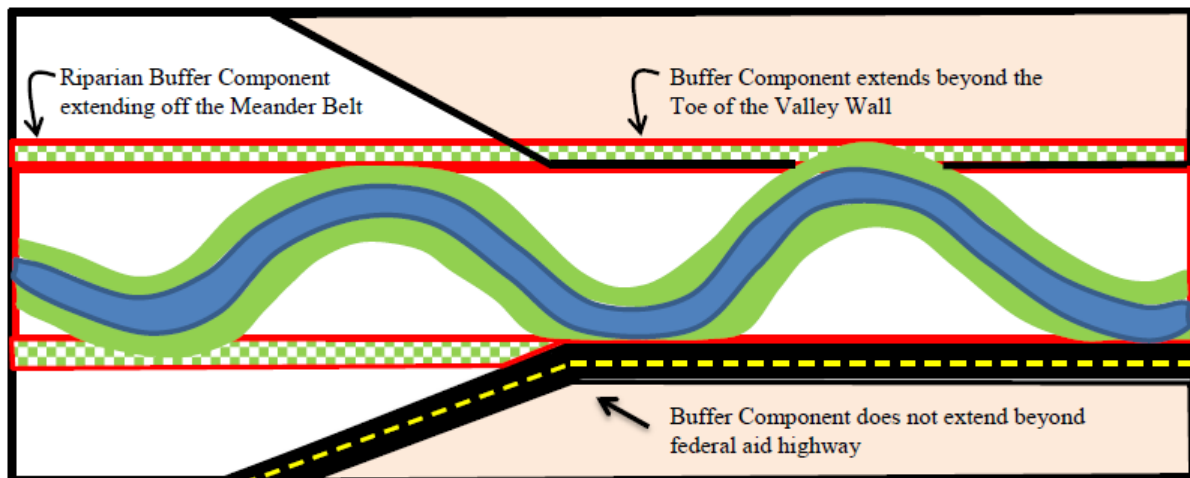
Figure 2. River corridors

River Corridors: River corridors (Figure 2) have been mapped by the Vermont Agency of Natural Resources using geospatial data and will be modified by VT ANR river scientists using available

field data. The data were used to calculate the “meander belt width” or area within which a river would move across the valley. As rivers shift their location both vertically and horizontally, erosion of adjacent lands can occur and threaten properties that may be outside of special flood hazard areas. The additional buffer allows for placement of structures beyond the meander belt width and provides for space for the changes in river geometry, bank stabilization and establishment of woody buffers to provide resistance to erosion from the movement of the channel (Vermont River Management Program 2010).

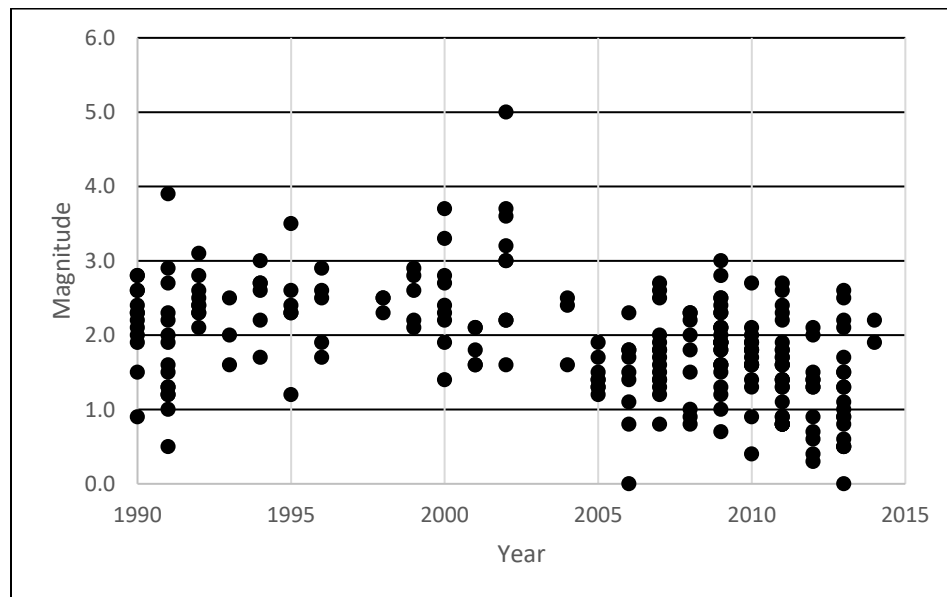
Figure 3. Plot of earthquake and magnitude for occurrences within 100 miles of Bennington County, VT. Source: Northeast Earthquake Maps and Catalog 2015

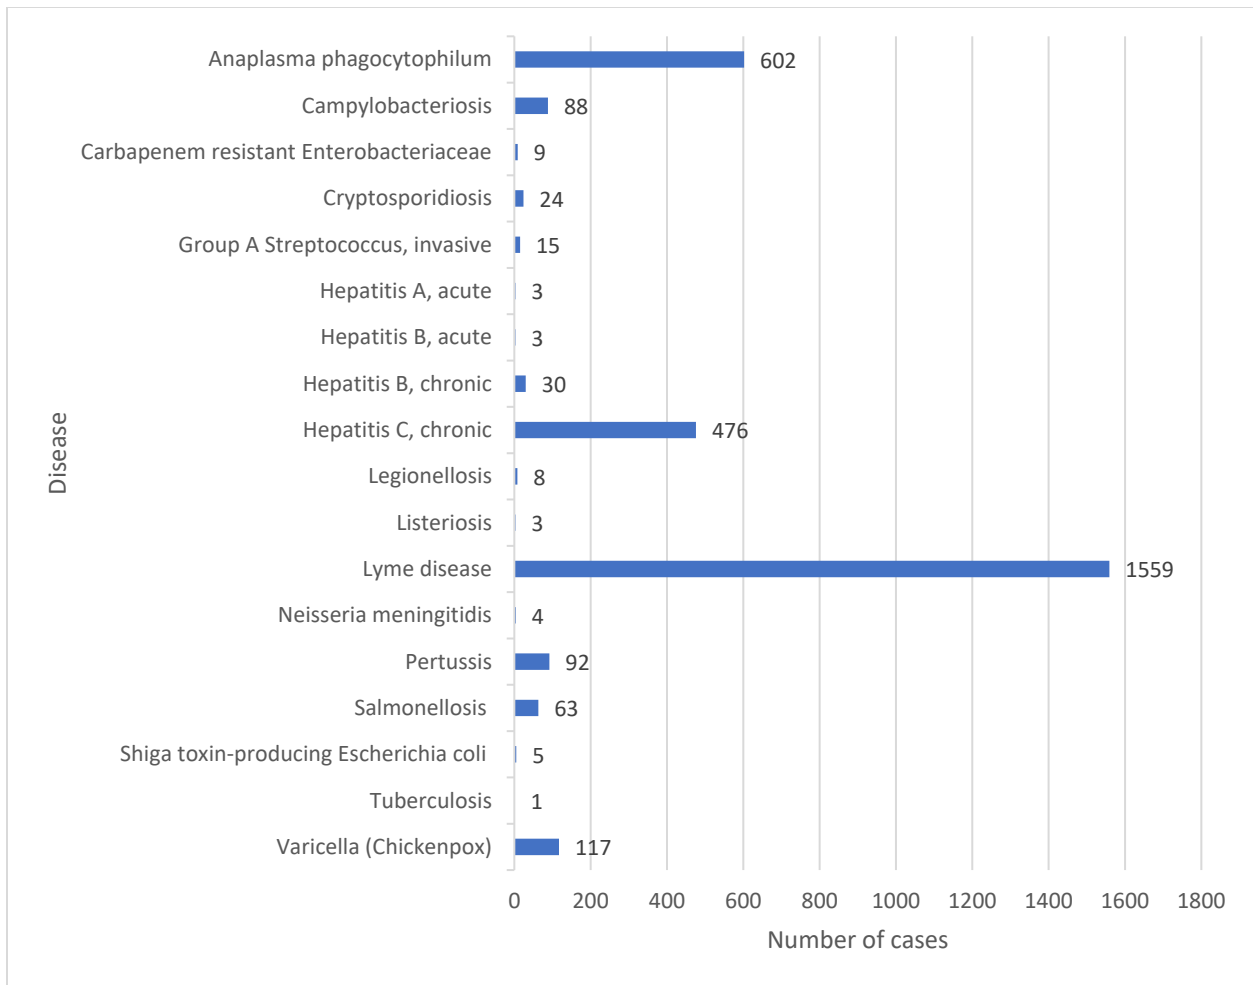
The most prevalent infectious disease in Bennington County has been Lyme disease, carried by and transmitted by ticks. The symptoms can range from minor to very severe and are a clear threat to anyone in the town. Figure 4 shows those diseases tracked by the Vermont Department of Health.

Figure 4. Disease cases in Bennington County from 2006 to 2019.

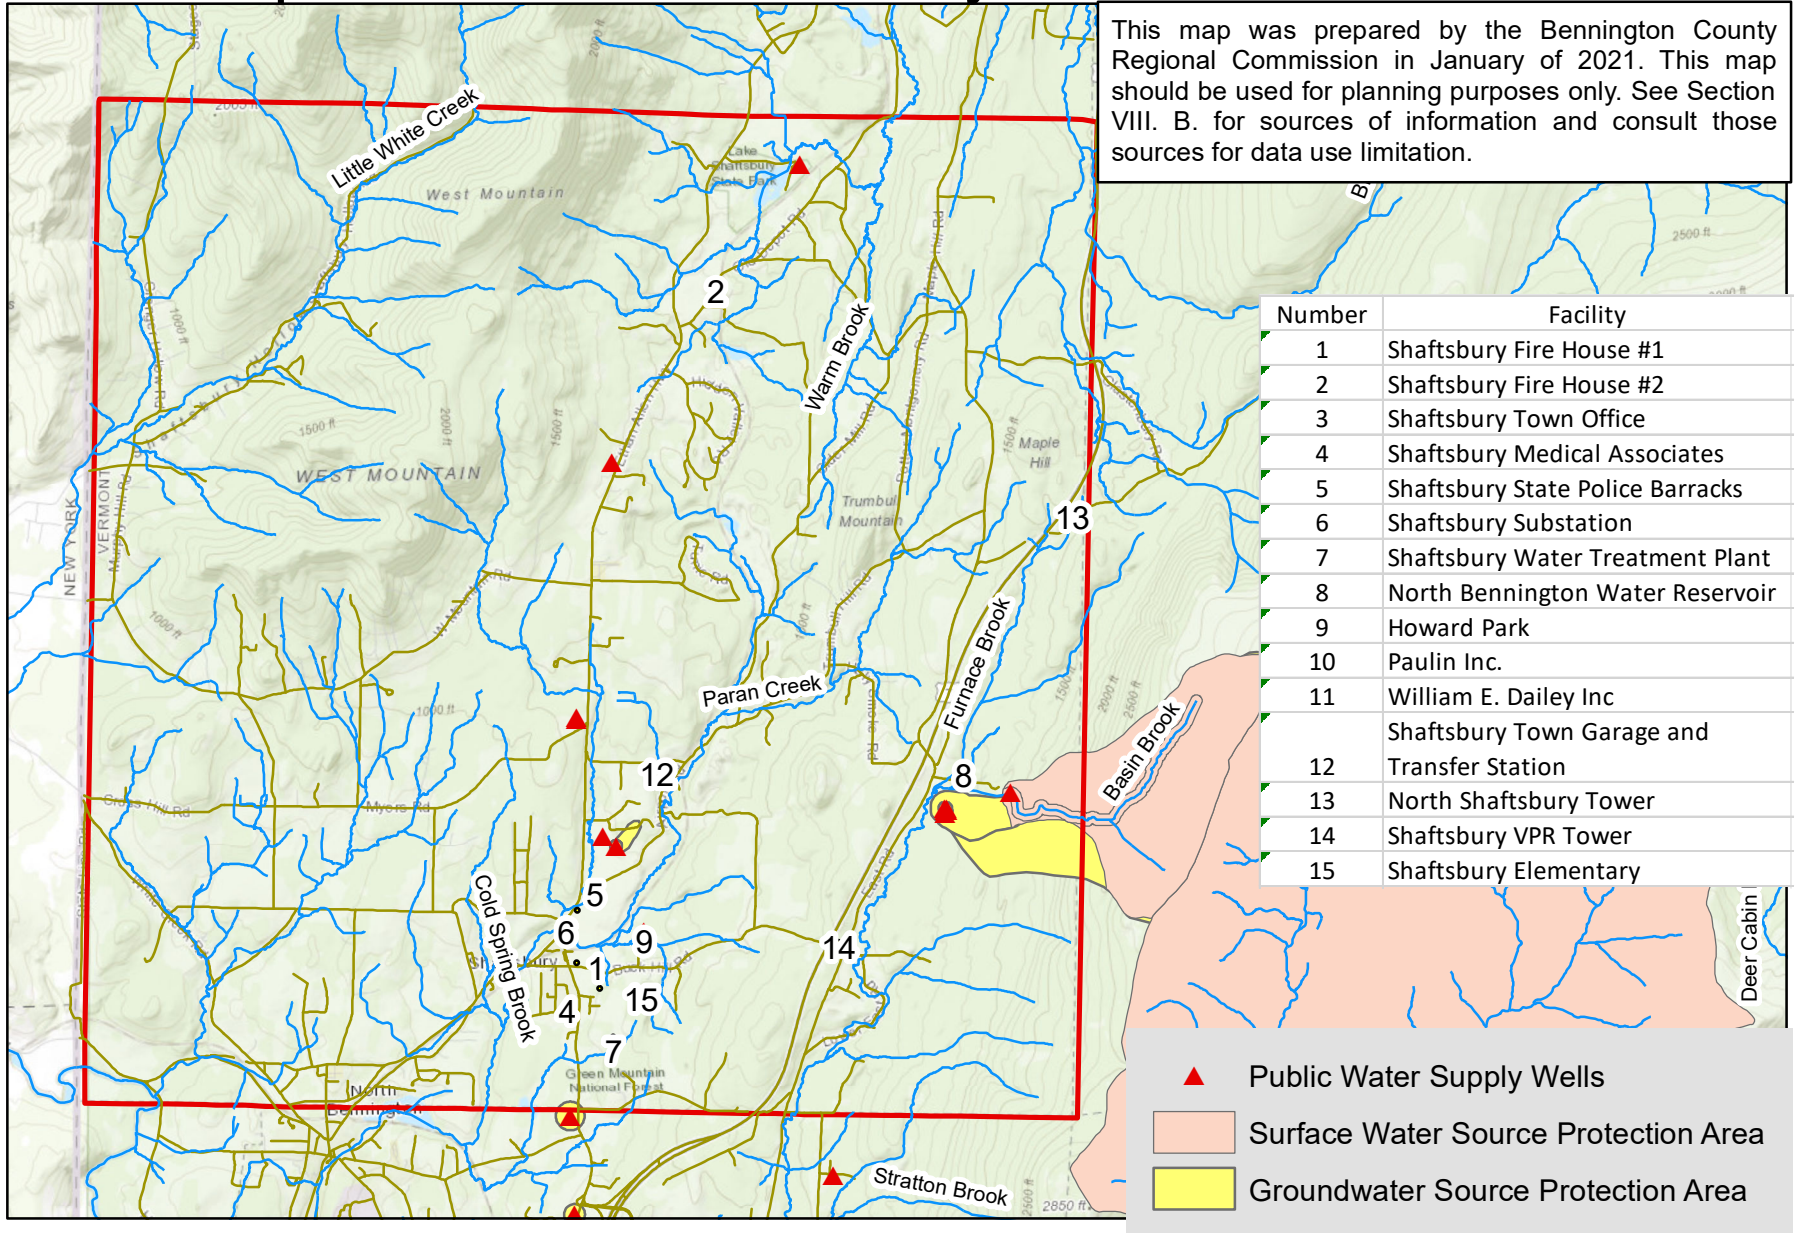
# Map 4. Town of Shaftsbury Critical Facilities

Number	Facility
1	Shaftsbury Fire House #1
2	Shaftsbury Fire House #2
3	Shaftsbury Town Office
4	Shaftsbury Medical Associates
5	Shaftsbury State Police Barracks
6	Shaftsbury Substation
7	Shaftsbury Water Treatment Plant
8	North Bennington Water Reservoir
9	Howard Park
10	Paulin Inc.
11	William E. Dailey Inc
12	Shaftsbury Town Garage and Transfer Station
13	North Shaftsbury Tower
14	Shaftsbury VPR Tower
15	Shaftsbury Elementary

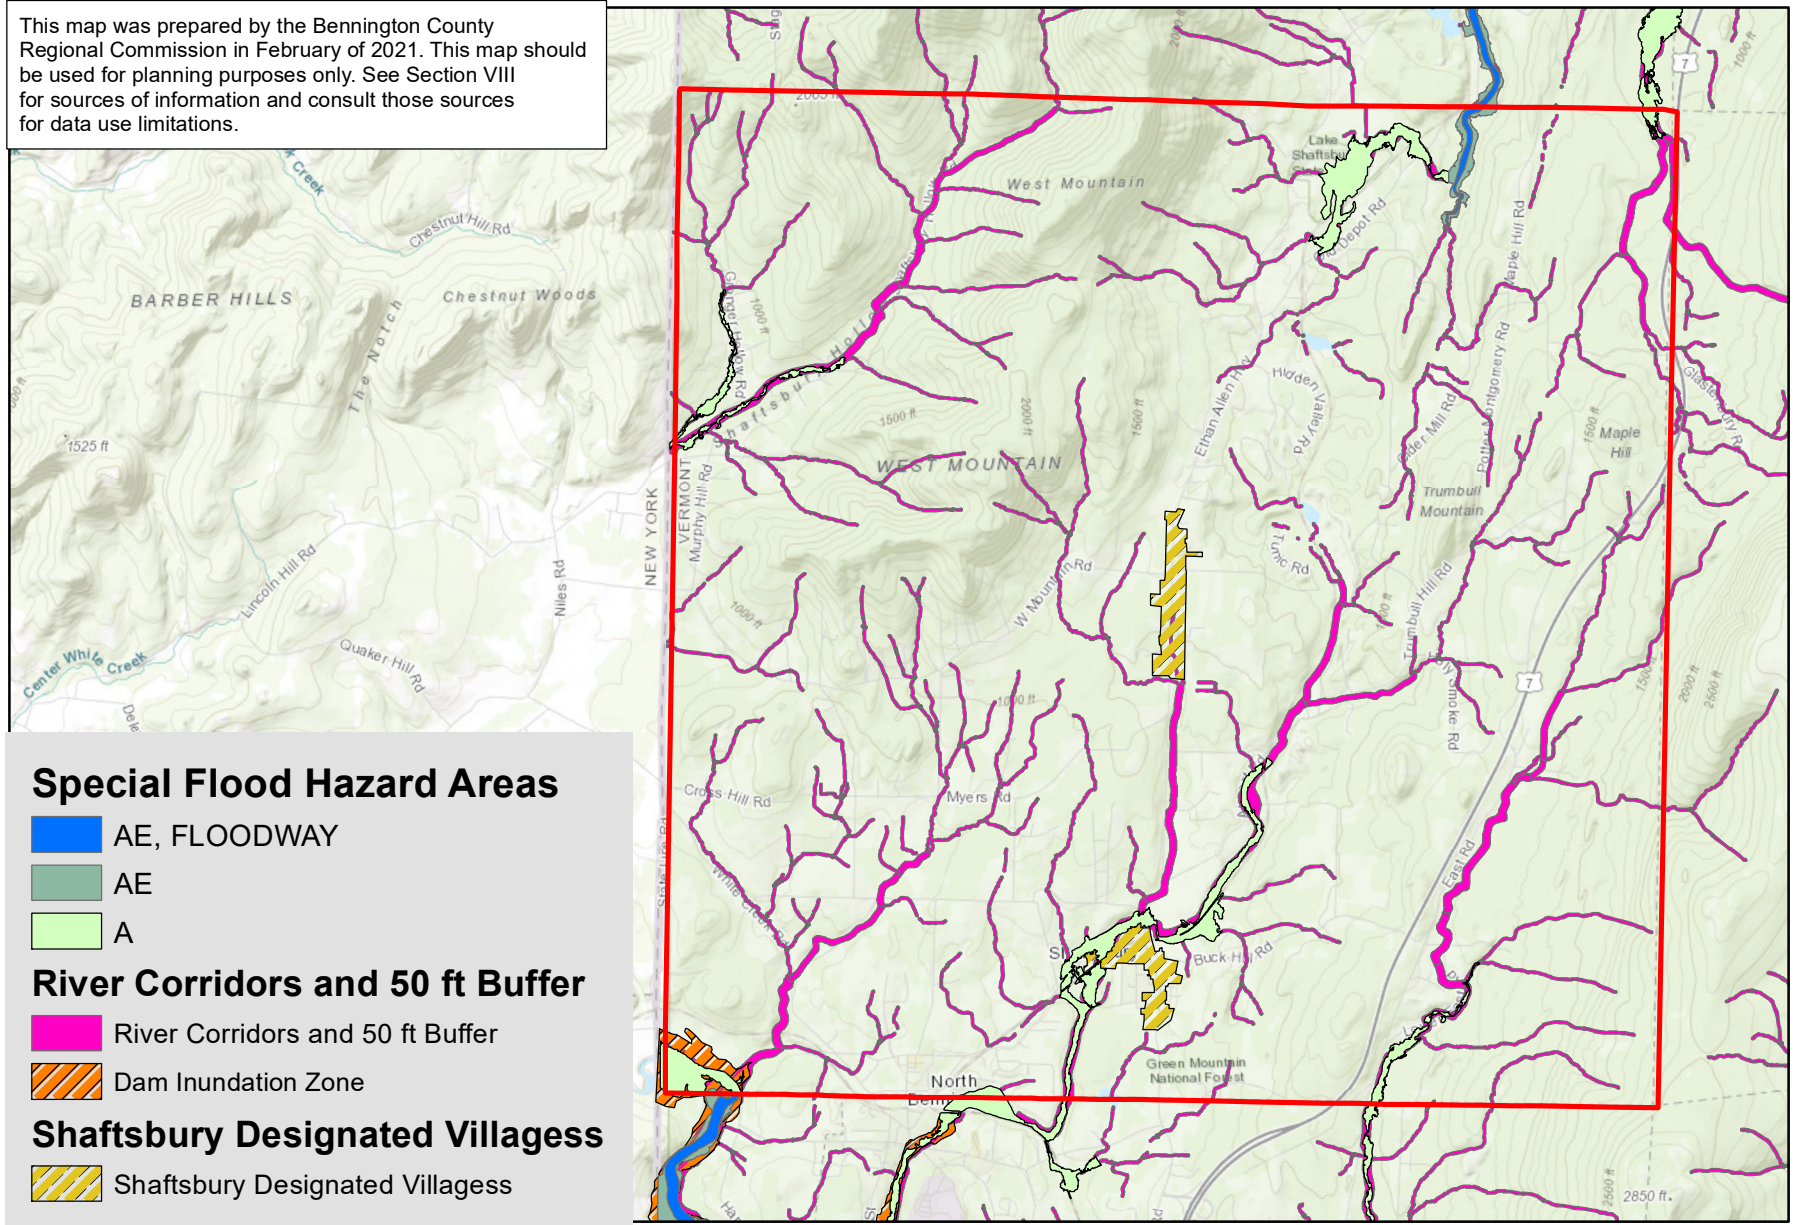
# Map 5. Special Flood Hazard Areas and River Corridors

**Special Flood Hazard Areas**

- AE, FLOODWAY
- AE
- A

Flash floods can occur after spring melt of mountain snow, following large storms such as Tropical Storm Irene, or after significant thunderstorms. Map 5 shows the location of both flood hazard zones and river corridors (formerly fluvial erosion hazard zones).

There are no stream gauges within the town of Shaftsbury. The closest is a gauge in Arlington that is only periodically monitored. There are no stations measuring fluvial erosion. Finally, no post Irene flood elevation data were collected in Shaftsbury. Shaftsbury has the Floodway and Zones AE and A mapped within the town. There have been no NFIP-designated repetitive losses within Shaftsbury. Therefore, based on local knowledge of past events and FEMA and VT ANR mapping, Map 5 show the most likely extent of damages from flooding or fluvial erosion.
