TOWN OF STAMFORD

# Hazard Mitigation Plan

MUNICIPAL ADOPTION DATE: AUGUST 15, 2024

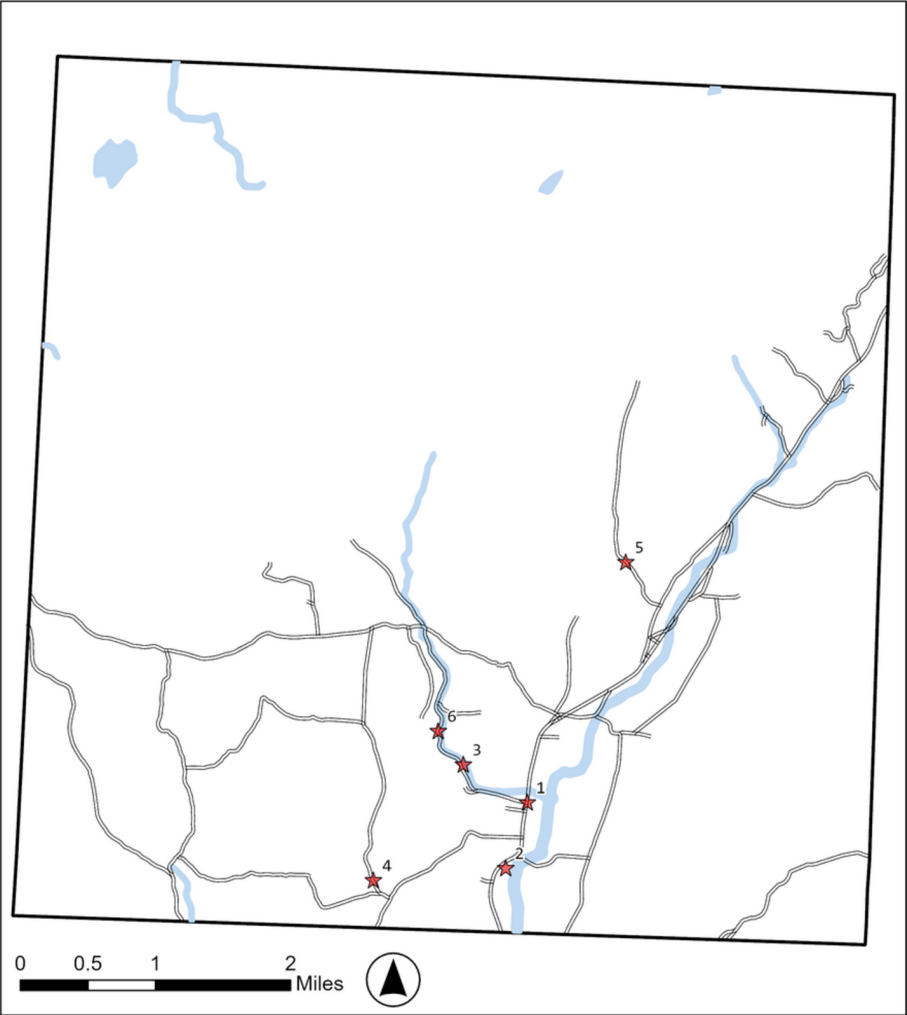
Map 7: Hazard areas in Stamford VT Source: Bennington County Regional Commission, 2023

Map 7 is a composite map showing areas identified by the planning team as vulnerable to flooding, steep grades, and areas needing major culvert upgrades. Other priority hazards were not mapped either as adequate surveys have not been completed, or they could affect the entire town. Table 20 lists the hazard areas, shown on Map 7.
